Project Number A-00402 (3700)

**Re-Inspection
Asbestos Survey Report - Revised**

**Wyvern Barracks
Barrack Road
Exeter
Devon
EX2 6AE**

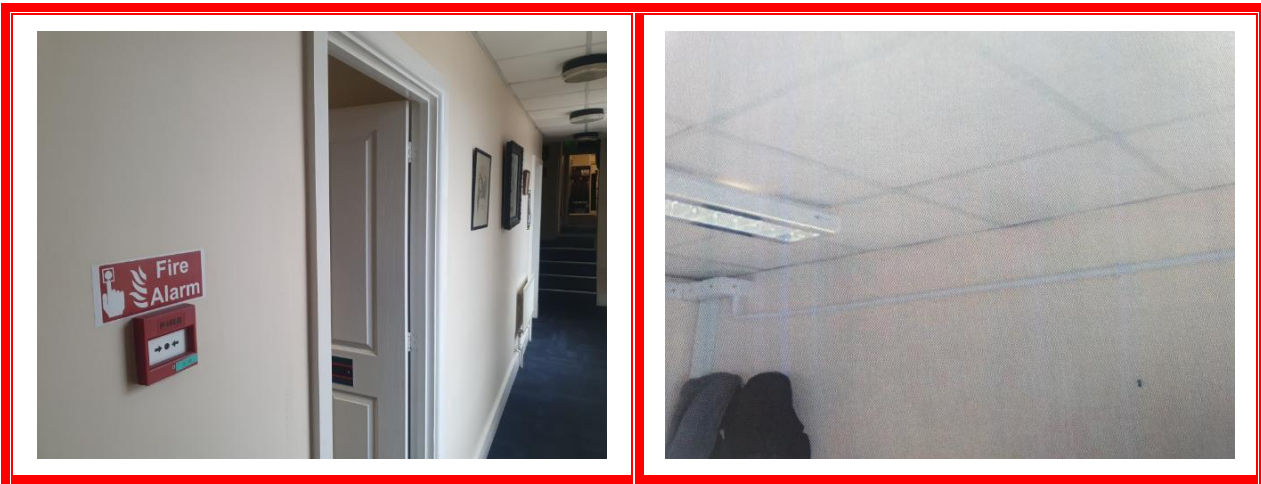
Item No:	36	Sample No:	N/A
Location:	Building 7, First Floor - Office F24

Material Description:	Safe - No Access Gained	
Identification:	Presumed to Contain Asbestos	
Approx. quantity:	1 no	
Accessibility	Difficult	<i>Assessment Score</i>
Product type:	Asbestos insulating board	2
Extent of Damage:	Major damage	3
Surface Treatment:	Unsealed AIB	2
Asbestos type:	Amosite, Chrysotile	2
Material Assessment Score:		9
Priority Assessment Score:		Medium
Action:	Manage	
Comments:	No access within safe casings without damaging safe. No photo was allowed on request of the room occupant

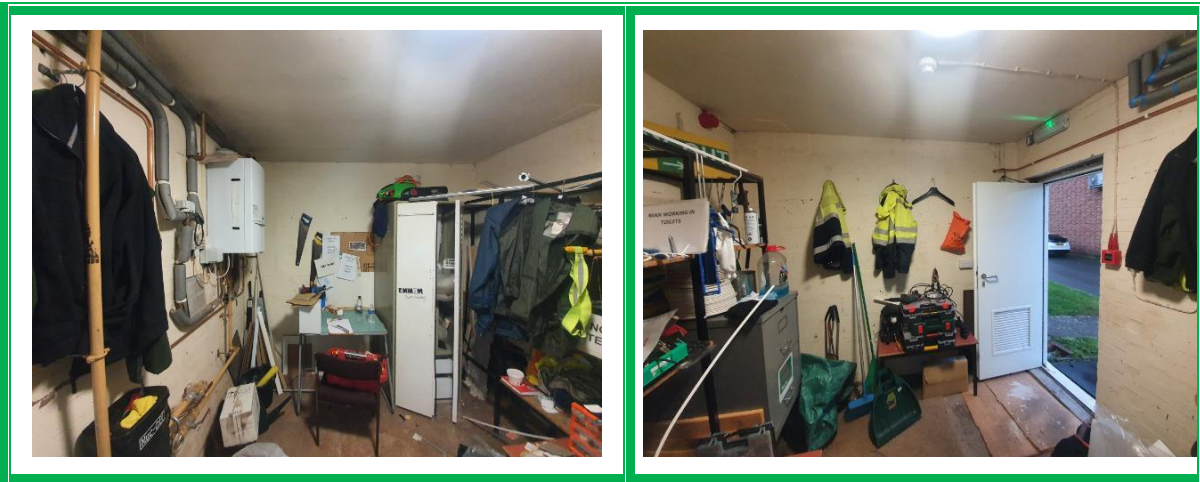
Item No:	9	Sample No:	N/A
Location:	Building 22, Ground Floor - Plant Room 009

Material Description:	No Suspect Materials Found	
Identification:	N/A	
Approx. quantity:	N/A	
Accessibility	N/A	<i>Assessment Score</i>
Product type:	N/A	N/A
Extent of Damage:	N/A	N/A
Surface Treatment:	N/A	N/A
Asbestos type:	N/A	N/A
Material Assessment Score:		
Priority Assessment Score:		
Action:	N/A	
Comments:	Previously un-accessed room. Now accessed and no asbestos found. Modern boiler

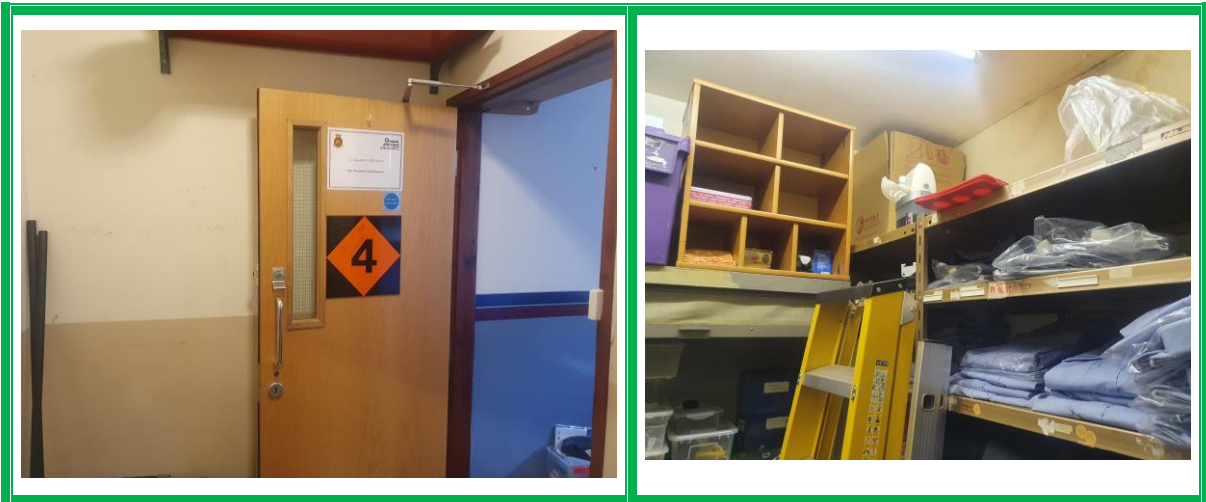
Item No:	13	Sample No:	N/A
Location:	Building 14, Ground Floor - Store

Material Description:	No Suspect Materials Found	
Identification:	N/A	
Approx. quantity:	N/A	
Accessibility	N/A	Assessment Score
Product type:	N/A	N/A
Extent of Damage:	N/A	N/A
Surface Treatment:	N/A	N/A
Asbestos type:	N/A	N/A
Material Assessment Score:		
Priority Assessment Score:		
Action:	N/A	
Comments:	Previously a no access area, now accessed. No asbestos found. Block walls, Plasterboard ceiling, Non-asbestos lino.

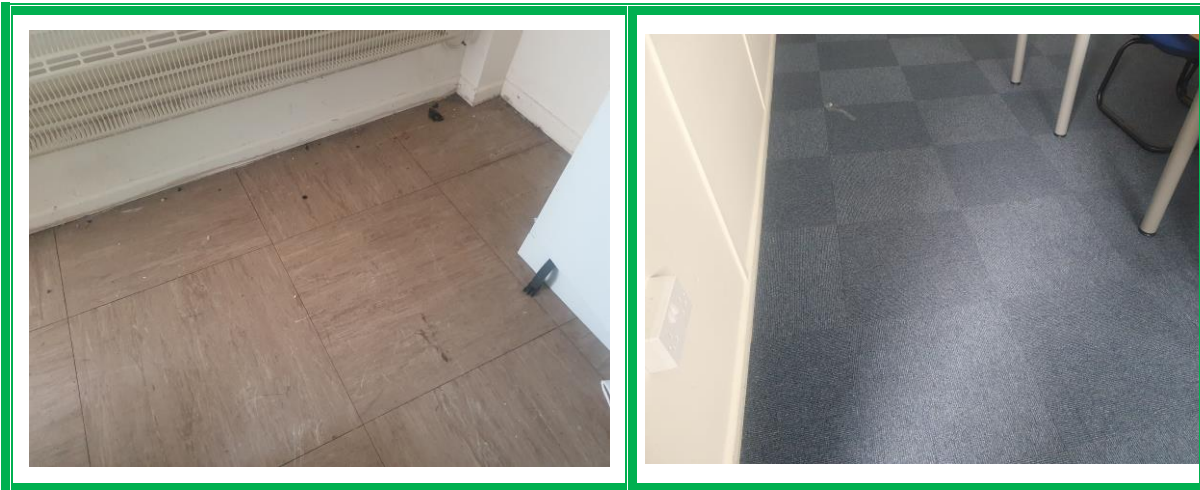
Item No:	15	Sample No:	N/A
Location:	Building 13, Ground Floor - Store 13B

Material Description:	No Suspect Materials Found	
Identification:	N/A	
Approx. quantity:	N/A	
Accessibility	N/A	<i>Assessment Score</i>
Product type:	N/A	N/A
Extent of Damage:	N/A	N/A
Surface Treatment:	N/A	N/A
Asbestos type:	N/A	N/A
Material Assessment Score:		
Priority Assessment Score:		
Action:	N/A	
Comments:	Previously a no access area, now accessed. No asbestos found. Non-asbestos floor tiles and ceiling tiles, plasterboard walls.

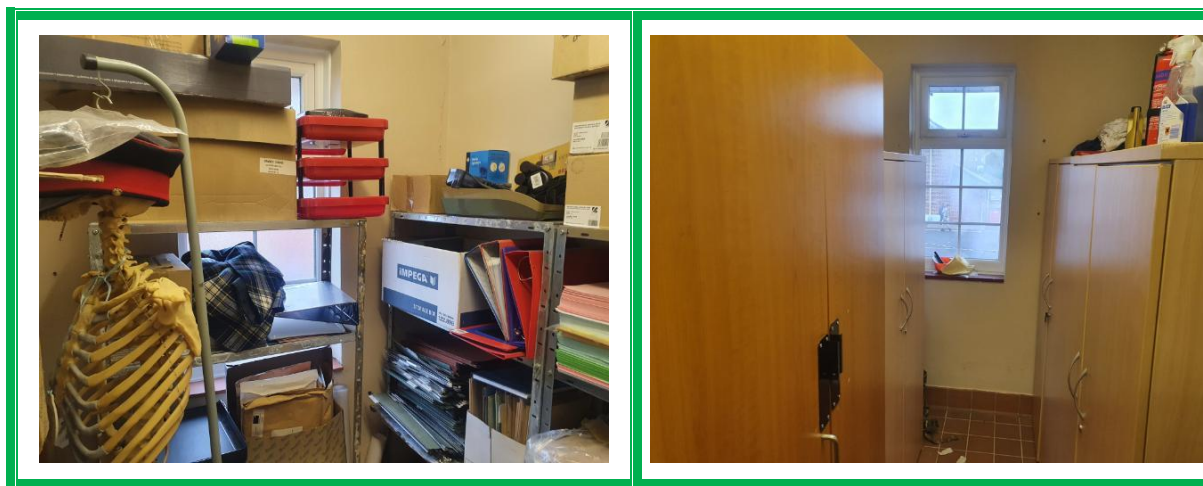
Item No:	24	Sample No:	N/A
Location:	Building 8, First Floor - Cupboards x 3 024

Material Description:	No Suspect Materials Found	
Identification:	N/A	
Approx. quantity:	N/A	
Accessibility	N/A	<i>Assessment Score</i>
Product type:	N/A	N/A
Extent of Damage:	N/A	N/A
Surface Treatment:	N/A	N/A
Asbestos type:	N/A	N/A
Material Assessment Score:		
Priority Assessment Score:		
Action:	N/A	
Comments:	Previously un-accessed rooms. Now accessed and no asbestos found. No access within timber boxing

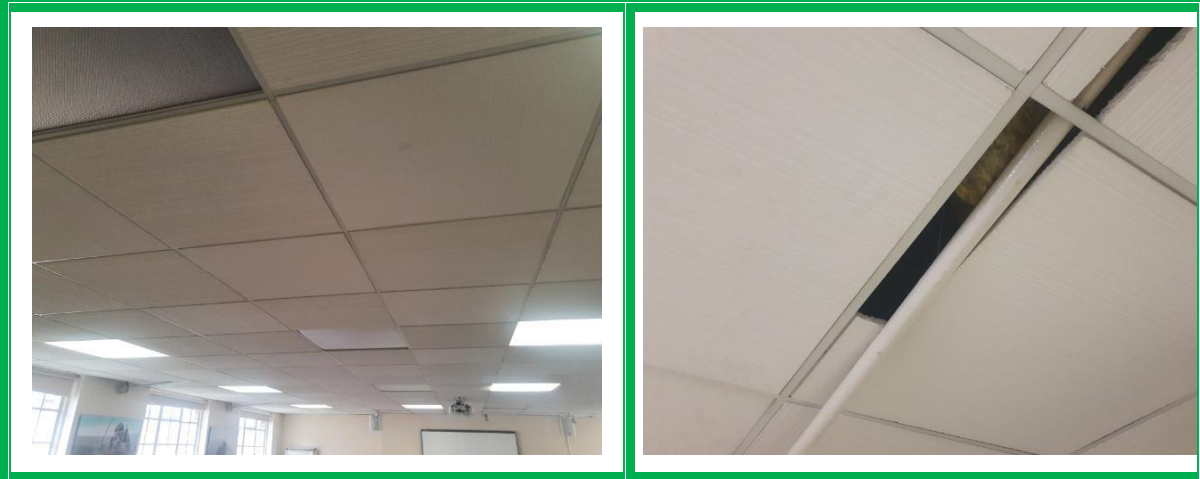
Item No:	39	Sample No:	DK/01
Location:	Building 7, Ground Floor - Conference Room and Room F17 039

Material Description:	Ceiling Tiles - Insulating Board	
Identification:	Sampled - No Asbestos Found	
Approx. quantity:	N/A	
Accessibility	N/A	<i>Assessment Score</i>
Product type:	N/A	N/A
Extent of Damage:	N/A	N/A
Surface Treatment:	N/A	N/A
Asbestos type:	N/A	N/A
Material Assessment Score:		
Priority Assessment Score:		
Action:	N/A	
Comments:	N/A

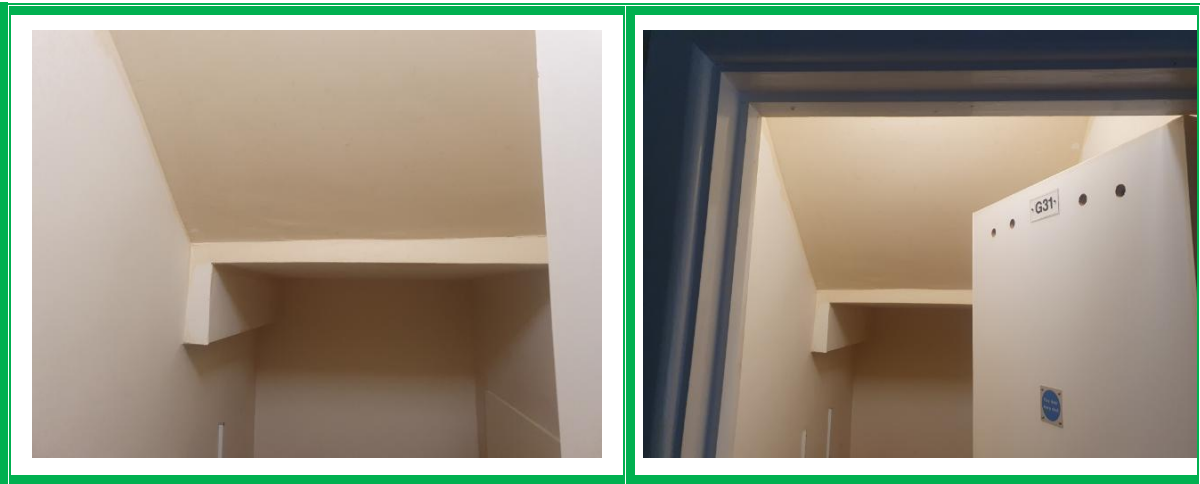
Item No:	40	Sample No:	N/A
Location:	Building 7, Ground Floor - Room G31 040

Material Description:	No Suspect Materials Found	
Identification:	N/A	
Approx. quantity:	N/A	
Accessibility	N/A	<i>Assessment Score</i>
Product type:	N/A	N/A
Extent of Damage:	N/A	N/A
Surface Treatment:	N/A	N/A
Asbestos type:	N/A	N/A
Material Assessment Score:		
Priority Assessment Score:		
Action:	N/A	
Comments:	Previously un-accessed room. Now accessed and no asbestos found

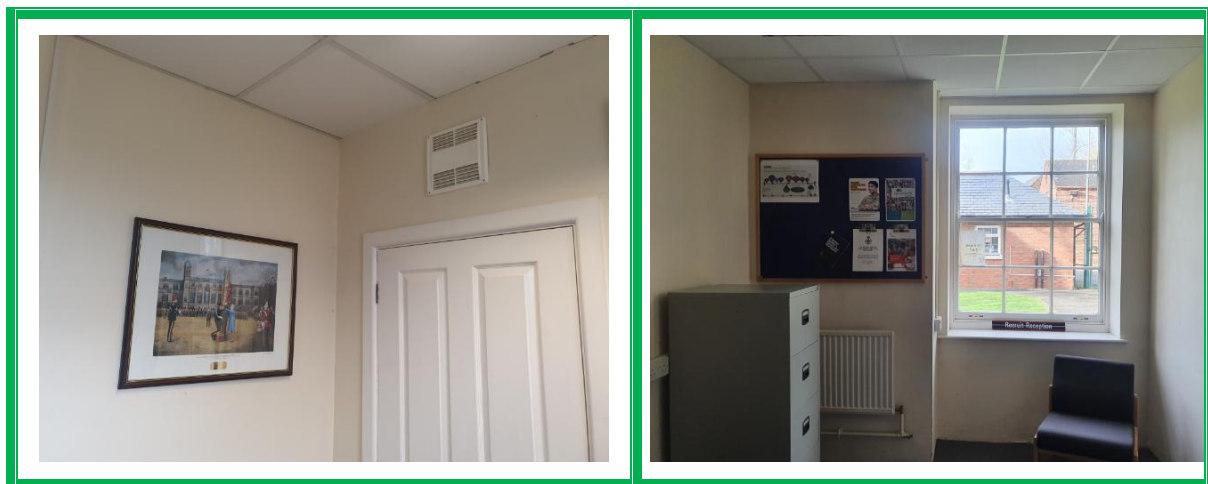
Item No:	41	Sample No:	N/A
Location:	Building 7, Ground Floor - Rooms G09, G10, G13 and G16

Material Description:	No Suspect Materials Found	
Identification:	N/A	
Approx. quantity:	N/A	
Accessibility	N/A	<i>Assessment Score</i>
Product type:	N/A	N/A
Extent of Damage:	N/A	N/A
Surface Treatment:	N/A	N/A
Asbestos type:	N/A	N/A
Material Assessment Score:		
Priority Assessment Score:		
Action:	N/A	
Comments:	Previously un-accessed rooms. Now accessed and no asbestos found

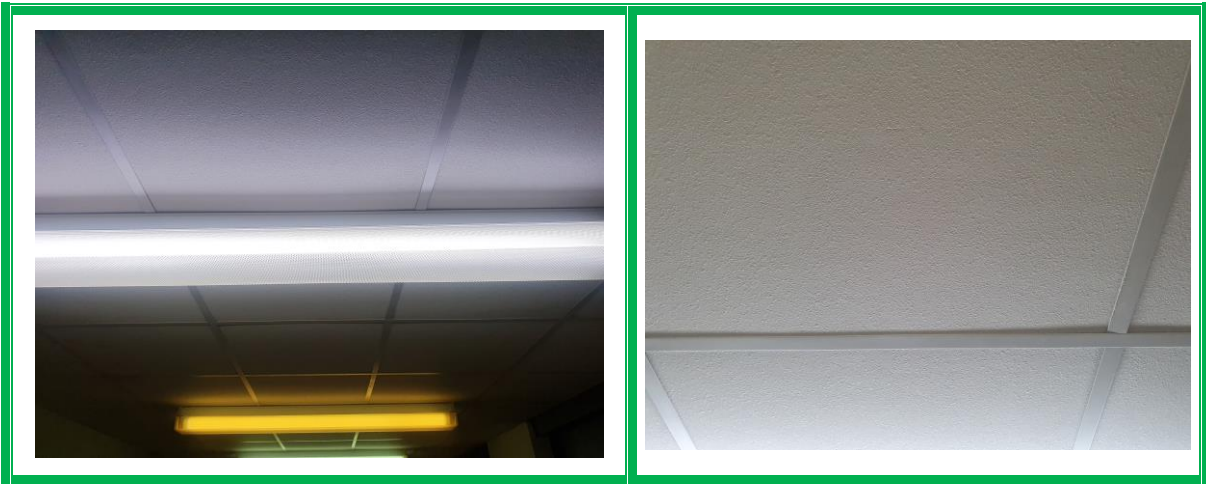
Item No:	42	Sample No:	N/A
Location:	715 Military Intelligence Room 5

Material Description:	No Suspect Materials Found	
Identification:	Previously Sampled DK/01 18/12/2020	
Approx. quantity:	N/A	
Accessibility	N/A	<i>Assessment Score</i>
Product type:	N/A	N/A
Extent of Damage:	N/A	N/A
Surface Treatment:	N/A	N/A
Asbestos type:	N/A	N/A
Material Assessment Score:		
Priority Assessment Score:		
Action:	N/A	
Comments:	Previously a no access area, now accessed. Non-Asbestos Sink Pad in Kitchen.

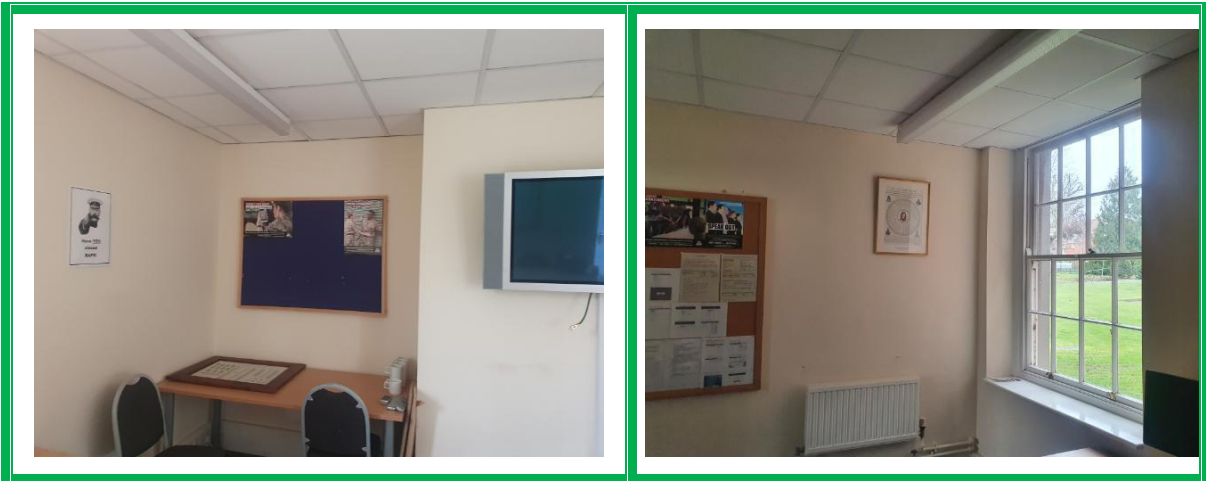
Item No:	44	Sample No:	N/A
Location:	Building 7, Ground Floor - Rooms G18, G19 and G20 044

Material Description:	No Suspect Materials Found	
Identification:	N/A	
Approx. quantity:	N/A	
Accessibility	N/A	<i>Assessment Score</i>
Product type:	N/A	N/A
Extent of Damage:	N/A	N/A
Surface Treatment:	N/A	N/A
Asbestos type:	N/A	N/A
Material Assessment Score:		
Priority Assessment Score:		
Action:	N/A	
Comments:	Previously un-accessed rooms. Now accessed and no asbestos found

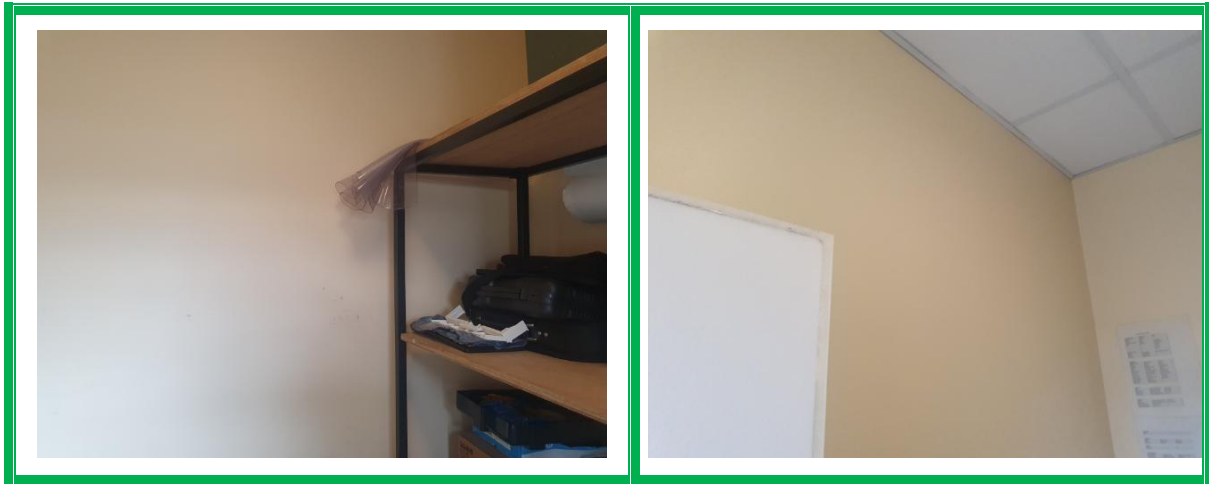
Item No:	45	Sample No:	N/A
Location:	Building 7, Ground Floor - Stores G24 and G25 045

Material Description:	No Suspect Materials Found	
Identification:	N/A	
Approx. quantity:	N/A	
Accessibility	N/A	<i>Assessment Score</i>
Product type:	N/A	N/A
Extent of Damage:	N/A	N/A
Surface Treatment:	N/A	N/A
Asbestos type:	N/A	N/A
Material Assessment Score:		
Priority Assessment Score:		
Action:	N/A	
Comments:	Previously un-accessed rooms. Now accessed and no asbestos found. No access under modern lino flooring

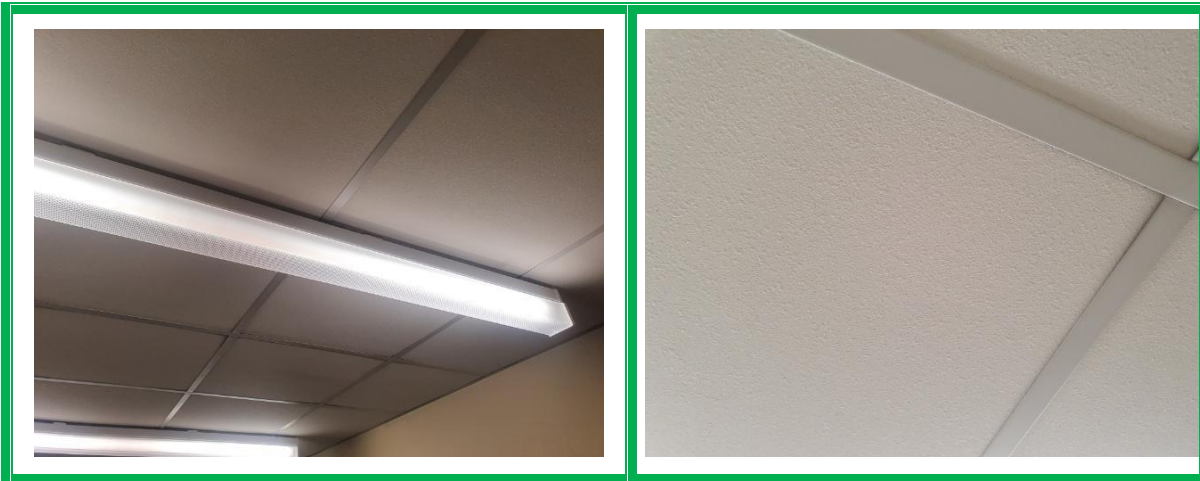
Item No:	46	Sample No:	DK/03
Location:	Building 7, First Floor - Rooms F2 to F10 and Corridor 046

Material Description:	Ceiling Tiles - Insulating Board	
Identification:	Sampled - No Asbestos Found	
Approx. quantity:	N/A	
Accessibility	N/A	<i>Assessment Score</i>
Product type:	N/A	N/A
Extent of Damage:	N/A	N/A
Surface Treatment:	N/A	N/A
Asbestos type:	N/A	N/A
Material Assessment Score:		
Priority Assessment Score:		
Action:	N/A	
Comments:	Tiles are non-asbestos supalux. Sampled for reassurance purposes only. Previously un-accessed rooms have now been accessed. Keys held at Guard Room.

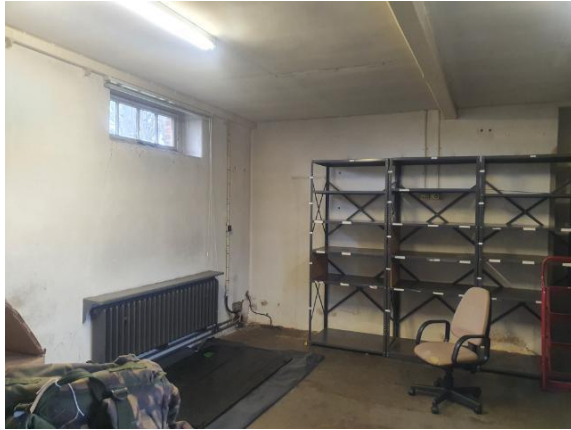
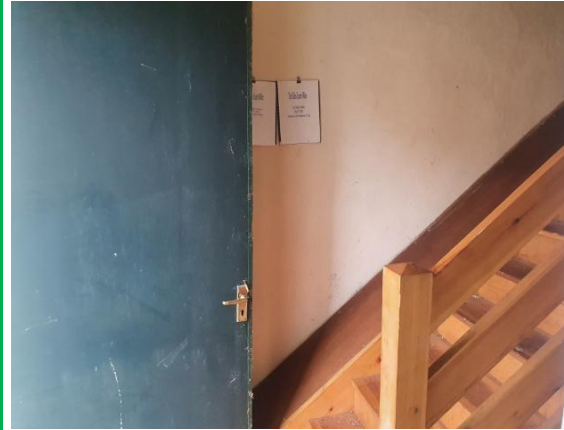
Location: Building 12, Ground Floor - Lobby and Store 051

Material Description:	No Suspect Materials Found	
Identification:	N/A	
Approx. quantity:	N/A	
Accessibility	N/A	<i>Assessment Score</i>
Product type:	N/A	N/A
Extent of Damage:	N/A	N/A
Surface Treatment:	N/A	N/A
Asbestos type:	N/A	N/A
Material Assessment Score:		
Priority Assessment Score:		
Action:	N/A	
Comments:	N/A

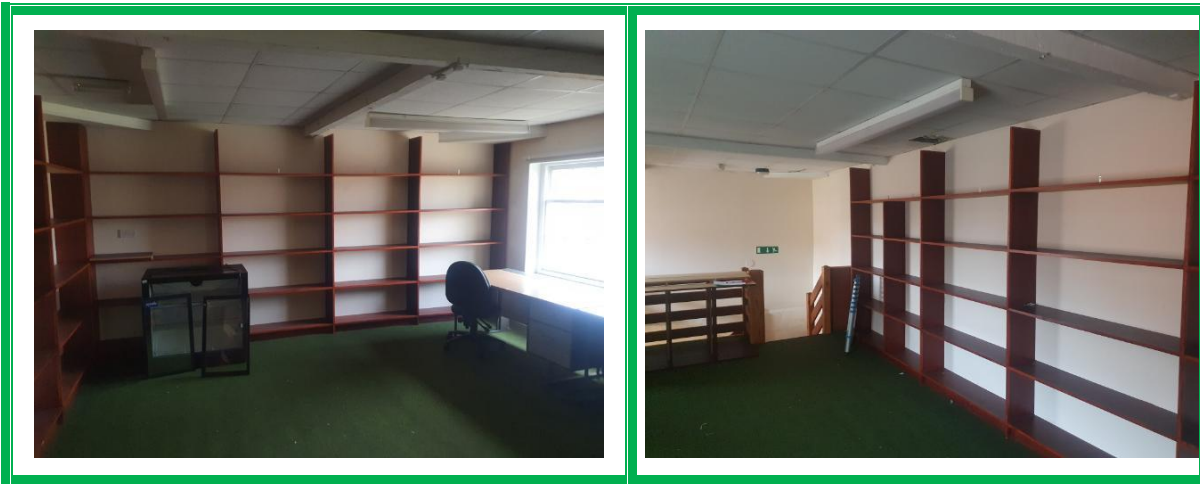
Item No:	52	Sample No:	N/A
Location:	Building 12, First Floor - Store 052

Material Description:	No Suspect Materials Found	
Identification:	N/A	
Approx. quantity:	N/A	
Accessibility	N/A	<i>Assessment Score</i>
Product type:	N/A	N/A
Extent of Damage:	N/A	N/A
Surface Treatment:	N/A	N/A
Asbestos type:	N/A	N/A
Material Assessment Score:		
Priority Assessment Score:		
Action:	N/A	
Comments:	Limited access above ceiling tiles due to insulation above tiles. Non asbestos electric heaters

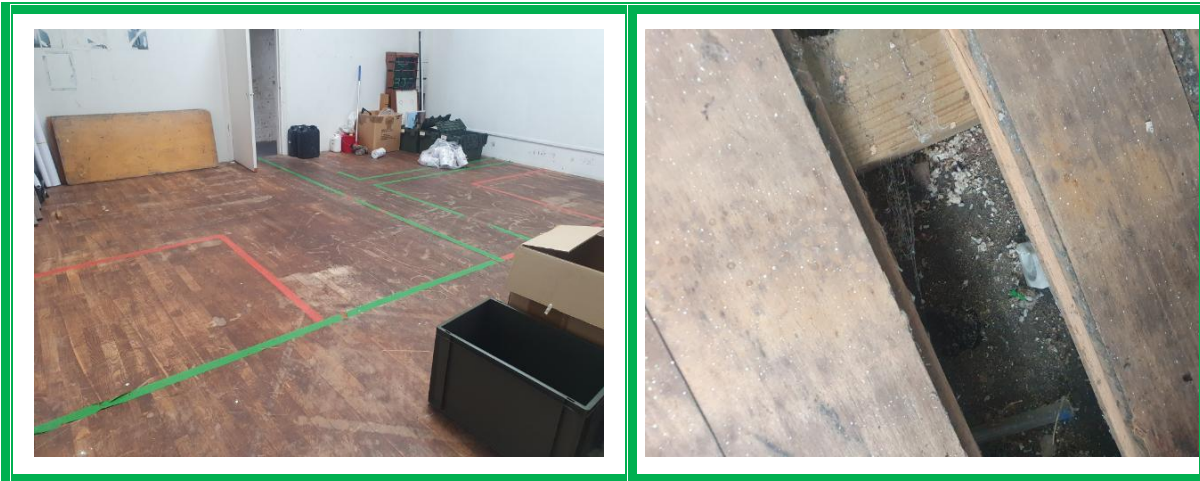
Item No:	53	Sample No:	DK/02
Location:	Building 15 (Squash Court), Ground Floor - Court 053

Material Description:	Bitumen to Floor - Bituminous Product	
Identification:	Sampled - No Asbestos Found	
Approx. quantity:	N/A	
Accessibility	N/A	<i>Assessment Score</i>
Product type:	N/A	N/A
Extent of Damage:	N/A	N/A
Surface Treatment:	N/A	N/A
Asbestos type:	N/A	N/A
Material Assessment Score:		
Priority Assessment Score:		
Action:	N/A	
Comments:	Located under timber floor

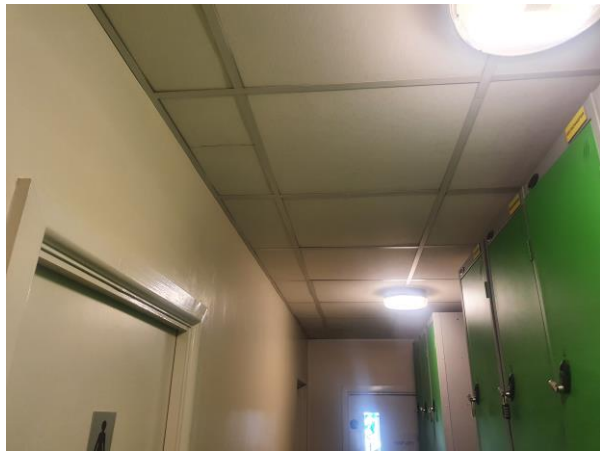
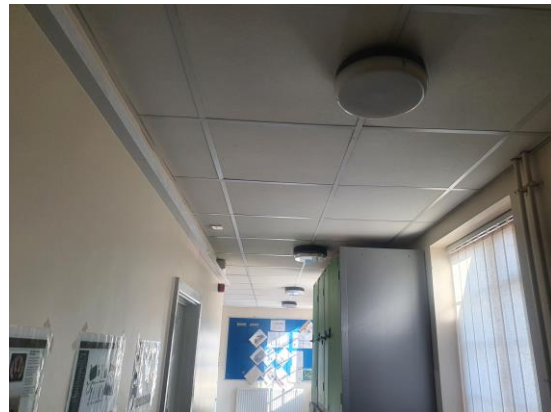
Location: 721 Military Intelligence Detachment, Corridors, WCs x 2 and Old Armoury 056

Material Description:	Ceiling Tiles - Insulating Board	
Identification:	As per Sample DK/03 - No Asbestos Found	
Approx. quantity:	N/A	
Accessibility	N/A	Assessment Score
Product type:	N/A	N/A
Extent of Damage:	N/A	N/A
Surface Treatment:	N/A	N/A
Asbestos type:	N/A	N/A
Material Assessment Score:		
Priority Assessment Score:		
Action:	N/A	
Comments:	Tiles are non-asbestos supalux. Sampled for reassurance purposes only.
