Project Number 2481

**Management
Asbestos Survey Report**

**7th Battalion, The Rifles C, Dorset,
BH12 5AD**

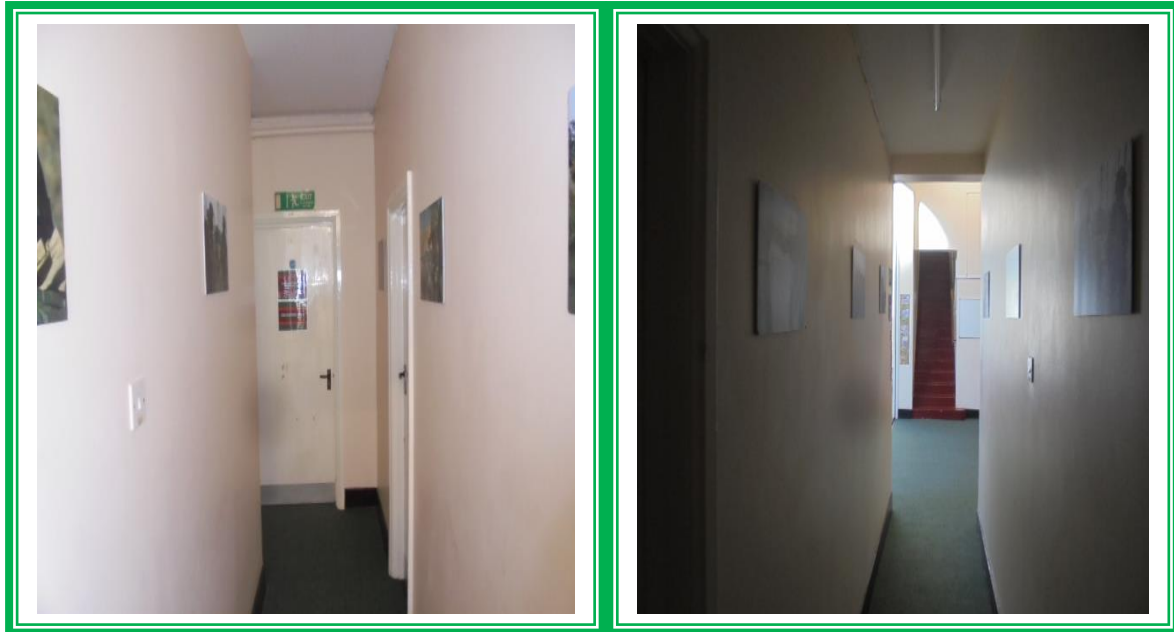
Location: Main Block – Ground Floor – Corridor 0.04

Material Description:	Visual Inspection – No Suspect Materials Found	
Identification:	N/A	
Approx. quantity:	N/A	
Accessibility	N/A	<i>Assessment Score</i>
Product type:	N/A	N/A
Extent of Damage:	N/A	N/A
Surface Treatment:	N/A	N/A
Asbestos type:	N/A	N/A
Material Assessment Score:		N/A
Priority Assessment Score:		N/A
Action:	N/A	
Comments:	N/A

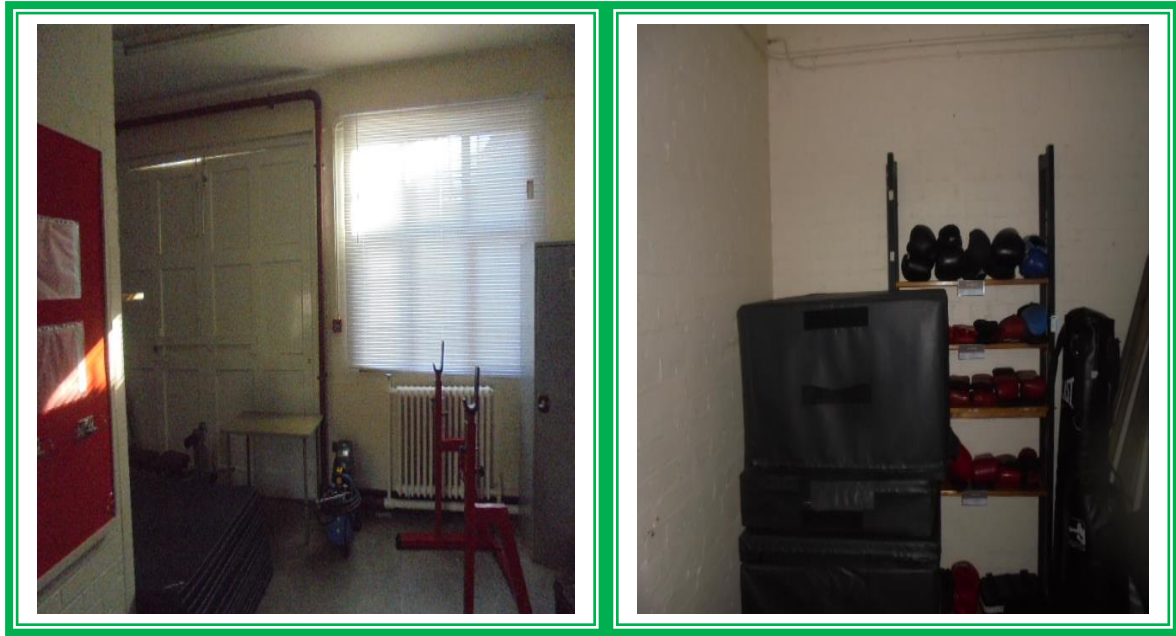
Location: Main Building – Ground Floor – Stored 0.09 and 0.10

Material Description:	Visual Inspection – No Suspect Materials Found	
Identification:	N/A	
Approx. quantity:	N/A	
Accessibility	N/A	<i>Assessment Score</i>
Product type:	N/A	N/A
Extent of Damage:	N/A	N/A
Surface Treatment:	N/A	N/A
Asbestos type:	N/A	N/A
Material Assessment Score:		N/A
Priority Assessment Score:		N/A
Action:	N/A	
Comments:	N/A

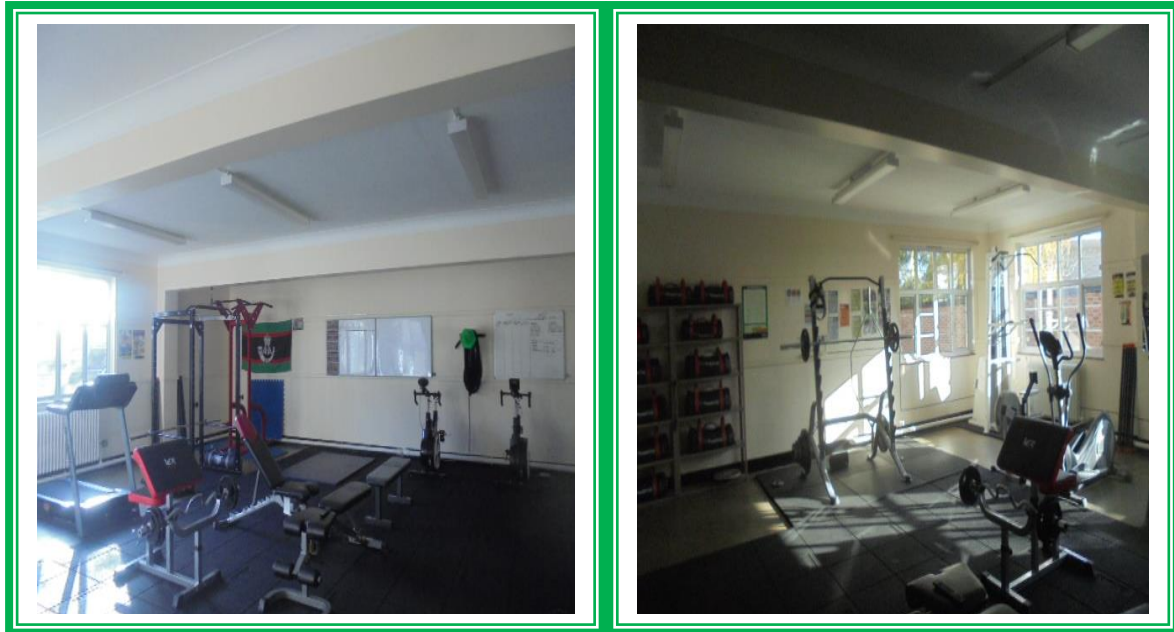
Location: Main Building – Ground Floor – Gym 0.11

Material Description:	Visual Inspection – No Suspect Materials Found	
Identification:	N/A	
Approx. quantity:	N/A	
Accessibility	N/A	Assessment Score
Product type:	N/A	N/A
Extent of Damage:	N/A	N/A
Surface Treatment:	N/A	N/A
Asbestos type:	N/A	N/A
Material Assessment Score:		N/A
Priority Assessment Score:		N/A
Action:	N/A	
Comments:	N/A

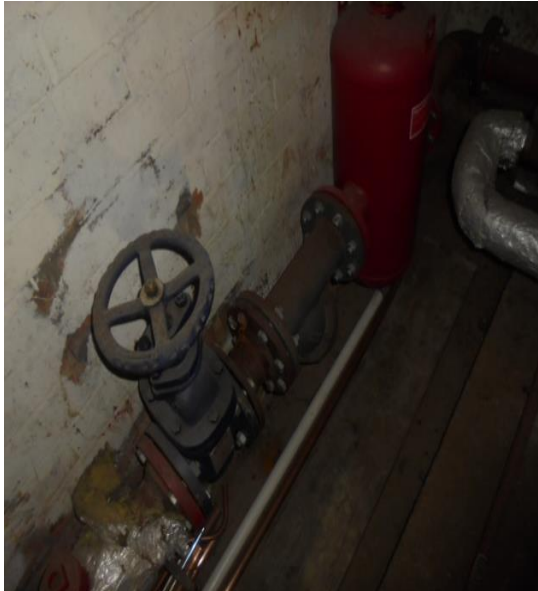
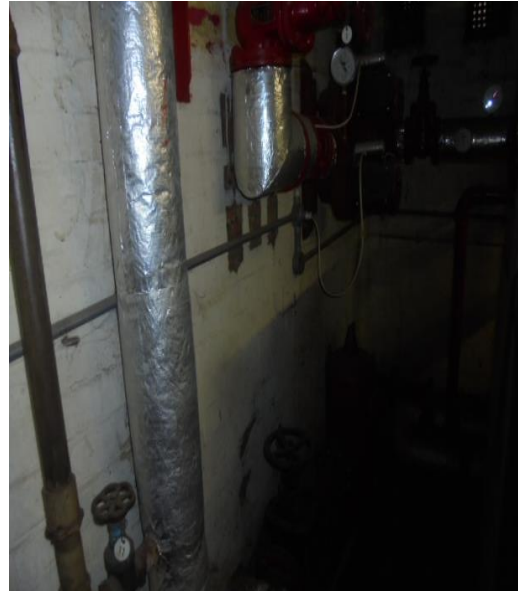
Location: Main Building – Basement Boiler Room B.02

Material Description:	Gaskets	
Identification:	Sampled – No Asbestos Detected	
Approx. quantity:	10 x Gaskets	
Accessibility	N/A	<i>Assessment Score</i>
Product type:	N/A	N/A
Extent of Damage:	N/A	N/A
Surface Treatment:	N/A	N/A
Asbestos type:	N/A	N/A
Material Assessment Score:		N/A
Priority Assessment Score:		N/A
Action:	N/A	
Comments:	Non-Asbestos Boiler

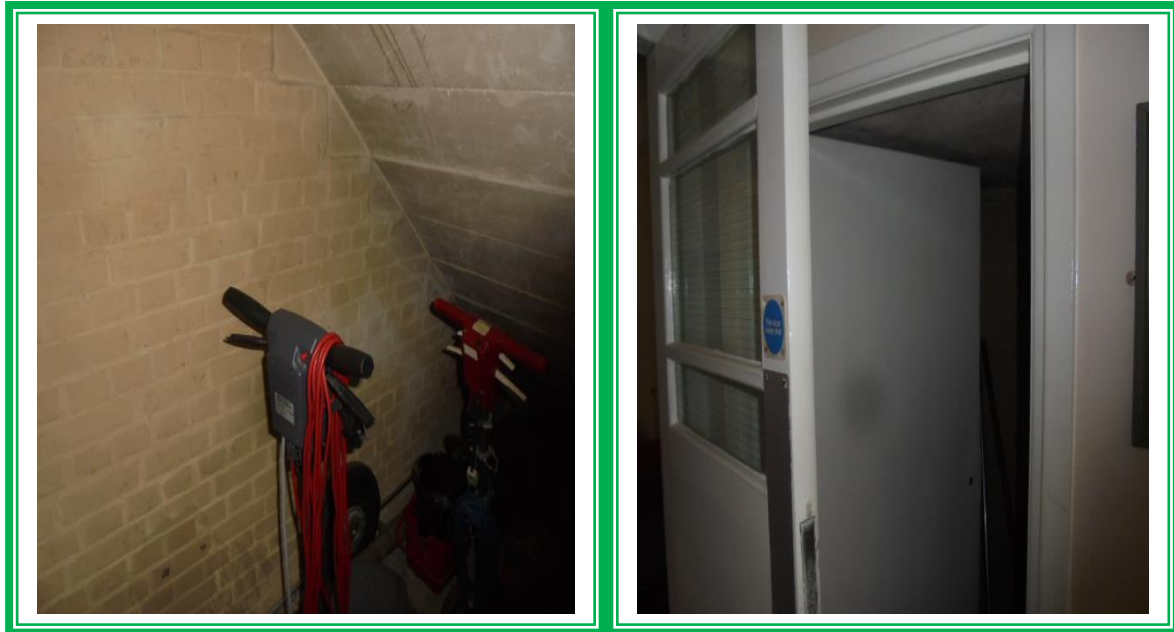
Location: Main Building – Ground Floor Cupboard 0.19

Material Description:	Visual Inspection – No Suspect Materials Found	
Identification:	N/A	
Approx. quantity:	N/A	
Accessibility	N/A	<i>Assessment Score</i>
Product type:	N/A	N/A
Extent of Damage:	N/A	N/A
Surface Treatment:	N/A	N/A
Asbestos type:	N/A	N/A
Material Assessment Score:		N/A
Priority Assessment Score:		N/A
Action:	N/A	
Comments:	N/A

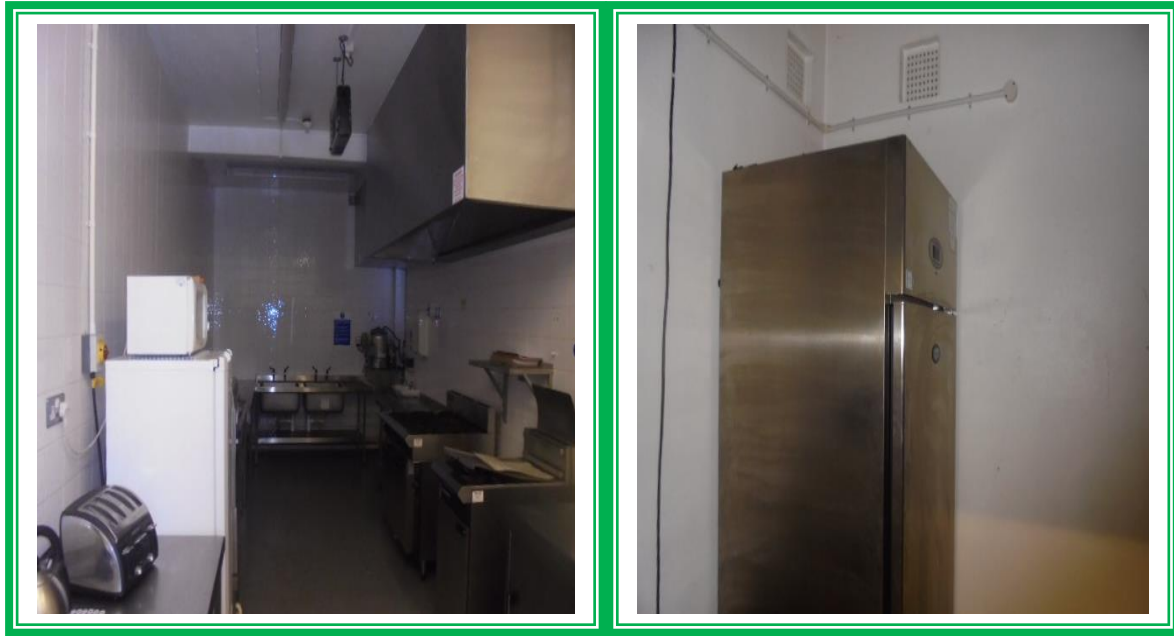
**Location: Main Building – Ground Floor Kitchen and Store
0.23 and 0.24**

Material Description:	Visual Inspection – No Suspect Materials Found	
Identification:	N/A	
Approx. quantity:	N/A	
Accessibility	N/A	<i>Assessment Score</i>
Product type:	N/A	N/A
Extent of Damage:	N/A	N/A
Surface Treatment:	N/A	N/A
Asbestos type:	N/A	N/A
Material Assessment Score:		N/A
Priority Assessment Score:		N/A
Action:	N/A	
Comments:	No Access within Timber Boxing

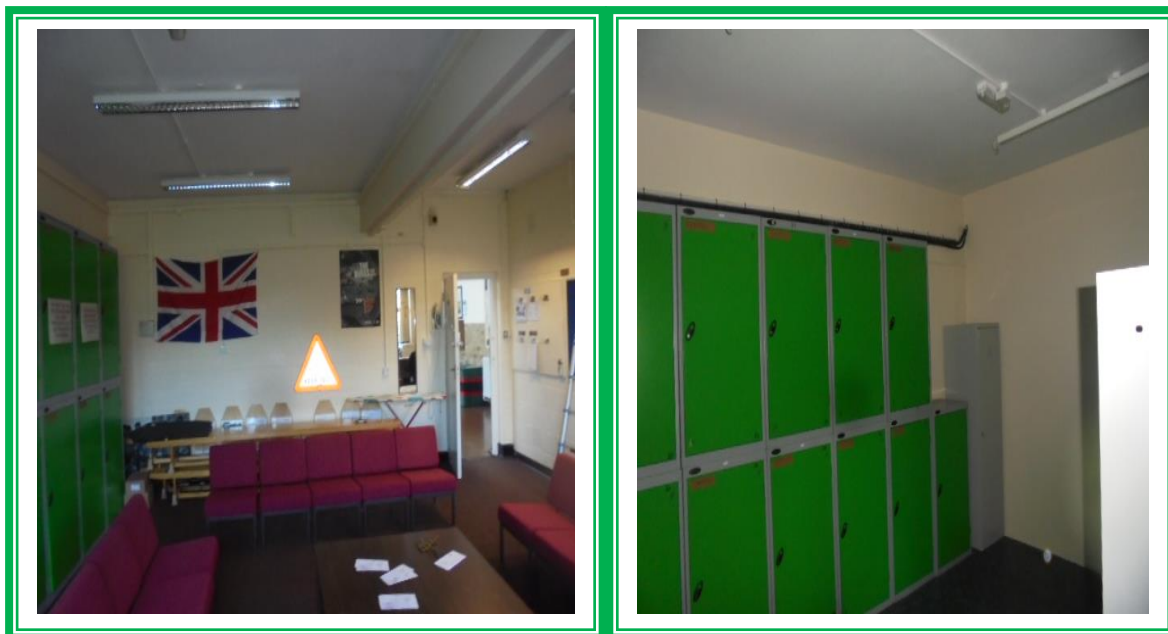
**Location: Main Building – Ground Floor Office and Store
0.25 and 0.26**

Material Description:	Visual Inspection – No Suspect Materials Found	
Identification:	N/A	
Approx. quantity:	N/A	
Accessibility	N/A	Assessment Score
Product type:	N/A	N/A
Extent of Damage:	N/A	N/A
Surface Treatment:	N/A	N/A
Asbestos type:	N/A	N/A
Material Assessment Score:		N/A
Priority Assessment Score:		N/A
Action:	N/A	
Comments:	Non-Asbestos Fiberboard Wall Panels in Store

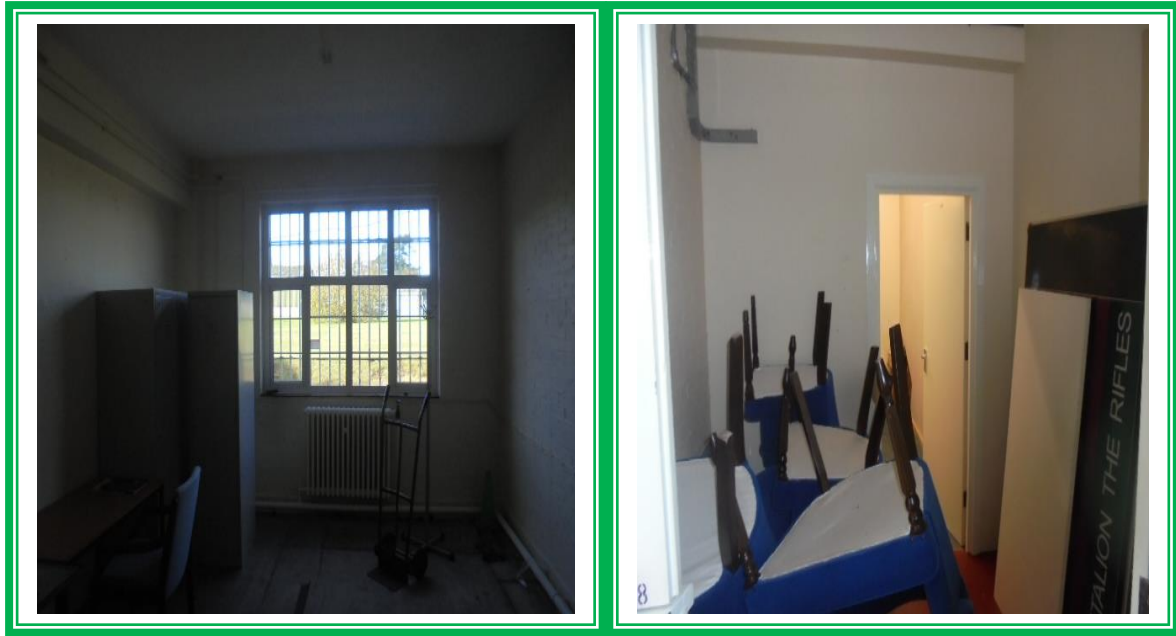
Location: Main Building – Ground Floor Stores 0.27, 0.28 and Store

Material Description:	Visual Inspection – No Suspect Materials Found	
Identification:	N/A	
Approx. quantity:	N/A	
Accessibility	N/A	Assessment Score
Product type:	N/A	N/A
Extent of Damage:	N/A	N/A
Surface Treatment:	N/A	N/A
Asbestos type:	N/A	N/A
Material Assessment Score:		N/A
Priority Assessment Score:		N/A
Action:	N/A	
Comments:	Non-Asbestos Fiberboard Wall Panels

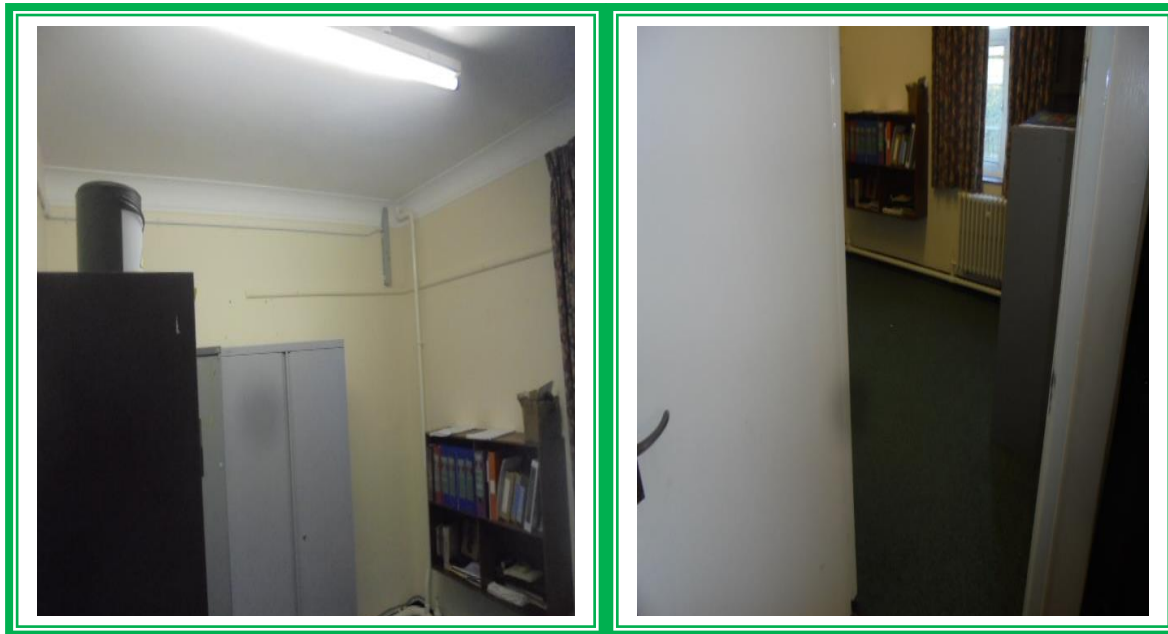
Location: Main Building – Ground Floor Store 0.35

Material Description:	Visual Inspection – No Suspect Materials Found	
Identification:	N/A	
Approx. quantity:	N/A	
Accessibility	N/A	<i>Assessment Score</i>
Product type:	N/A	N/A
Extent of Damage:	N/A	N/A
Surface Treatment:	N/A	N/A
Asbestos type:	N/A	N/A
Material Assessment Score:		N/A
Priority Assessment Score:		N/A
Action:	N/A	
Comments:	N/A

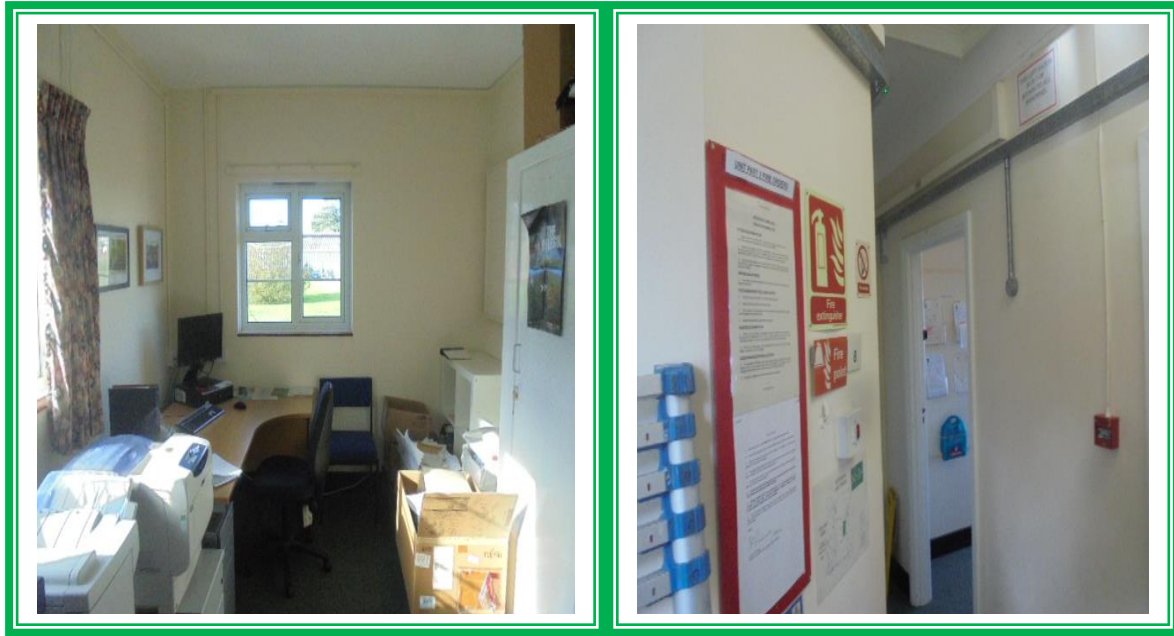
Location: Main Building – First Floor Admin Office and Corridor 1.02 and 1.01

Material Description:	Visual Inspection – No Suspect Materials Found	
Identification:	N/A	
Approx. quantity:	N/A	
Accessibility	N/A	<i>Assessment Score</i>
Product type:	N/A	N/A
Extent of Damage:	N/A	N/A
Surface Treatment:	N/A	N/A
Asbestos type:	N/A	N/A
Material Assessment Score:		N/A
Priority Assessment Score:		N/A
Action:	N/A	
Comments:	N/A

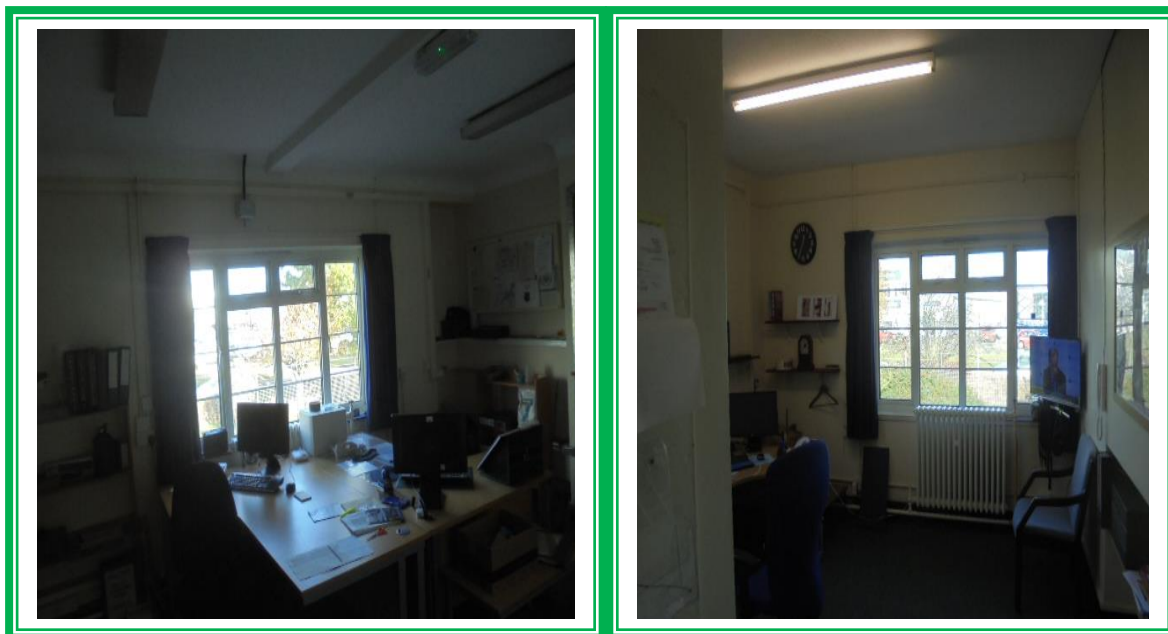
Location: Main Building – First Floor Offices 1.06. 1.07 and 1.03

Material Description:	Visual Inspection – No Suspect Materials Found	
Identification:	N/A	
Approx. quantity:	N/A	
Accessibility	N/A	<i>Assessment Score</i>
Product type:	N/A	N/A
Extent of Damage:	N/A	N/A
Surface Treatment:	N/A	N/A
Asbestos type:	N/A	N/A
Material Assessment Score:		N/A
Priority Assessment Score:		N/A
Action:	N/A	
Comments:	N/A

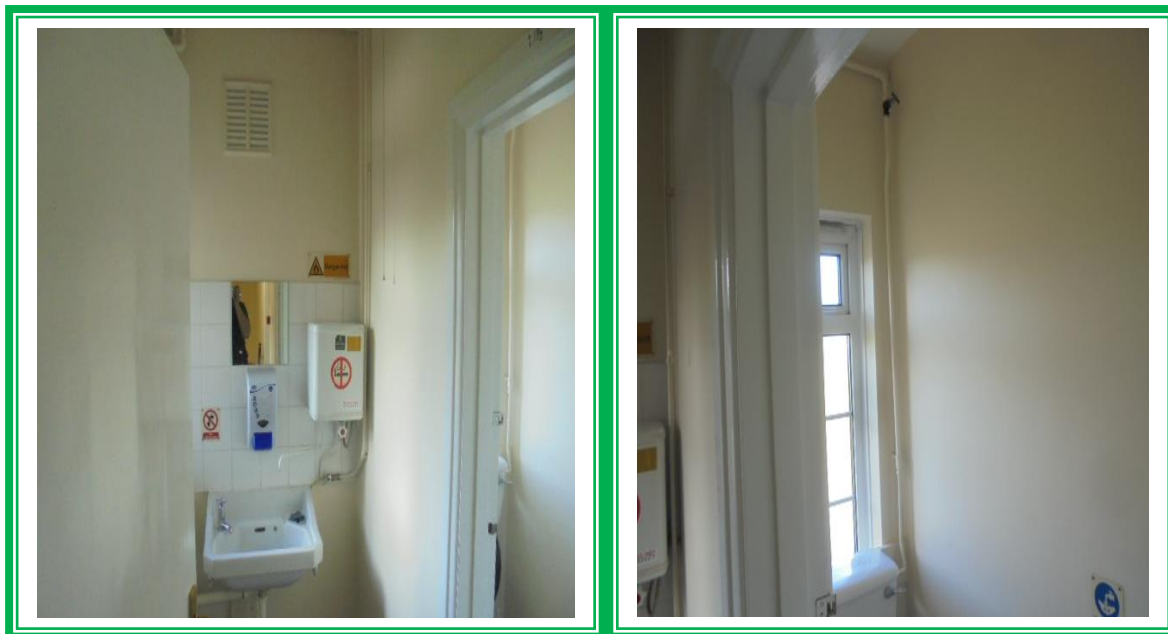
Location: Main Building – First Floor WC 1.04

Material Description:	Visual Inspection – No Suspect Materials Found	
Identification:	N/A	
Approx. quantity:	N/A	
Accessibility	N/A	Assessment Score
Product type:	N/A	N/A
Extent of Damage:	N/A	N/A
Surface Treatment:	N/A	N/A
Asbestos type:	N/A	N/A
Material Assessment Score:		N/A
Priority Assessment Score:		N/A
Action:	N/A	
Comments:	Non-Asbestos Toilet Seat

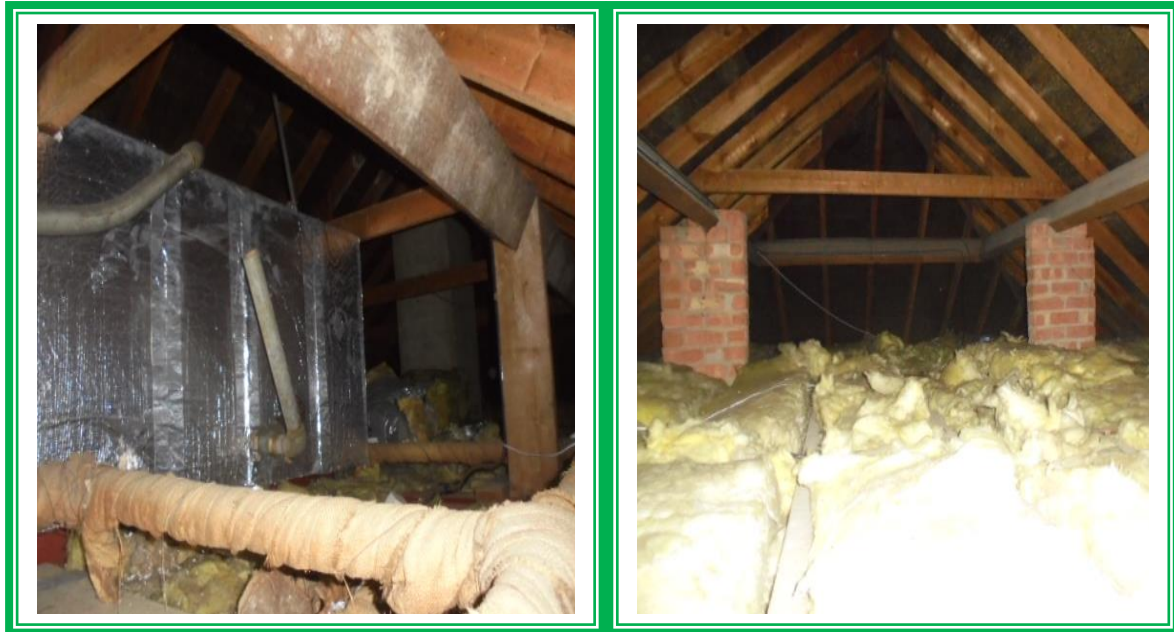
Location: Main Building – Loft Space above 1.01

Material Description:	Visual Inspection – No Suspect Materials Found	
Identification:	N/A	
Approx. quantity:	N/A	
Accessibility	N/A	<i>Assessment Score</i>
Product type:	N/A	N/A
Extent of Damage:	N/A	N/A
Surface Treatment:	N/A	N/A
Asbestos type:	N/A	N/A
Material Assessment Score:		N/A
Priority Assessment Score:		N/A
Action:	N/A	
Comments:	Limited Access into Loft as no Crawlboards were Available. Non asbestos hessian pipe insulation

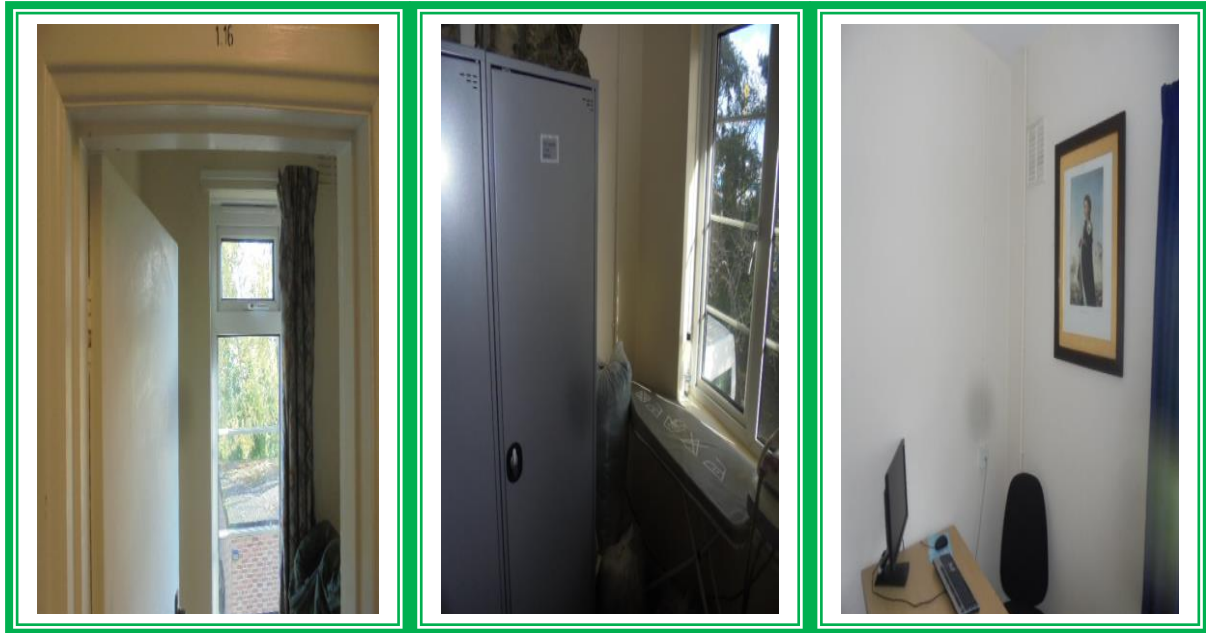
Location: Main Building – First Floor Store 1.16, 1.14 and Office 1.13

Material Description:	Visual Inspection – No Suspect Materials Found	
Identification:	N/A	
Approx. quantity:	N/A	
Accessibility	N/A	Assessment Score
Product type:	N/A	N/A
Extent of Damage:	N/A	N/A
Surface Treatment:	N/A	N/A
Asbestos type:	N/A	N/A
Material Assessment Score:		N/A
Priority Assessment Score:		N/A
Action:	N/A	
Comments:	N/A

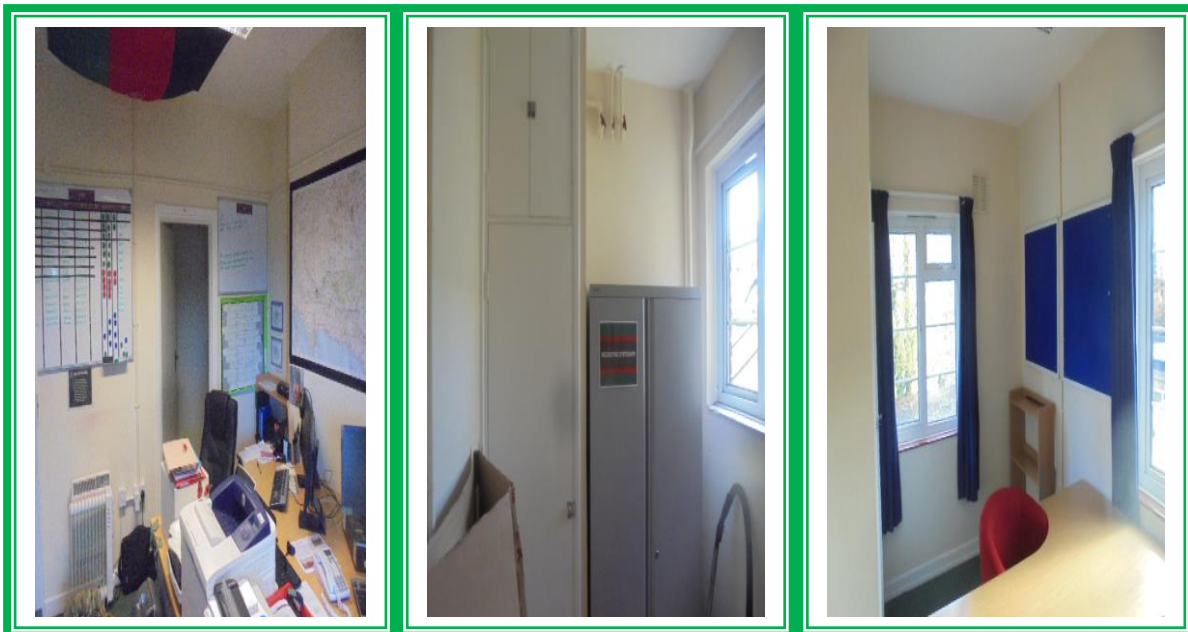
**Item No: 38****Sample No: N/A****Location: Main Building – First Floor Offices 1.11, 1.10, 1.09 and Store 1.12**

Material Description:	Visual Inspection – No Suspect Materials Found	
Identification:	N/A	
Approx. quantity:	N/A	
Accessibility	N/A	Assessment Score
Product type:	N/A	N/A
Extent of Damage:	N/A	N/A
Surface Treatment:	N/A	N/A
Asbestos type:	N/A	N/A
Material Assessment Score:		N/A
Priority Assessment Score:		N/A
Action:	N/A	
Comments:	N/A

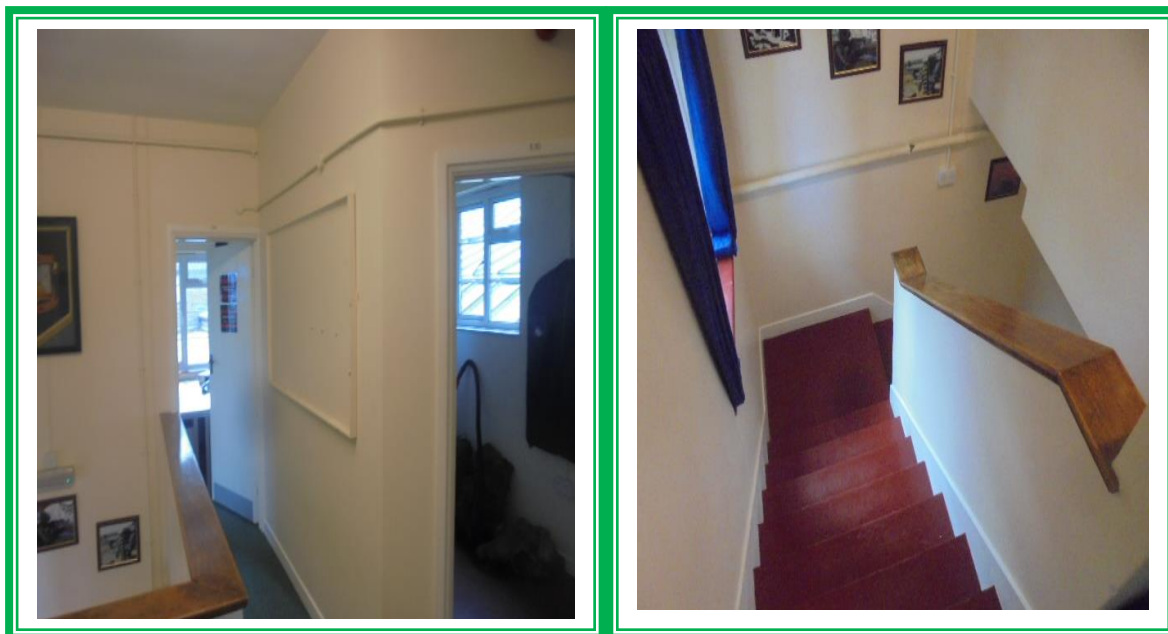
Location: Main Building – First Floor Landing and Stairwell 1.08

Material Description:	Visual Inspection – No Suspect Materials Found	
Identification:	N/A	
Approx. quantity:	N/A	
Accessibility	N/A	<i>Assessment Score</i>
Product type:	N/A	N/A
Extent of Damage:	N/A	N/A
Surface Treatment:	N/A	N/A
Asbestos type:	N/A	N/A
Material Assessment Score:		N/A
Priority Assessment Score:		N/A
Action:	N/A	
Comments:	N/A

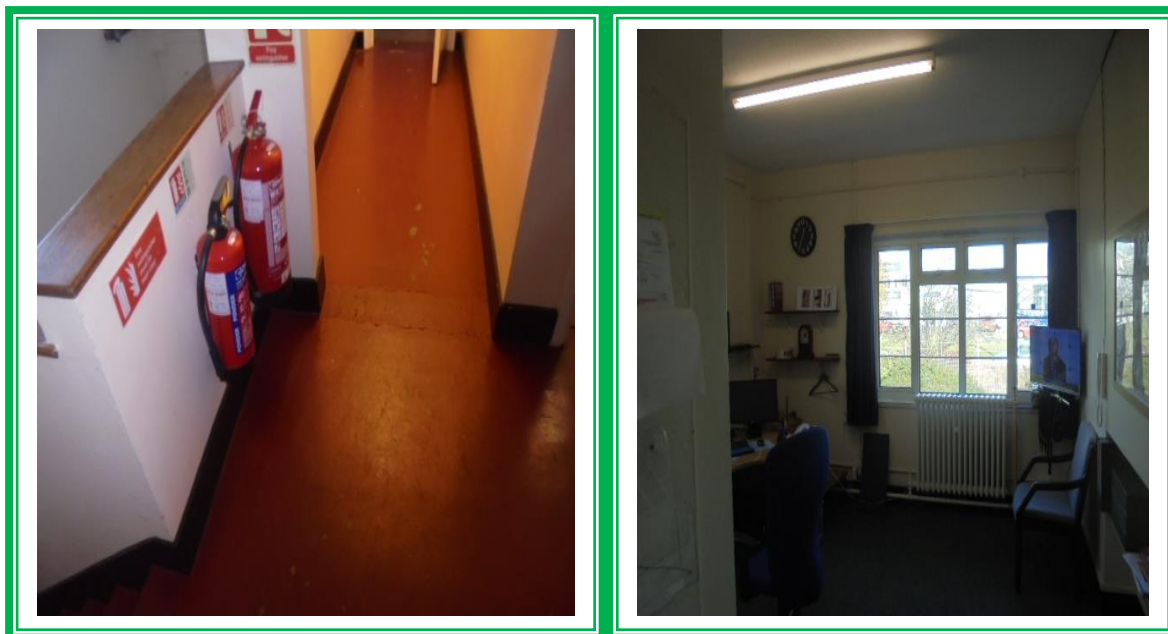
Location: Main Building – First Floor Landing and Stairwell 1.17

Material Description:	Visual Inspection – No Suspect Materials Found	
Identification:	N/A	
Approx. quantity:	N/A	
Accessibility	N/A	Assessment Score
Product type:	N/A	N/A
Extent of Damage:	N/A	N/A
Surface Treatment:	N/A	N/A
Asbestos type:	N/A	N/A
Material Assessment Score:		N/A
Priority Assessment Score:		N/A
Action:	N/A	
Comments:	N/A

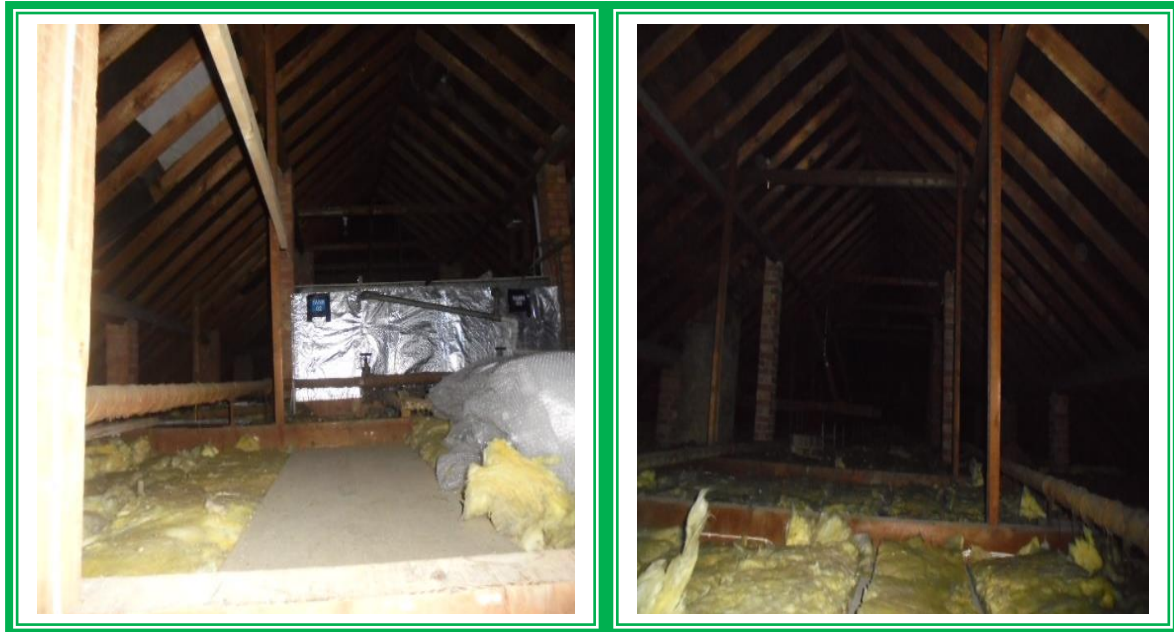
Location: First Floor – Loft Space above 1.17

Material Description:	Visual Inspection – No Suspect Materials Found	
Identification:	N/A	
Approx. quantity:	N/A	
Accessibility	N/A	<i>Assessment Score</i>
Product type:	N/A	N/A
Extent of Damage:	N/A	N/A
Surface Treatment:	N/A	N/A
Asbestos type:	N/A	N/A
Material Assessment Score:		N/A
Priority Assessment Score:		N/A
Action:	N/A	
Comments:	Limited Access into Loft as no Crawlboards Available

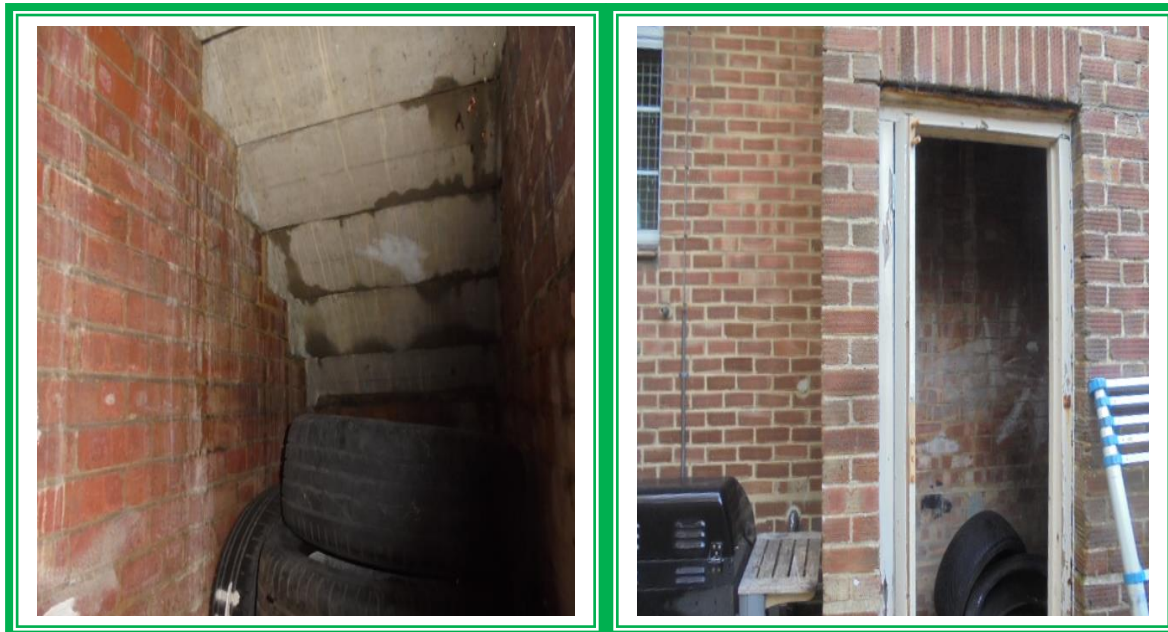
Location: Ground Floor – Tyre Store 0.40

Material Description:	Visual Inspection – No Suspect Materials Found	
Identification:	N/A	
Approx. quantity:	N/A	
Accessibility	N/A	<i>Assessment Score</i>
Product type:	N/A	N/A
Extent of Damage:	N/A	N/A
Surface Treatment:	N/A	N/A
Asbestos type:	N/A	N/A
Material Assessment Score:		N/A
Priority Assessment Score:		N/A
Action:	N/A	
Comments:	N/A

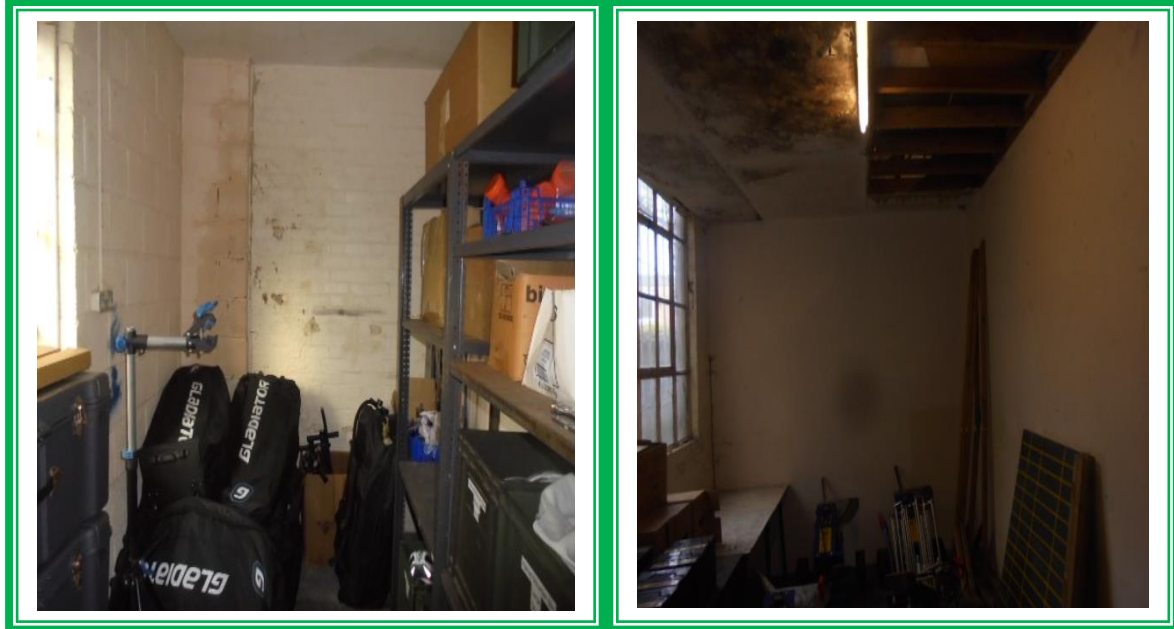
Location: Building 7 – Stores X 2

Material Description:	Visual Inspection – No Suspect Materials Found	
Identification:	N/A	
Approx. quantity:	N/A	
Accessibility	N/A	<i>Assessment Score</i>
Product type:	N/A	N/A
Extent of Damage:	N/A	N/A
Surface Treatment:	N/A	N/A
Asbestos type:	N/A	N/A
Material Assessment Score:		N/A
Priority Assessment Score:		N/A
Action:	N/A	
Comments:	N/A

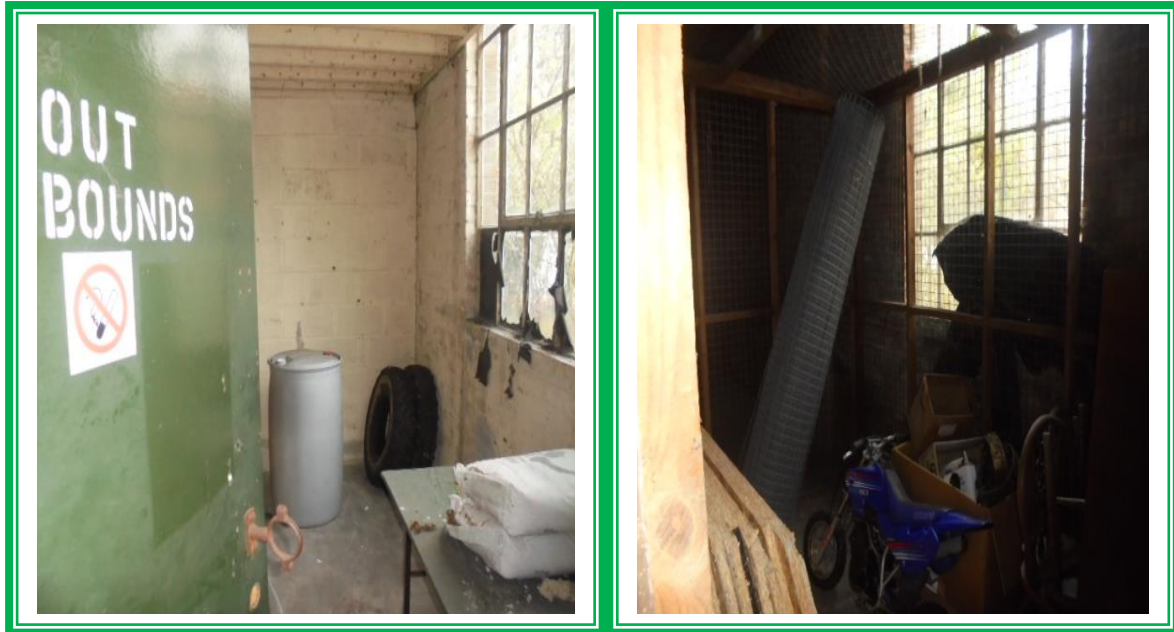
Location: Building 7 – Cage and Store

Material Description:	Visual Inspection – No Suspect Materials Found	
Identification:	N/A	
Approx. quantity:	N/A	
Accessibility	N/A	<i>Assessment Score</i>
Product type:	N/A	N/A
Extent of Damage:	N/A	N/A
Surface Treatment:	N/A	N/A
Asbestos type:	N/A	N/A
Material Assessment Score:		N/A
Priority Assessment Score:		N/A
Action:	N/A	
Comments:	N/A

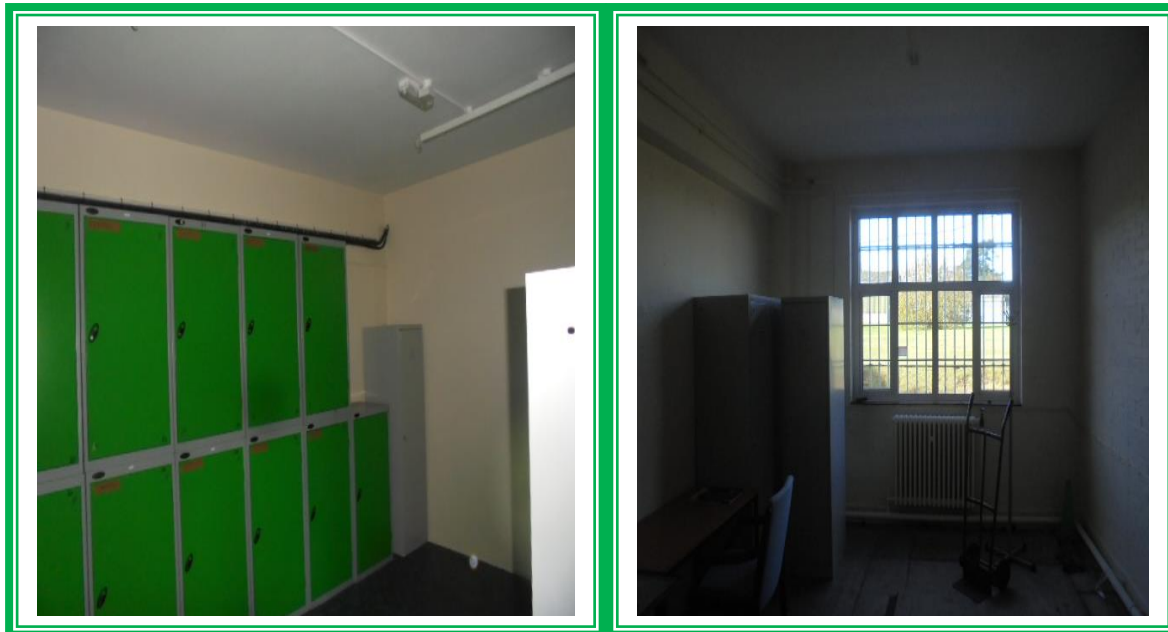
Location: Building 4 – Garage Stores X 2

Material Description:	Visual Inspection – No Suspect Materials Found	
Identification:	N/A	
Approx. quantity:	N/A	
Accessibility	N/A	<i>Assessment Score</i>
Product type:	N/A	N/A
Extent of Damage:	N/A	N/A
Surface Treatment:	N/A	N/A
Asbestos type:	N/A	N/A
Material Assessment Score:		N/A
Priority Assessment Score:		N/A
Action:	N/A	
Comments:	N/A

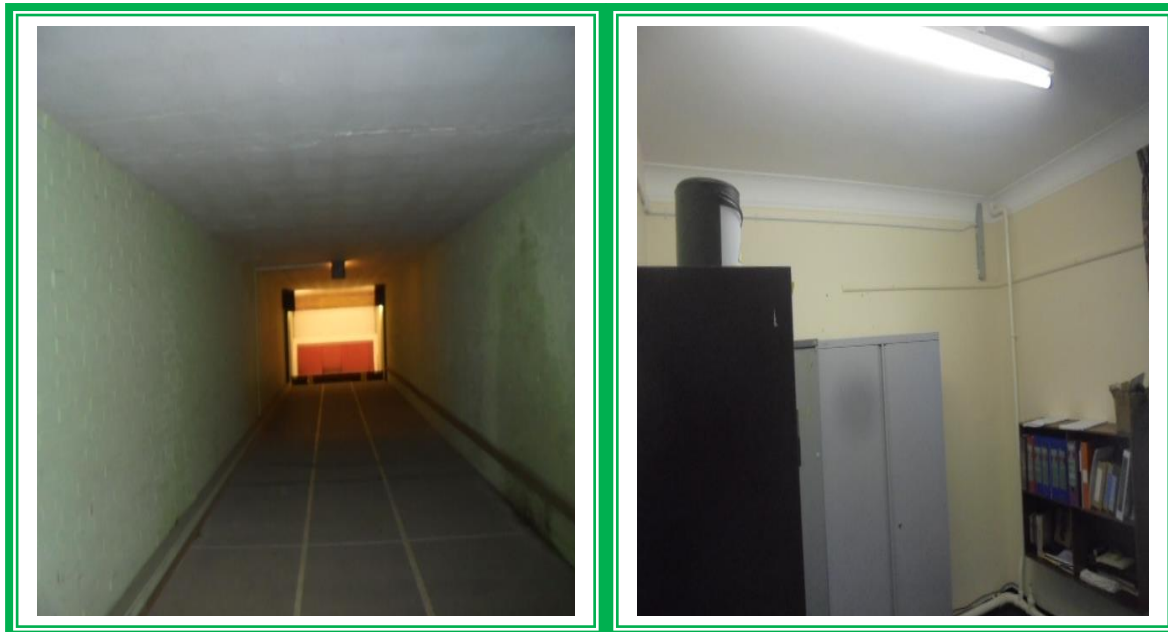
Location: Range

Material Description:	Visual Inspection – No Suspect Materials Found	
Identification:	N/A	
Approx. quantity:	N/A	
Accessibility	N/A	<i>Assessment Score</i>
Product type:	N/A	N/A
Extent of Damage:	N/A	N/A
Surface Treatment:	N/A	N/A
Asbestos type:	N/A	N/A
Material Assessment Score:		N/A
Priority Assessment Score:		N/A
Action:	N/A	
Comments:	N/A

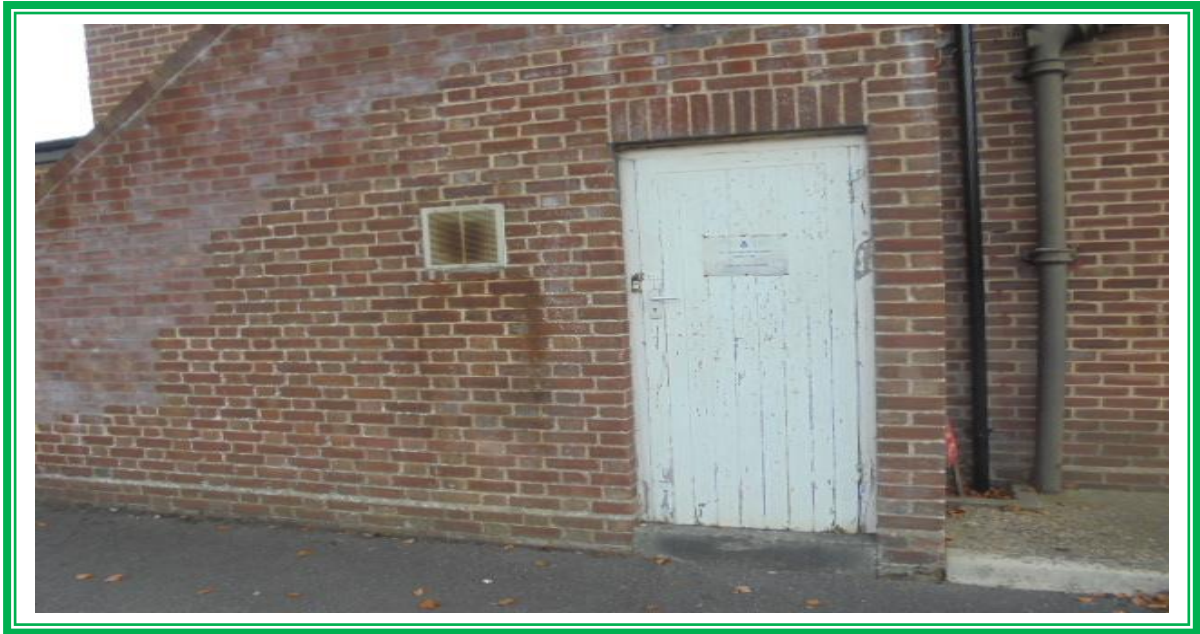
Location: Main Building – Under Stairs Store

Material Description:	Visual Inspection – No Suspect Materials Found	
Identification:	N/A	
Approx. quantity:	N/A	
Accessibility	N/A	<i>Assessment Score</i>
Product type:	N/A	N/A
Extent of Damage:	N/A	N/A
Surface Treatment:	N/A	N/A
Asbestos type:	N/A	N/A
Material Assessment Score:		N/A
Priority Assessment Score:		N/A
Action:	N/A	
Comments:	N/A
