LEGIONELLA RISK ASSESSMENT

THE PREVENTION AND CONTROL OF LEGIONNAIRES' DISEASE

Client:	Wessex RF & CA
Site:	Ilfracombe Platoon
Address:	The Gunshed, Winsham, Ilfracombe, Devon EX34 8EY
Risk Rating:	Low
Report Ref:	AQST/LRA/340
Surveyed By:	D. Fletcher
Survey Date:	22 nd January 2024
Report Date:	15 th February 2024
Written By:	L. Blakemore
Checked By:	J. Rooney
Recommended Review Date:	January 2026

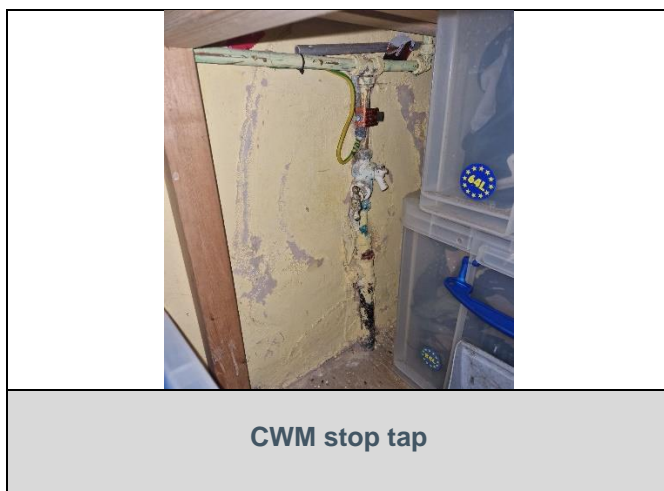
Photos

Source of supply	Towns mains
Number of mains cold water supply?	1
Location of main isolation valve?	Main Building stores
Is there a water meter installed?	No
Is the pipework labelled?	No
Materials of construction	¾" galv – 15mm copper
Are there any materials or fittings visibly present on the mains water system, that do not conform to the Water Regulations Advisory Scheme (WRAS) directory?	No
Mains water temperature °C (sentinel outlets)	
Are all other distribution temperatures that were tested within the correct temperature range? i.e. Below 20 °C?	Yes
Are there any none flow through expansion vessels to any services on this system?	Yes
Is the pipework suitably insulated?	No
Does the cold-water supply have any inline filters including scale inhibitors/softeners?	No
COMMENTS	
Mains Water Supply Risk Score	Medium

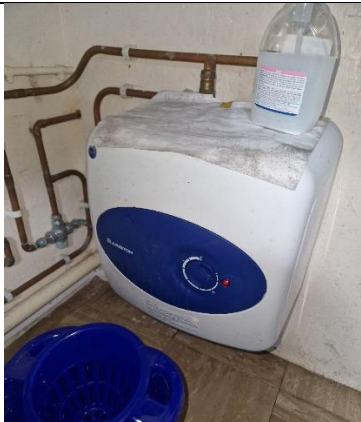
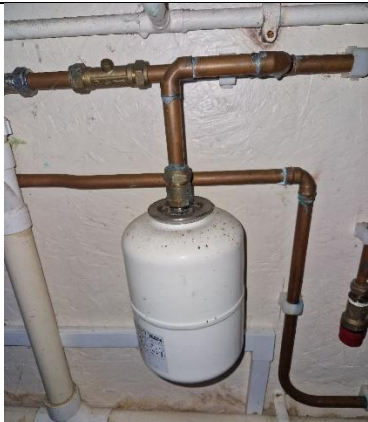
Water Heater ID Number	Location	Make/model and capacity of each heater	Mains or tank fed	Full clean possible	EXPANSION VESSEL INFO	
					Is there a pressure vessel – Yes/No	If yes – make model and size and whether fitted horizontally or vertically
WH 01	Gents wc	Ariston 10ltr	Mains	No	Yes	2ltr upside down

WH 01	Upside down expansion vessel

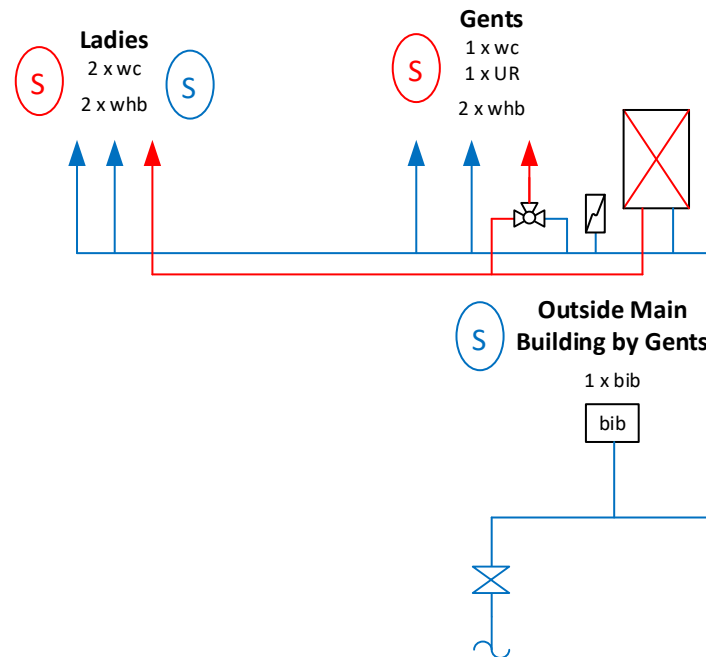
8. LINE DRAWINGS OF WATER SYSTEMS

NB: Due to the complexity of the pipe work at this site it is not possible to ensure the total accuracy of these line drawings. They may require revision.
