# LEGIONELLA RISK ASSESSMENT

## THE PREVENTION AND CONTROL OF LEGIONNAIRES' DISEASE

| <b>Site:</b> | 2469 (Exeter St Thomas) Squadron |
| <b>Report Ref:</b> | AQST/LRA/349 |

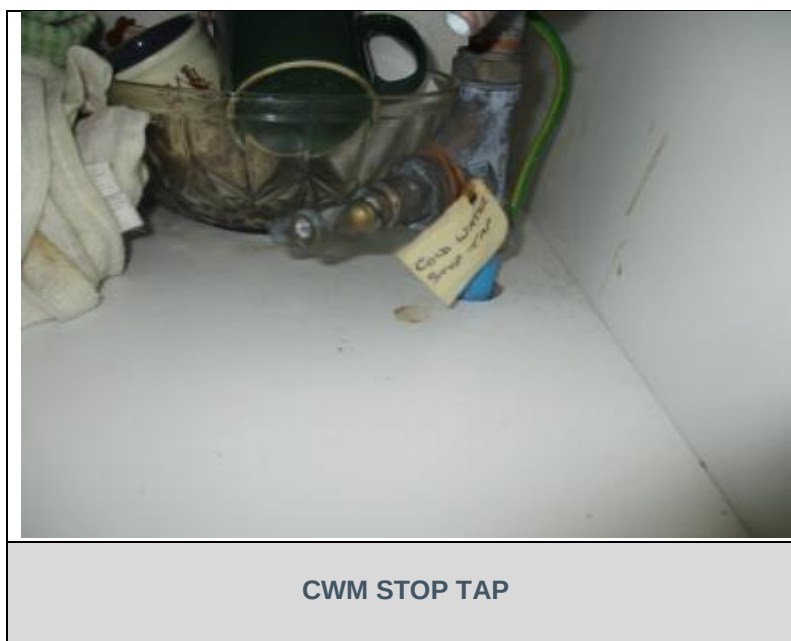
### 6.1 MAINS WATER SUPPLY REPORT

| Mains Water Supply Risk Score | <b>LOW</b> |

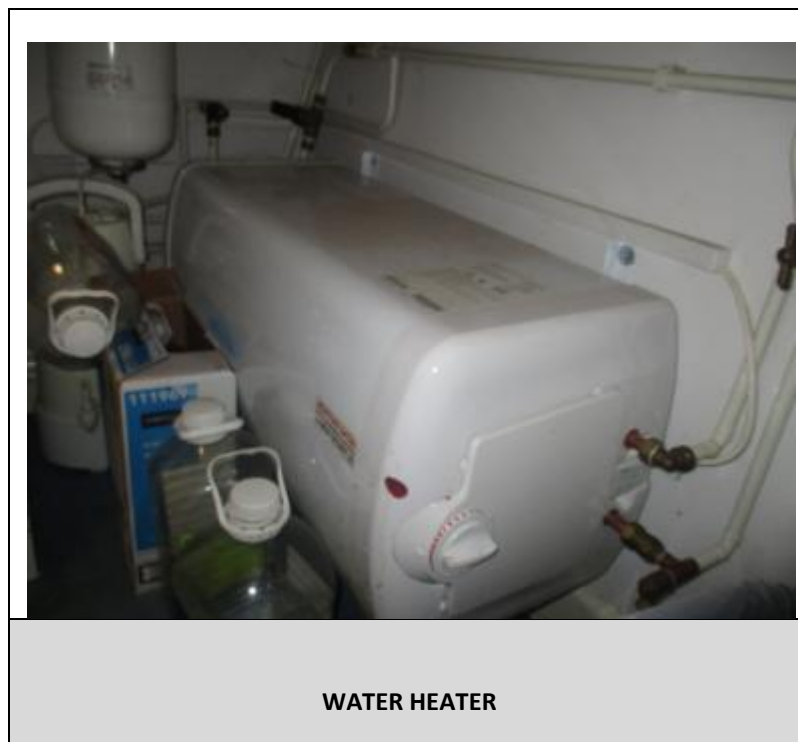
| Water Heater ID Number | Location | Make/model and capacity of each heater | Mains or tank fed | Full clean possible | EXPANSION VESSEL INFO | |
|---|---|---|---|---|---|---|
| POU WH1 | Kitchen | Heatrae Sadia 50ltr | Mains | No | Yes | Aquasystem 8 ltr vertical |

| SYSTEM TYPES | | RISK RATING |
|---|---|---|
| 1. | <b>Drain off recommended for the expansion vessel</b> | Low |
