LEGIONELLA RISK ASSESSMENT

Client:	Wessex RF & CA
Site:	Calne ATC
Address:	Bryans Close Road, Calne, Wiltshire SN11 9AA
Risk Rating:	Low
Report Ref:	AQST/LRA/383
Surveyed By:	N O'Leary
Survey Date:	7 th March 2024
Report Date:	26 th March 2024
Written By:	L. Blakemore
Checked By:	J. Rooney
Recommended Review Date:	March 2026

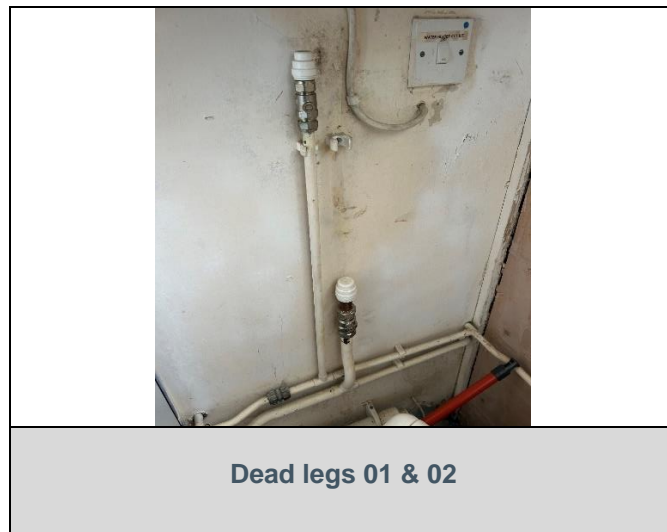
PHOTOS:

LOCATIONS	SYSTEM	ACTION
01 & 02 – Wc	Cold & Hot	Remove

SYSTEM TYPES		RISK RATING
	DEAD LEGS AND BLIND ENDS:	
01	See schedule 6.6 for remedial actions.	High
	Actioned date: Company/initials:	
	POINT OF USE WATER HEATERS:	
01	Expansion vessel requires a drain off fitting	Medium
	Actioned date: Company/initials:

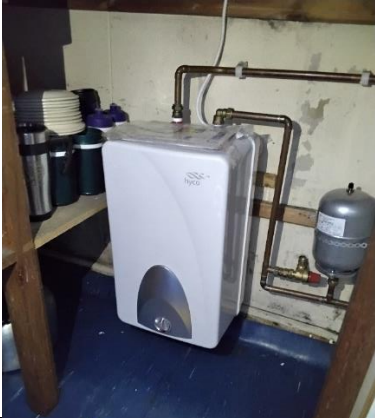
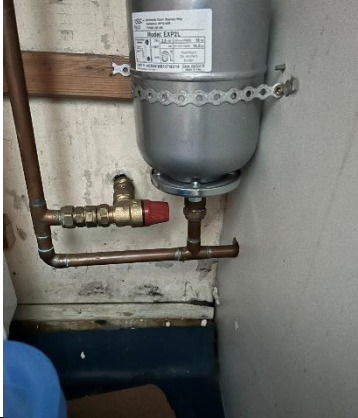
WH 01	Expansion vessel

Water Heater ID Number	Location	Make/model and capacity of each heater	Mains or tank fed	Full clean possible	EXPANSION VESSEL INFO	
					Is there a pressure vessel – Yes/No	If yes – make model and size and whether fitted horizontally or vertically
WH 01	Kitchen	Hyco	Mains	No	Yes	2ltr vertical
