LEGIONELLA RISK ASSESSMENT

Client:	Wessex RF & CA
Site:	Arle Road Platoon
Address:	Arle Road Platoon, Arle Road, Cheltenham, GL51 8JU
Risk Rating:	Medium
Report Ref:	AQST/LRA/353
Surveyed By:	Alan Rodgerson
Survey Date:	08/03/2024
Report Date:	30/04/2024
Written By:	Alan Rodgerson
Checked By:	J. Rooney
Recommended Review Date:	08/03/2026

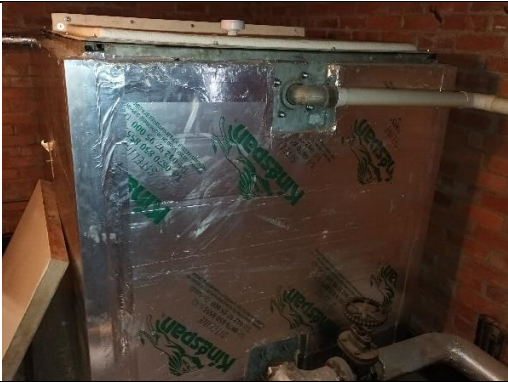
Tank Ref : CWST 1

Drain valve	Is there a drain valve – size if applicable	No drain off No
Water in Tank	Temperature C	12.9
	Degree of sediment	light
	Biological slime severe/medium/light	light
	Extent of corrosion	None
	Is there adequate crossflow within the tank? i.e. inlet opposed from outlet?	Yes
	Is the stored water over capacity??	No
Labels	Is the tank labelled	No
	Supply pipe labelled or coded	Yes
	Outlets labelled or coded	No
Operation	How far to adequate drain	
	Power supply – volts/distance	240V 8 mtr
	Is lighting adequate	Yes
	Access limit ht x w	400 x 1500
CWST Risk Score		Low

<p>CWST 1</p>	<p>CWST 1 interior</p>

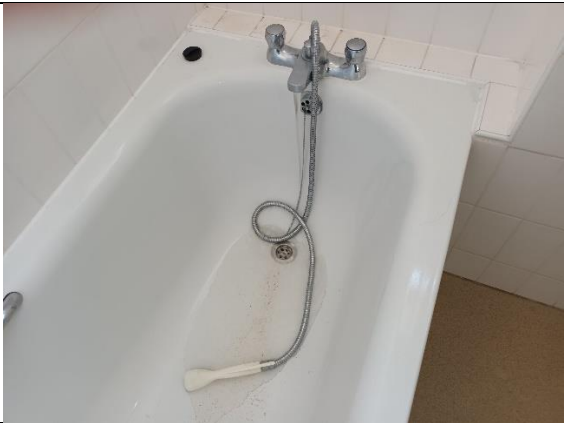
Location	Nos of showers	Dismantled/ cleaned and disinfected YES/NO	Overall condition	Any repairs replacements	Regularity of Use
Caretakers flat	1	Yes	Good	None	Flushed
Shower Room	2	Yes	Good	None	Flushed
COMMENTS:

<p>Shower attachment on caretaker's bath</p>	<p>Typical electric shower</p>

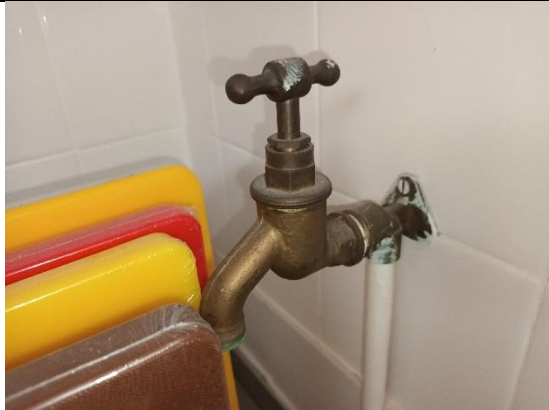
Bib tap
