# LEGIONELLA RISK ASSESSMENT

## THE PREVENTION AND CONTROL OF LEGIONNAIRES' DISEASE

| <b>Site:</b> | Brockworth Platoon |
| <b>Report Ref:</b> | AQST/LRA/398 |

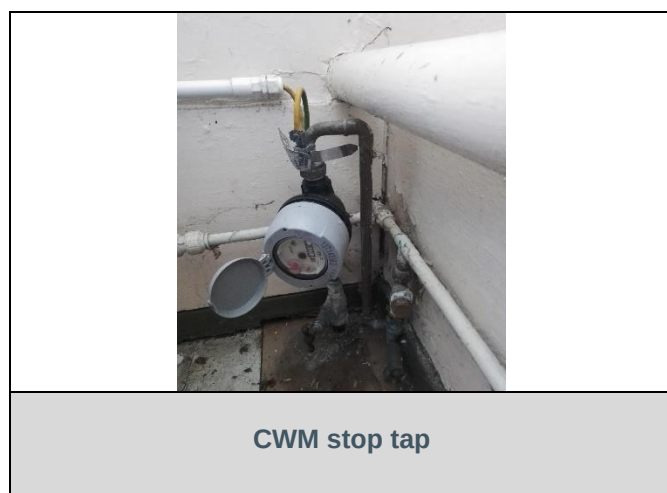
## Photos

| Mains Water Supply Risk Score | Low |

| SYSTEM TYPES | | RISK RATING |
|---|---|---|
| 01 | CWM stop tap should be clearly labelled | Low |

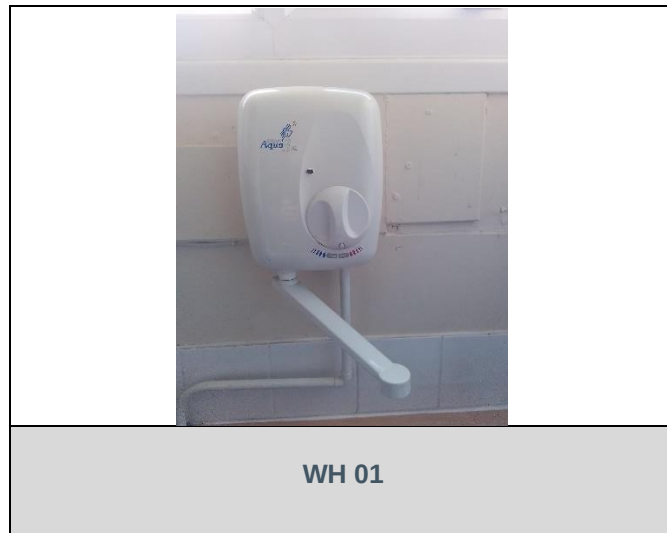
| Water Heater ID Number | Location | Make/model and capacity of each heater | Mains or tank fed | Full clean possible | EXPANSION VESSEL INFO | |
|---|---|---|---|---|---|---|
| WH 01 | Kitchen | Galaxy Aqua Instant | Mains | No | No | |
