# LEGIONELLA RISK ASSESSMENT

## THE PREVENTION AND CONTROL OF LEGIONNAIRES' DISEASE

<b>Client:</b>	Wessex RF & CA
<b>Site:</b>	CTC Somerset ACF Yoxter
<b>Address:</b>	Priddy, Cheddar, Somerset BA5 3BS
<b>Risk Rating:</b>	Medium
<b>Report Ref:</b>	AQST/LRA/365
<b>Surveyed By:</b>	O. Franklin
<b>Survey Date:</b>	19 <sup>th</sup> January 2024
<b>Report Date:</b>	20 <sup>th</sup> February 2024
<b>Written By:</b>	L. Blakemore
<b>Checked By:</b>	J. Rooney
<b>Recommended Review Date:</b>	January 2026

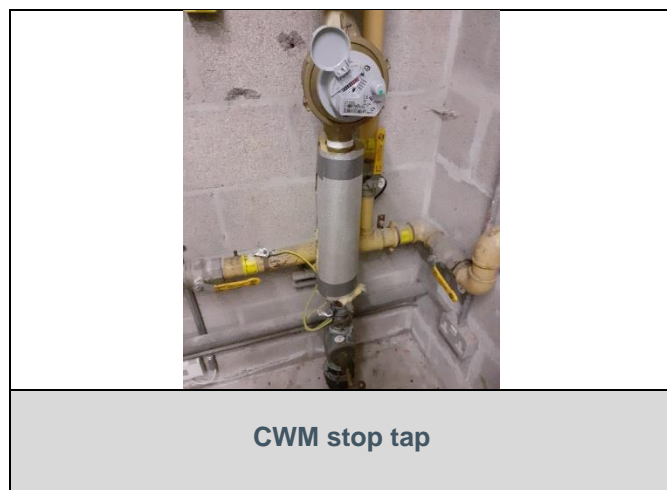
Source of supply	MCW
Number of mains cold water supply?	1
Location of main isolation valve?	Main boiler room
Is there a water meter installed?	Yes
Is the pipework labelled?	No
Materials of construction	54mm copper
Are there any materials or fittings visibly present on the mains water system, that do not conform to the Water Regulations Advisory Scheme (WRAS) directory?	Yes
Mains water temperature °C (sentinel outlets)	Nearest Tap to Incoming Main Furthest Tap from Incoming Main
Are all other distribution temperatures that were tested within the correct temperature range? i.e. Below 20 °C?	Yes
Are there any none flow through expansion vessels to any services on this system?	Yes
Is the pipework suitably insulated?	Yes
Does the cold-water supply have any inline filters including scale inhibitors/softeners?	Yes
<b>COMMENTS</b>	
Mains Water Supply Risk Score	Low

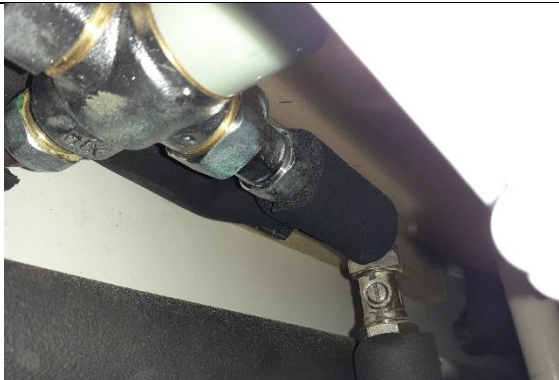
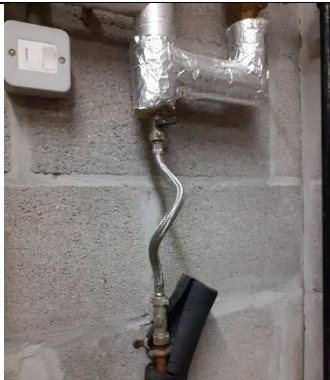
<b>Example of difficult access to TMV</b>	<b>Example of flexi's</b>

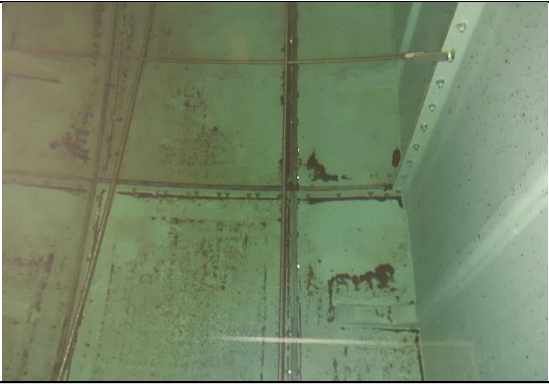
<b>Water in Tank</b>	Temperature C	28.7°C
	Degree of sediment	Low
	Biological slime severe/medium/light	Nil
	Extent of corrosion	Nil
	Is there adequate crossflow within the tank? i.e. inlet opposed from outlet?	Yes
	Is the stored water over capacity??	No
<b>Labels</b>	Is the tank labelled	Yes
	Supply pipe labelled or coded	Coded
	Outlets labelled or coded	Coded
<b>Operation</b>	How far to adequate drain	5m
	Power supply – volts/distance	240v 5m
	Is lighting adequate	Yes
	Access limit ht x w	1960 x 2310 Double doors
<b>CWST Risk Score</b>		Medium

<p>A photograph showing the exterior of a cold water storage tank (CWST 01). The tank is a large, rectangular, light-colored metal structure with several vertical panels. It is situated in a room with a brick wall and a window in the background. A wooden platform is in front of the tank, and some pipes are visible at the base.</p>

<p>A photograph showing the interior of the cold water storage tank (CWST 01). The tank is made of green-painted metal and shows significant rust and corrosion, particularly along the edges and joints. A horizontal metal bar is visible across the top of the tank.</p>
<p>CWST 01</p>	<p>Inside CWST 01</p>

1. Investigate high cold water storage tank temperature.

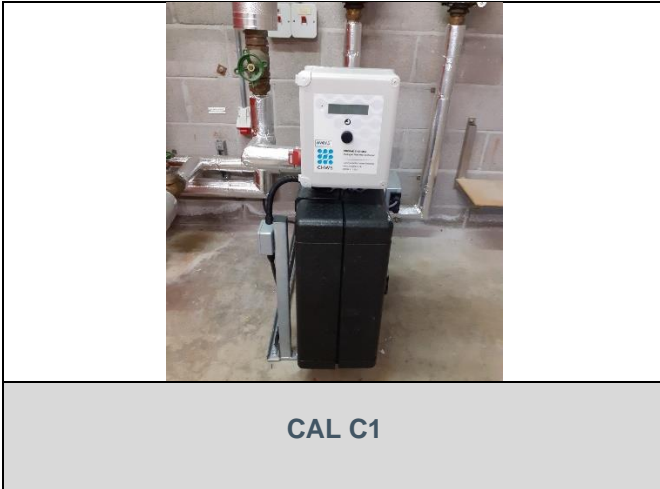
HWSV Ref : CAL C1 – Heat Exchanger

Location of hot water storage vessel	Main plant room
Construction	Aluminium
Size of hot water storage vessel	N/A
Horizontal/vertical	Vertical
Storage/non-storage	Non-storage
Main heat source	Boiler
Supplementary heating	None
Insulation type	-
Is there an open vent	No
Is there an Expansion Vessel	N/A
Size of Expansion Vessel	N/A
IS there a flow through Valve fitted?	N/A
Is there a drain fitted & what size?	Yes
What size is access hatch	N/A
Is there a drain valve – if yes give size	½"
Does drain valve work	Yes
Condition of water from drain valve	Clear
Size and materials cold feed pipe	No cold feed (cold feed in Cal C2)
Is cold feed valved	-
Fed from mains, tank or softened	-
Pressure gauge reading	No gauge
Temp from main gauge on hot water flow	62.9°C
Temp from gauge on sec return flow	No gauge
Safety valve size	-
Is system circulated by sec return (yes/no)	Yes
Is calorifier circulated	-
Anti-stratification Pump (yes/no)	No

Has pump got a time clock	N/A
If yes – how many hours is it set in any 24	N/A
Isolating valves on flow/return	Yes
Is calorifier labelled	No
Is pipe work coded/labelled	No
Power supply voltage/distance	240v 10m
How far to adequate drain	10m
Periods of availability for working	By appointment
Access limit Height x width	1900 x 2310
Temperature from nearest hot outlet	62.3°C
Hot Water Storage Vessel Risk Score	Low

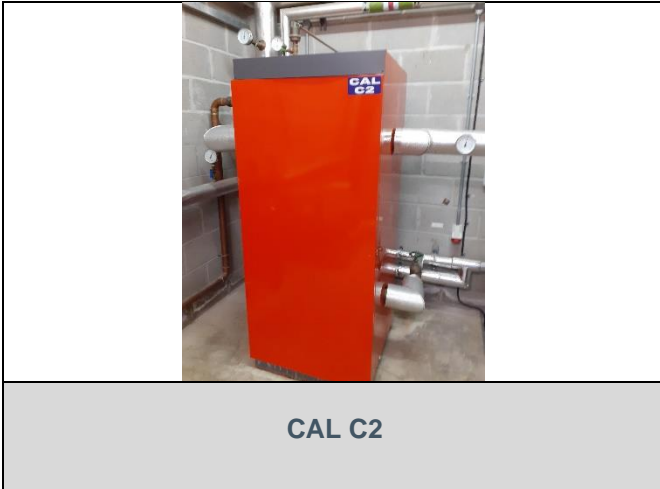
**CAL C2**

Location of hot water storage vessel	Main plant room
Construction	Galv
Size of hot water storage vessel	1770 x 750
Horizontal/vertical	Vertical
Storage/non-storage	Storage
Main heat source	Cal C1 (Heat exchanger)
Supplementary heating	None
Insulation type	Factory
Is there an open vent	No
Is there an Expansion Vessel	N/A
Size of Expansion Vessel	N/A
IS there a flow through Valve fitted?	N/A
Is there a drain fitted & what size?	Yes
What size is access hatch	N/A
Is there a drain valve – if yes give size	½"
Does drain valve work	Yes
Condition of water from drain valve	Clear
Size and materials cold feed pipe	54mm
Is cold feed valved	Yes
Fed from mains, tank or softened	Boosted from Tank 01
Pressure gauge reading	1.9 bar
Temp from main gauge on hot water flow	65.0°C
Temp from gauge on sec return flow	62.0°C
Safety valve size	54mm
Is system circulated by sec return (yes/no)	Yes single
Is calorifier circulated	Yes
Anti-stratification Pump (yes/no)	No

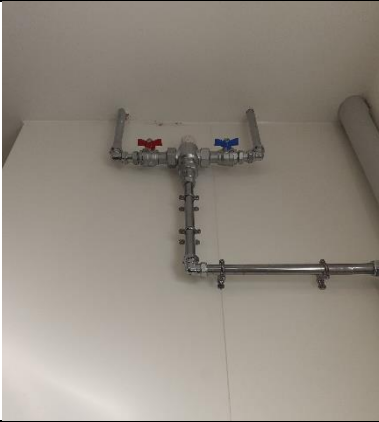
**Example of Shower TMV**

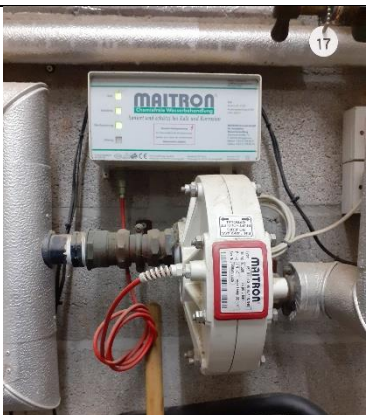
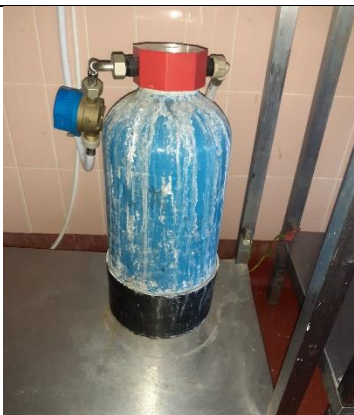
Maitron	Kitchen softener

LOCATION	MAKE/MODEL	SERVICE RECORDS AVAILABLE	SALT SUPPLY AT TIME OF VISIT
CWM supply in boiler room	Maitron (elec type)	No	N/A
Main Kitchen	Unknown	No	N/A
