LEGIONELLA RISK ASSESSMENT

Client:	Wessex RFCA
Site:	Wyvern Barracks Building 11
Address:	Wyvern Barracks, Barrack Road, Exeter, EX2 6AR
Risk Rating:	Medium
Report Ref:	AQST/LRA/331
Surveyed By:	Jon Barton
Survey Date:	11 th -13 th March 2024
Report Date:	15 th March 2024
Recommended Review Date:	March 2026

PREMISES : Wyvern Barracks - Building 11

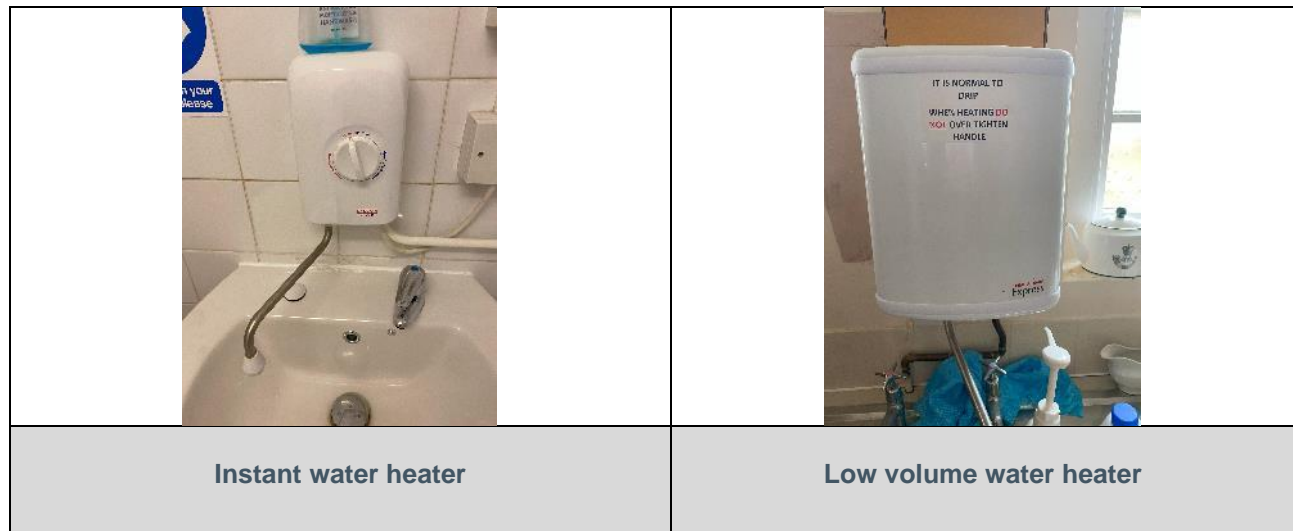
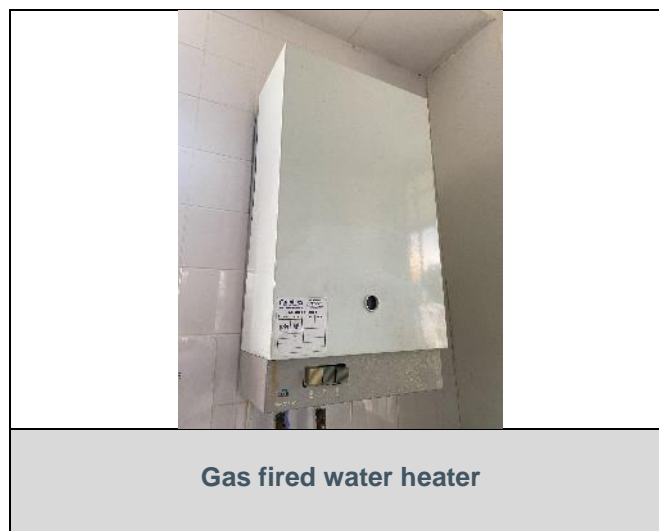
6.7 POINT OF USE WATER HEATERS

Water Heater ID Number	Location	Make/model and capacity of each heater	Mains or tank fed	Full clean possible	EXPANSION VESSEL INFO	
					Is there a pressure vessel – Yes/No	If yes – make model and size and whether fitted horizontally or vertically
1	Female WC	Santon instant	Mains	No	No	-
2	Main kitchen	Mersey gas	Mains	No	No	-
3	Small kitchen	Sadia 7	Mains	No	No	-
4	Male WC	Steeple 7	Mains	No	No	-

SYSTEM TYPES		RISK RATING
COLD WATER MAINS:		
Satisfactory		
COLD WATER STORAGE TANKS:		
None on site		
HOT WATER CALORIFIERS:		
None on site		
POINT OF USE WATER HEATERS:		
The Small kitchen water heater is not operational. Repair/replace as required.		Medium
Actioned date:	Company/initials:	
The gas water heater supplying the main kitchen is very old and problematic. The push buttons are hanging off and I could not get this to produce hot water at the time of the survey. Replace this water heater. Consider using a high volume water heater which does not require gas and avoid the ongoing service costs associated with a gas water heater.		Medium
Actioned date:	Company/initials:	
SHOWERS AND SPRAY OUTLETS:		
None on site		
GENERAL: Control Schemes		
There is a new logbook on site. This logbook new logbook should contain the following information: -A copy of this risk assessment -An up to date management structure listing the on-site responsible people -The RFCA legionella policy -Aquastat's reports (or add a statement showing where these records are kept) -Evidence of any servicing/maintenance -Results from any legionella or TVC samples		High
