LEGIONELLA RISK ASSESSMENT

Client:	Wessex RF & CA
Site:	Parkstone Platoon
Address:	Weymouth Road, Parkstone, Poole, Dorset BH14 0DS
Risk Rating:	Low
Report Ref:	AQST/LRA/521
Surveyed By:	D. Fletcher
Survey Date:	10 th May 2024
Report Date:	15 th May 2024
Written By:	L. Blakemore
Checked By:	J. Rooney
Recommended Review Date:	May 2026

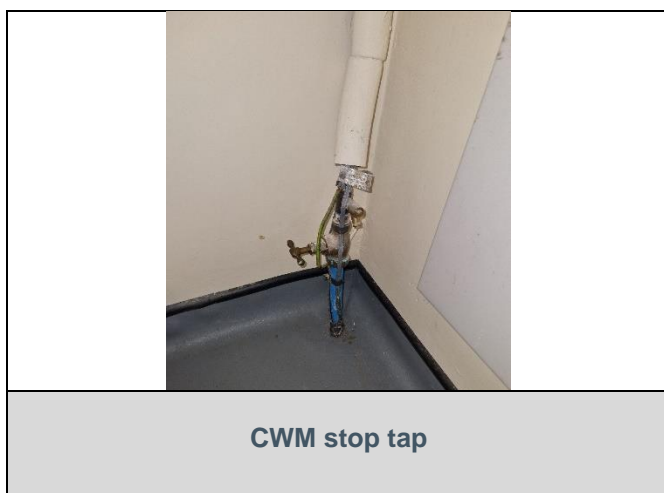
Photos

Source of supply	Towns mains
Number of mains cold water supply?	1
Location of main isolation valve?	Adult wc
Is there a water meter installed?	No
Is the pipework labelled?	No
Materials of construction	22mm blue poly - 22mm copper
Are there any materials or fittings visibly present on the mains water system, that do not conform to the Water Regulations Advisory Scheme (WRAS) directory?	No
Mains water temperature °C (sentinel outlets)	Nearest Tap to Incoming Main Furthest Tap from Incoming Main 15.3
Are all other distribution temperatures that were tested within the correct temperature range? i.e. Below 20 °C?	Yes
Are there any none flow through expansion vessels to any services on this system?	Yes
Is the pipework suitably insulated?	No
Does the cold-water supply have any inline filters including scale inhibitors/softeners?	No
COMMENTS	
Mains Water Supply Risk Score	Low

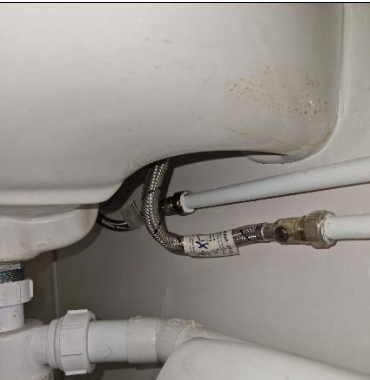
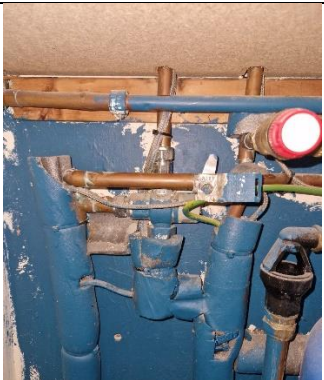
Are dead legs / infrequently used outlets present within system pipework?	Yes
Are thermostatic mixer valves present on individual outlets?	No
Are there single mixer valves serving a number of outlets?	Yes
Is the mixed temperature of the pipework >1m?	Yes
Are flexible hoses fitted to any services on the mains water system?	Yes
Is there any unused equipment connected?	No
Is any scale/debris present on any of the tap outlets?	No
Do any tap outlets have any spray or other inserts fitted?	No
Are strainers fitted?	On TMV

Example of flexi's	TMV

SYSTEM TYPES		RISK RATING
COLD WATER MAINS:		
01	CWM stop tap should be clearly labelled	Low
	Actioned date: Company/initials:	
HOT AND COLD WATER SYSTEMS:		
01	Flexi hoses should be WRAS approved and hot coiled or twisted	High
	Actioned date: Company/initials:	
DEAD LEGS AND BLIND ENDS:		
01	See schedule 6.6 for remedial actions.	High
	Actioned date: Company/initials:	
POINT OF USE WATER HEATERS:		
01	Kitchen water heater expansion vessel has been installed upside down. Requires moving and a drain installing to allow flushing	High
	Actioned date: Company/initials:	
TMVs AND TMTs:		
01	Kitchen TMV requires isolation valves fitting to allow servicing. TMV will need to be moved/repiped to make room for isolation valves (move/repipe all pipework when moving expansion vessel)	High
	Actioned date: Company/initials:	
02	We would recommend removing the TMV from the kitchen and adding local TMV's if required in wc's	High

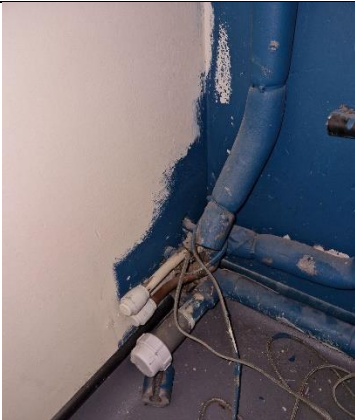
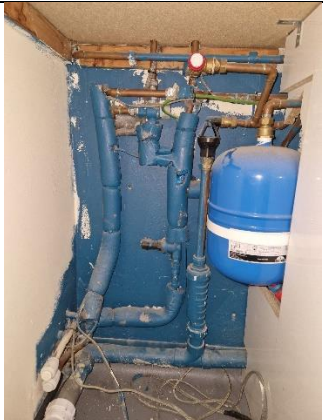
LOCATIONS	SYSTEM	ACTION
01 & 02 – Kitchen to the left of sink under water heater	1 x hot & 1 x cold	Remove/cut back when repiping TMV & expansion vessel

Dead legs 01 & 02	Pipework to be re-routed

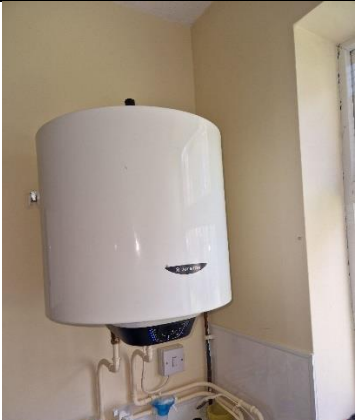
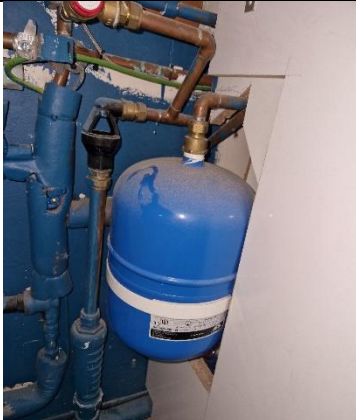
Water Heater ID Number	Location	Make/model and capacity of each heater	Mains or tank fed	Full clean possible	EXPANSION VESSEL INFO	
					Is there a pressure vessel – Yes/No	If yes – make model and size and whether fitted horizontally or vertically
WH 01	Kitchen	Ariston 49ltr	Mains	No	Yes	8ltr upside down

WH 01	Expansion vessel
