## LEGIONELLA RISK ASSESSMENT

### THE PREVENTION AND CONTROL OF LEGIONNAIRES' DISEASE

<b>Client:</b>	Wessex RFCA
<b>Site:</b>	Wyvern Barracks Building 2
<b>Address:</b>	Wyvern Barracks, Barrack Road, Exeter, EX2 6AR
<b>Risk Rating:</b>	Medium
<b>Report Ref:</b>	AQST/LRA/331
<b>Surveyed By:</b>	Jon Barton
<b>Survey Date:</b>	11 <sup>th</sup> – 13 <sup>th</sup> March 2024
<b>Report Date:</b>	15 <sup>th</sup> March 2024
<b>Recommended Review Date:</b>	March 2026

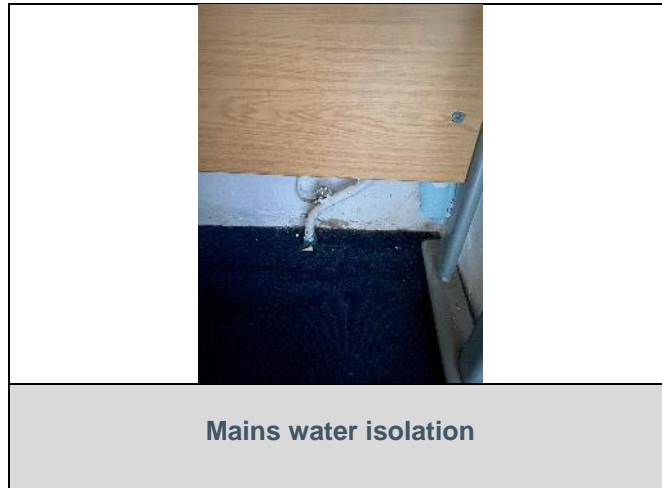
**6.1 MAINS WATER SUPPLY REPORT (continued)**

Source of supply	Mains water
Number of mains cold water supply?	1
Location of main isolation valve?	Entrance area
Is there a water meter installed?	No
Is the pipework labelled?	No
Materials of construction	Copper
Are there any materials or fittings visibly present on the mains water system, that do not conform to the Water Regulations Advisory Scheme (WRAS) directory?	No
Mains water temperature °C (sentinel outlets)	Nearest Tap to Incoming Main: 10.C Furthest Tap from Incoming Main: 10.C
Are all other distribution temperatures that were tested within the correct temperature range? i.e. Below 20 °C?	Yes
Are there any non- flow through expansion vessels to any services on this system?	No
Is the pipework suitably insulated?	Yes
Does the cold-water supply have any inline filters including scale inhibitors/softeners?	No
<b>COMMENTS</b>	
Mains Water Supply Risk Score	Low

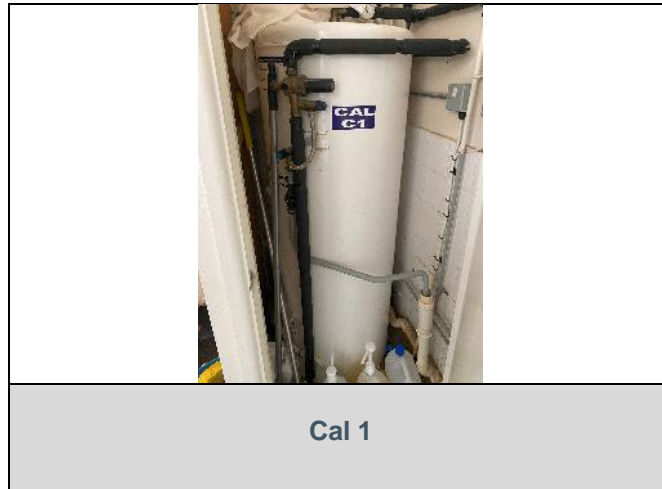
**6.4 HOT WATER STORAGE REPORT (continued)**

Location of hot water storage vessel	Male ablutions
Construction	Stainless steel
Size of hot water storage vessel	250 litre
Horizontal/vertical	Vertical
Storage/non-storage	Storage
Main heat source	LPHW
Supplementary heating	Immersion
Insulation type	Pre insulated
Is there an open vent	No
Is there an Expansion Vessel	No
Size of Expansion Vessel	-
IS there a flow through Valve fitted?	-
Is there a drain fitted & what size?	-
What size is access hatch	N/A
Is there a drain valve – if yes give size	Yes ½ “
Does drain valve work	Not attempted
Condition of water from drain valve	-
Size and materials cold feed pipe	22mm copper
Is cold feed valved	Yes
Fed from mains, tank or softened	Mains
Pressure gauge reading	N/A
Temp from main gauge on hot water flow	62.C
Temp from gauge on sec return flow	N/A
Safety valve size	2 s ½ “
Is system circulated by sec return (yes/no)	No
Is calorifier circulated	No
Anti-stratification Pump (yes/no)	No

Has pump got a time clock	-
If yes – how many hours is it set in any 24	-
Isolating valves on flow/return	No
Is calorifier labelled	Yes
Is pipe work coded/labelled	No
Power supply voltage/distance	10m
How far to adequate drain	20m
Periods of availability for working	By prior appointment
Access limit Height x width	2000 x 500
Temperature from nearest hot outlet	62.C
Hot Water Storage Vessel Risk Score	Low

- Satisfactory

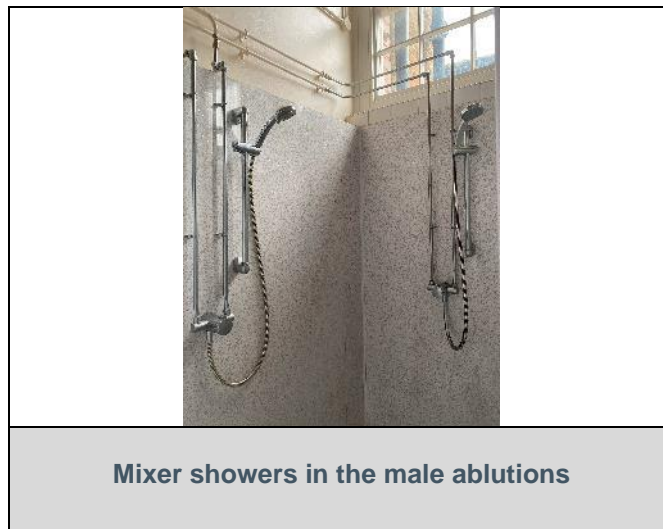
Location	Nos of showers	Dismantled/ cleaned and disinfected YES/NO	Overall condition	Any repairs replacements	Regularity of Use
Male ablutions	3	No	Good	No	Unknown
<b>COMMENTS:</b>					
<ul style="list-style-type: none"> <li>Satisfactory condition</li> <li>Flush weekly if not used weekly</li> </ul>

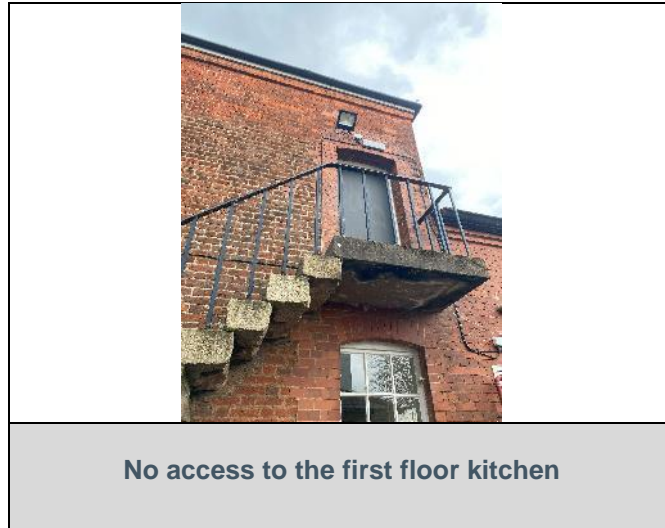
## 6.7 POINT OF USE WATER HEATERS

Water Heater ID Number	Location	Make/model and capacity of each heater	Mains or tank fed	Full clean possible	EXPANSION VESSEL INFO	
					Is there a pressure vessel – Yes/No	If yes – make model and size and whether fitted horizontally or vertically
1	FF kitchen	No access

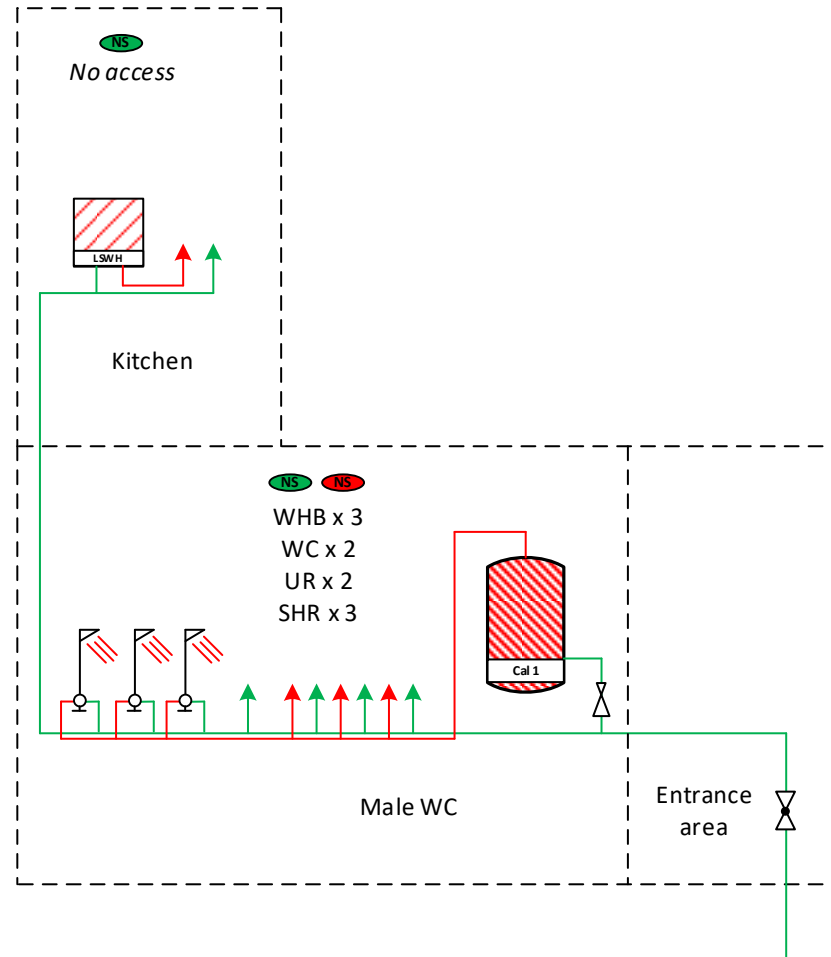
## 8. LINE DRAWINGS OF WATER SYSTEMS SITE: Wyvern Barracks - Building 2

NB: Due to the complexity of the pipe work at this site it is not possible to ensure the total accuracy of these line drawings. They may require revision.
