## LEGIONELLA RISK ASSESSMENT

<b>Client:</b>	Wessex RF & CA
<b>Site:</b>	Bridgwater ACF
<b>Address:</b>	Friarn Meadows, Friarn Avenue, Bridgwater TA6 3RA
<b>Risk Rating:</b>	Low
<b>Report Ref:</b>	AQRA/AQST/LRA/077
<b>Surveyed By:</b>	D. Fletcher
<b>Survey Date:</b>	6 <sup>th</sup> July 2023
<b>Report Date:</b>	3 <sup>rd</sup> August 2023
<b>Recommended Review Date:</b>	July 2025

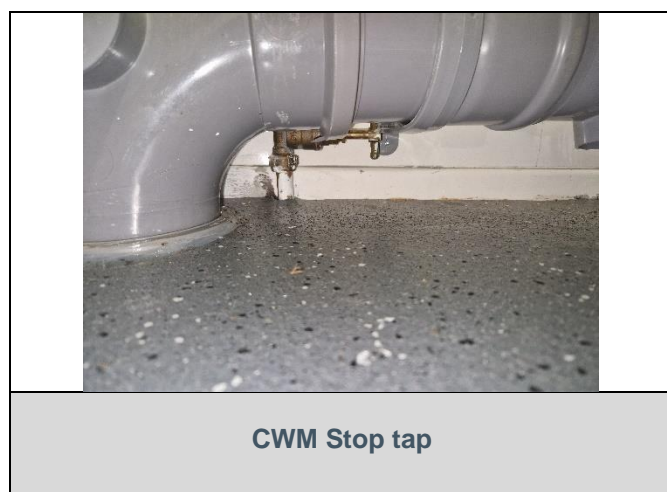
### Photos

Source of supply	Towns mains
Number of mains cold water supply?	1
Location of main isolation valve?	Ladies wc (left wc)
Is there a water meter installed?	No
Is the pipework labelled?	No
Materials of construction	15mm copper
Are there any materials or fittings visibly present on the mains water system, that do not conform to the Water Regulations Advisory Scheme (WRAS) directory?	No
Mains water temperature °C (sentinel outlets)	Nearest Tap to Incoming Main 16.8 Furthest Tap from Incoming Main 17.2
Are all other distribution temperatures that were tested within the correct temperature range? i.e. Below 20 °C?	Yes
Are there any none flow through expansion vessels to any services on this system?	Yes
Is the pipework suitably insulated?	No
Does the cold-water supply have any inline filters including scale inhibitors/softeners?	No
<b>COMMENTS</b>	
Mains Water Supply Risk Score	<b>Medium</b>

SYSTEM TYPES		RISK RATING
<b>COLD WATER MAINS:</b>		
01	CWM stop tap should be clearly labelled	
	Actioned date: Company/initials:	
<b>POINT OF USE WATER HEATERS:</b>		
01	Where possible water heaters should be set to produce at least 50°C from hot tap outlets within 1 running minute. Some instantaneous water heaters are not manufactured to produce high temperatures	High
	Actioned date: Company/initials:	
<b>GENERAL: Control Schemes</b>		
01	During times of low use the building should be flushed thoroughly on a weekly basis and recorded in the log book	High
	Actioned date: Company/initials:	
02	Hot and cold representative outlet monitoring should be carried out on a monthly basis and recorded in the log book	High
	Actioned date: Company/initials:	
03	Flexi hoses should be WRAS approved and not coiled or twisted	High
	Actioned date: Company/initials:

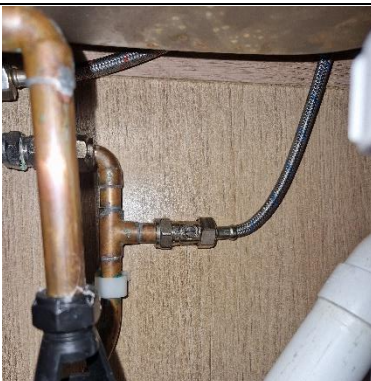
Are dead legs / infrequently used outlets present within system pipework?	No
Are thermostatic mixer valves present on individual outlets?	No
Are there single mixer valves serving a number of outlets?	No
Is the mixed temperature of the pipework >1m?	N/A
Are flexible hoses fitted to any services on the mains water system?	Yes
Is there any unused equipment connected?	No
Is any scale/debris present on any of the tap outlets?	No
Do any tap outlets have any spray or other inserts fitted?	No
Are strainers fitted?	No

Example of flexi's

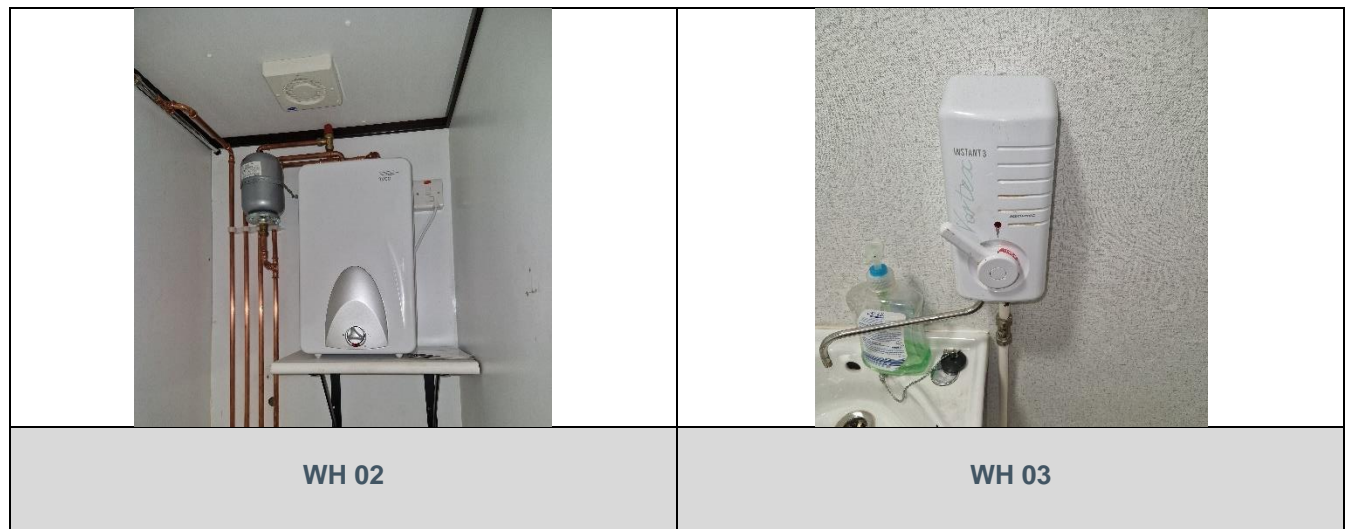
## 6.7 POINT OF USE WATER HEATERS

Water Heater ID Number	Location	Make/model and capacity of each heater	Mains or tank fed	Full clean possible	EXPANSION VESSEL INFO	
					Is there a pressure vessel – Yes/No	If yes – make model and size and whether fitted horizontally or vertically
WH 01	Kitchen	Albion 10ltr	Mains	No	Yes	2ltr vertical
WH 02	Cleaners store	Hycos 15ltr	Mains	No	Yes	2ltr vertical
WH 03	Disabled	Instant vortex	Mains	No	No
