## LEGIONELLA RISK ASSESSMENT

### THE PREVENTION AND CONTROL OF LEGIONNAIRES' DISEASE

<b>Client:</b>	Wessex RF & CA
<b>Site:</b>	Yate ACF
<b>Address:</b>	Great Western Business Park, Armstrong Way, Yate BS37 5NG
<b>Risk Rating:</b>	Low
<b>Report Ref:</b>	AQRA/AQ1209
<b>Surveyed By:</b>	O. Franklin
<b>Survey Date:</b>	20 <sup>th</sup> June 2023
<b>Report Date:</b>	28 <sup>th</sup> June 2023
<b>Recommended Review Date:</b>	June 2025

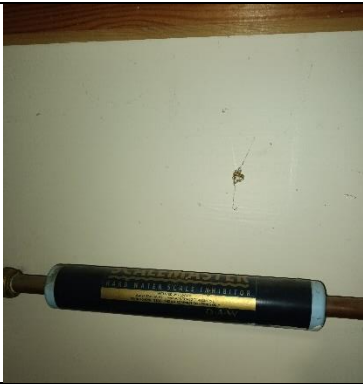
Source of supply	MCW
Number of mains cold water supply?	1
Location of main isolation valve?	Kitchen
Is there a water meter installed?	No
Is the pipework labelled?	No
Materials of construction	30mm blue poly/22mm copper
Are there any materials or fittings visibly present on the mains water system, that do not conform to the Water Regulations Advisory Scheme (WRAS) directory?	Flexi's
Mains water temperature °C (sentinel outlets)	Nearest Tap to Incoming Main 21.0 Furthest Tap from Incoming Main 21.0
Are all other distribution temperatures that were tested within the correct temperature range? i.e. Below 20 °C?	No due to time of year
Are there any none flow through expansion vessels to any services on this system?	Yes
Is the pipework suitably insulated?	Yes
Does the cold-water supply have any inline filters including scale inhibitors/softeners?	Yes
<b>COMMENTS</b>	
Mains Water Supply Risk Score	Low

Stop tap	Scalemaster

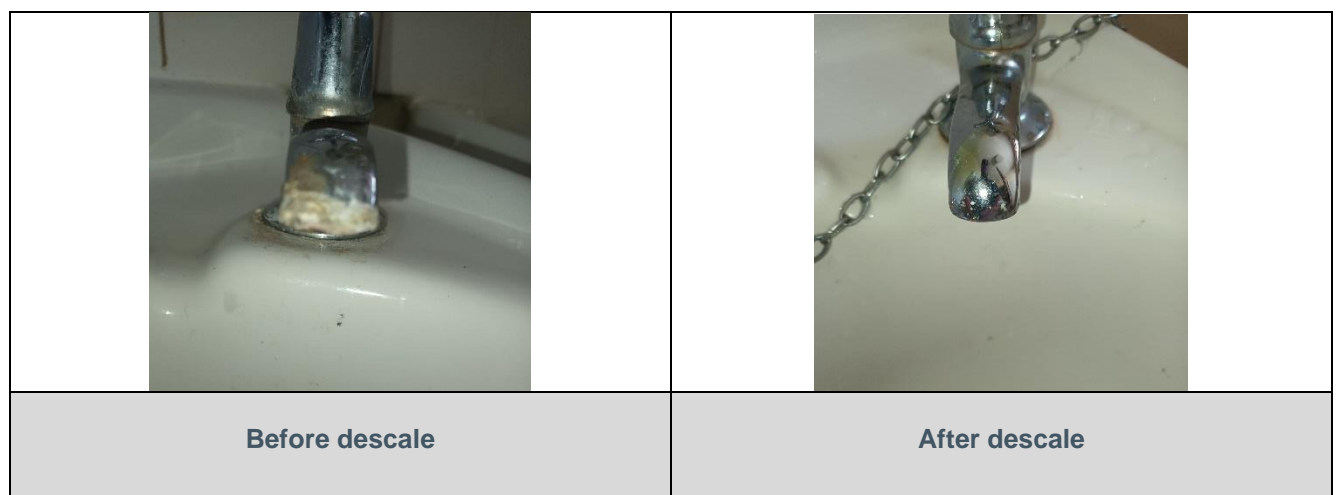
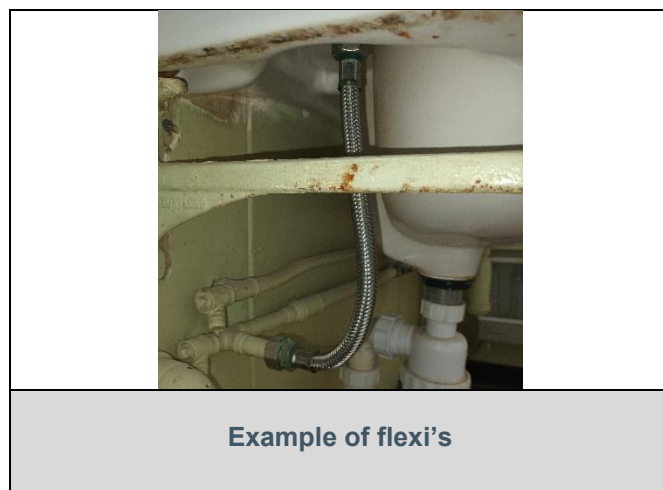
Are dead legs / infrequently used outlets present within system pipework?	None seen
Are thermostatic mixer valves present on individual outlets?	No
Are there single mixer valves serving a number of outlets?	N/A
Is the mixed temperature of the pipework >1m?	N/A
Are flexible hoses fitted to any services on the mains water system?	Yes
Is there any unused equipment connected?	No
Is any scale/debris present on any of the tap outlets?	Yes descaled at time of assessment
Do any tap outlets have any spray or other inserts fitted?	No
Are strainers fitted?	No

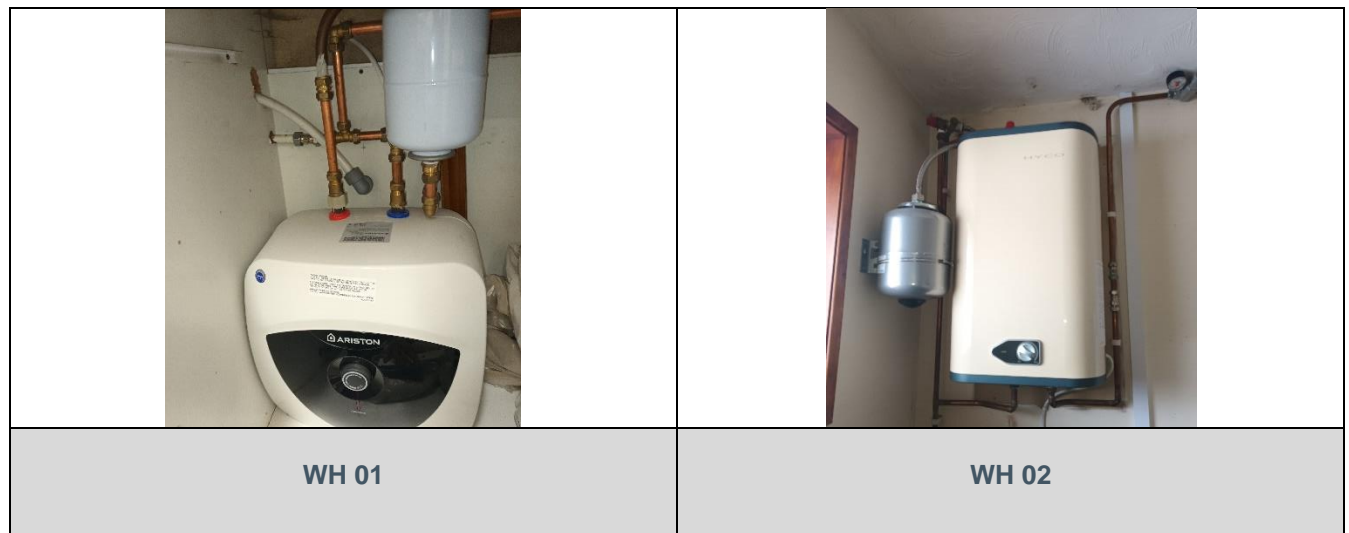
Water Heater ID Number	Location	Make/model and capacity of each heater	Mains or tank fed	Full clean possible	EXPANSION VESSEL INFO	
					Is there a pressure vessel – Yes/No	If yes – make model and size and whether fitted horizontally or vertically
WH 01	Kitchen	Ariston 10ltr	Mains	No	Yes	2ltr vertical
WH 02	Adult wc	Hyco 30ltr	Mains	No	Yes	5ltr vertical

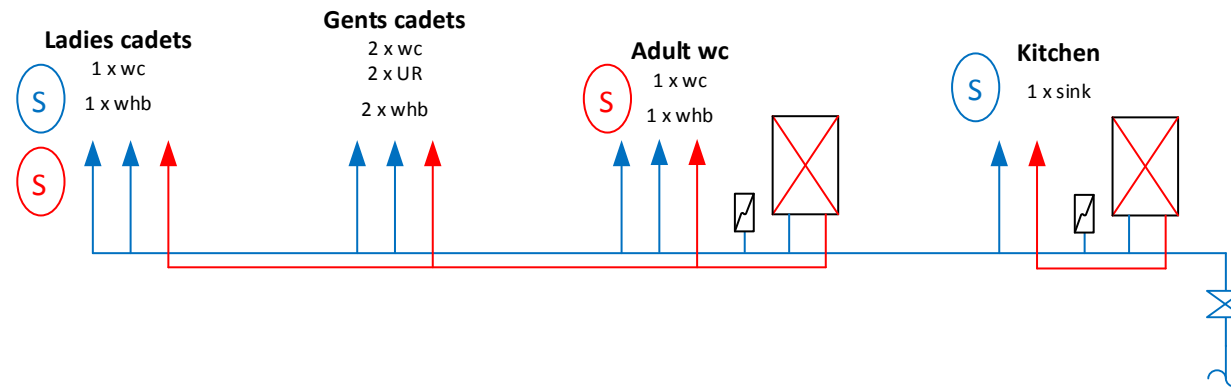
## 8. LINE DRAWINGS OF WATER SYSTEMS

**NB: Due to the complexity of the pipe work at this site it is not possible to ensure the total accuracy of these line drawings. They may require revision.**
