## LEGIONELLA RISK ASSESSMENT

| <b>Client:</b> | Wessex RF & CA |
| <b>Site:</b> | Weston-super-Mare ATC |
| <b>Report Ref:</b> | AQST/LRA/210 |

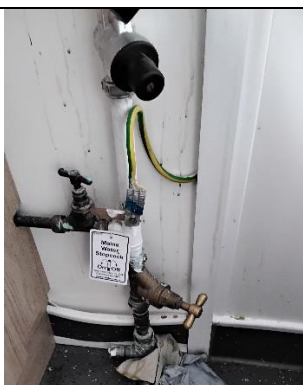
**CWM stop tap**

| Materials of construction | 22mm copper - leaking |
| Are there any materials or fittings visibly present on the mains water system, that do not conform to the Water Regulations Advisory Scheme (WRAS) directory? | Yes |
| Mains Water Supply Risk Score | <b>Medium</b> |

| SYSTEM TYPES | | RISK RATING |
|---|---|---|
| 01 | The stop tap is leaking and requires replacing | Low |
