LEGIONELLA RISK ASSESSMENT

Client:	Wessex RF & CA
Site:	Pilning ACF
Address:	Redwick Road, Pilning BS35 4LZ
Risk Rating:	Low
Report Ref:	AQRA/AQ1177
Surveyed By:	O. Franklin
Survey Date:	20 th June 2023
Report Date:	27 th June 2023
Recommended Review Date:	June 2025

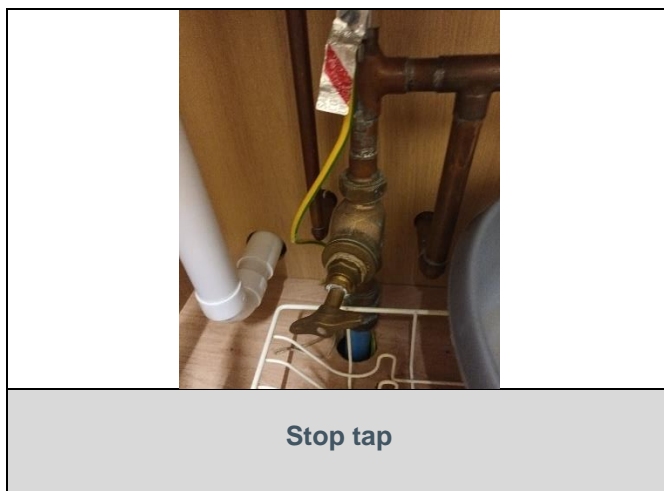
Photos

Source of supply	MCW
Number of mains cold water supply?	1
Location of main isolation valve?	Kitchen under sink
Is there a water meter installed?	No
Is the pipework labelled?	No
Materials of construction	28mm copper
Are there any materials or fittings visibly present on the mains water system, that do not conform to the Water Regulations Advisory Scheme (WRAS) directory?	Flexi's
Mains water temperature °C (sentinel outlets)	Nearest Tap to Incoming Main 16.6 Furthest Tap from Incoming Main 16.6
Are all other distribution temperatures that were tested within the correct temperature range? i.e. Below 20 °C?	Yes
Are there any non flow through expansion vessels to any services on this system?	Yes
Is the pipework suitably insulated?	Yes
Does the cold-water supply have any inline filters including scale inhibitors/softeners?	No
COMMENTS	
Mains Water Supply Risk Score	Low

SYSTEM TYPES		RISK RATING
	COLD WATER MAINS:	
01	CWM stop tap should be clearly labelled	
	Actioned date: Company/initials:	
	GENERAL: Control Schemes	
01	Flexi's should be WRAS approved	Medium
	Actioned date: Company/initials:

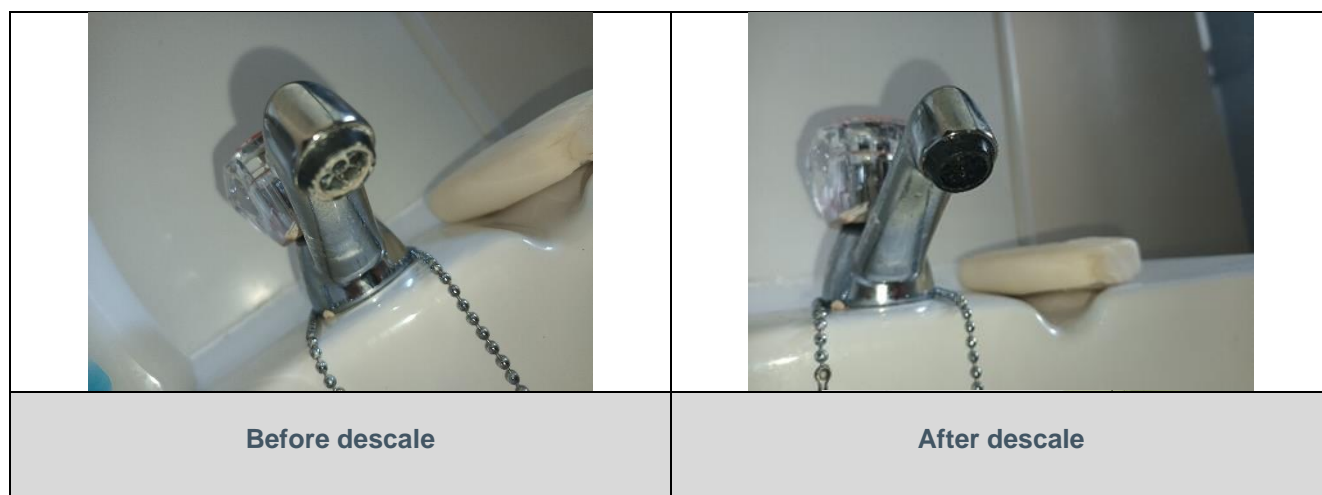
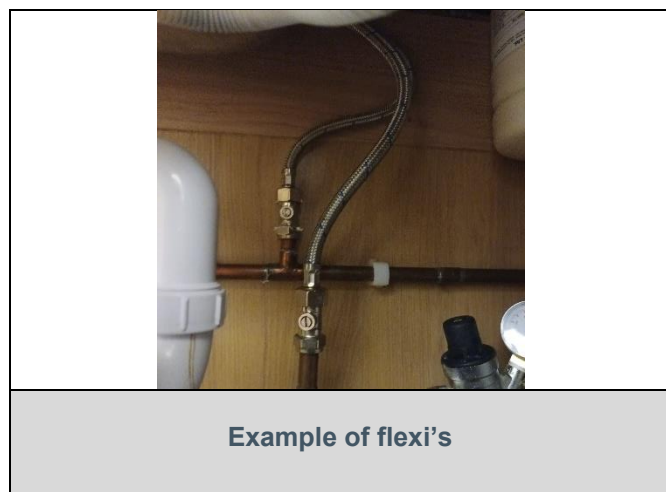
Are dead legs / infrequently used outlets present within system pipework?	None seen
Are thermostatic mixer valves present on individual outlets?	Yes
Are there single mixer valves serving a number of outlets?	Yes
Is the mixed temperature of the pipework >1m?	No
Are flexible hoses fitted to any services on the mains water system?	Yes
Is there any unused equipment connected?	No
Is any scale/debris present on any of the tap outlets?	Yes descale at time of assessment
Do any tap outlets have any spray or other inserts fitted?	No
Are strainers fitted?	No

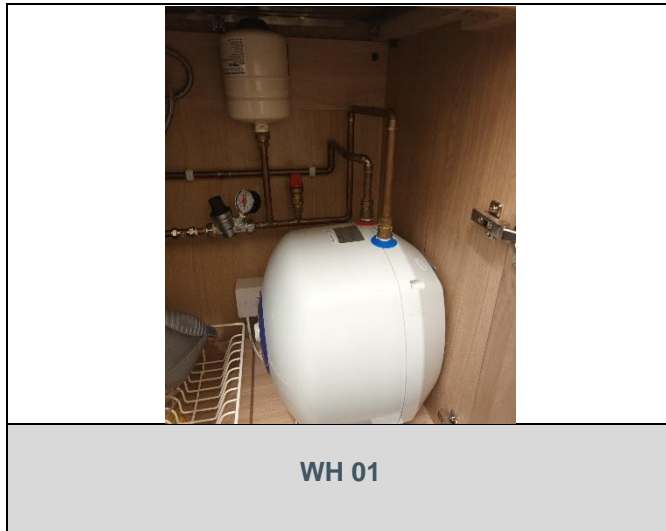
Water Heater ID Number	Location	Make/model and capacity of each heater	Mains or tank fed	Full clean possible	EXPANSION VESSEL INFO	
					Is there a pressure vessel – Yes/No	If yes – make model and size and whether fitted horizontally or vertically
WH 01	Kitchen	Eva flo 15ltr	Mains	No	Yes	Globel 1ltr vertical

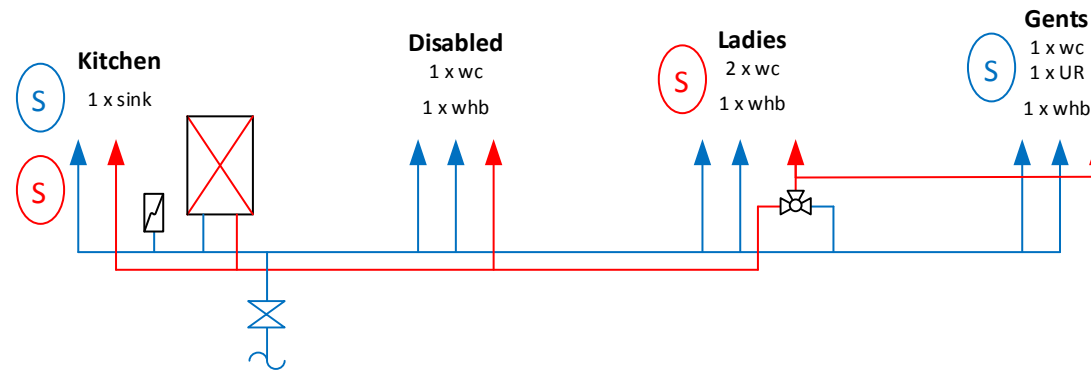
8. LINE DRAWINGS OF WATER SYSTEMS

NB: Due to the complexity of the pipe work at this site it is not possible to ensure the total accuracy of these line drawings. They may require revision.
