# LEGIONELLA RISK ASSESSMENT

| <b>Client:</b> | Wessex RF & CA |
| <b>Site:</b> | Wootton Bassett Platoon |
| <b>Report Ref:</b> | AQST/LRA/413 |

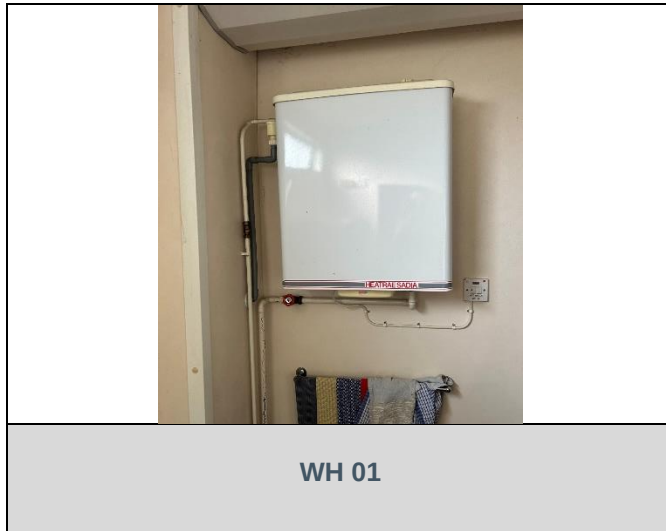
| Water Heater ID Number | Location | Make/model and capacity of each heater | Mains or tank fed | Full clean possible | EXPANSION VESSEL INFO | |
|---|---|---|---|---|---|---|
| WH 01 | Kitchen | Sadia 25ltr | Mains | Yes | No | |

| SYSTEM TYPES | | RISK RATING |
|---|---|---|
| 01 | The water heater is broken and requires replacing with an unvented water heater | High |
