LEGIONELLA RISK ASSESSMENT

THE PREVENTION AND CONTROL OF LEGIONNAIRES' DISEASE

Client:	Wessex RF & CA
Site:	Bishops Cleeve Platoon
Address:	24 Church Road, Bishops Cleeve, Cheltenham GL52 4LR
Risk Rating:	Low
Report Ref:	AQRA/AQ1134
Surveyed By:	O. Franklin
Survey Date:	27 th June 2023
Report Date:	29 th June 2023
Recommended Review Date:	June 2025

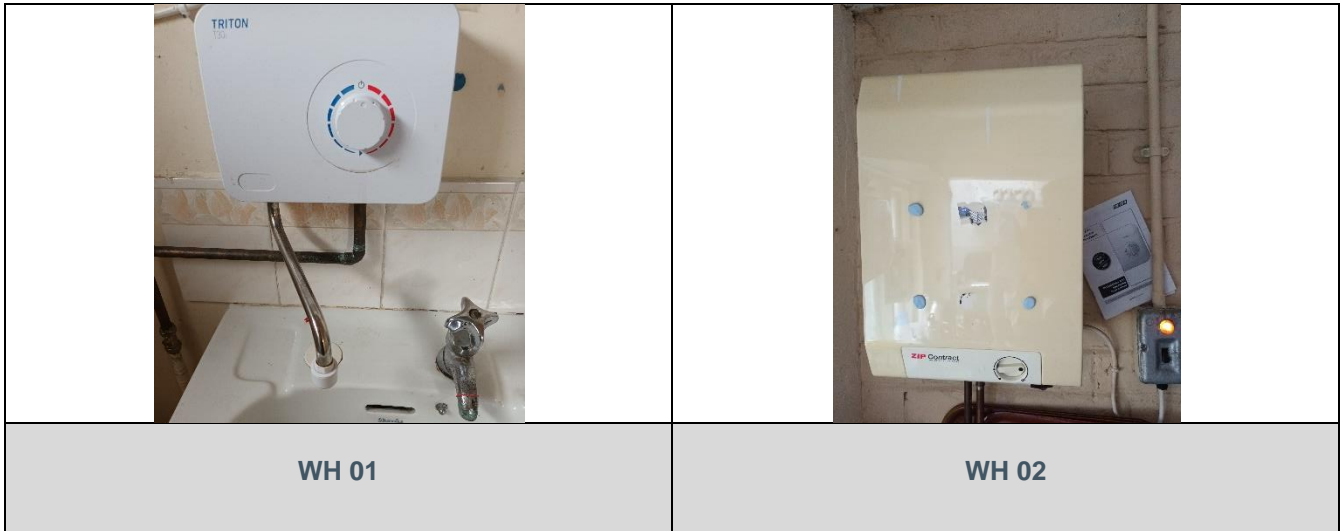
6.7 POINT OF USE WATER HEATERS

Water Heater ID Number	Location	Make/model and capacity of each heater	Mains or tank fed	Full clean possible	EXPANSION VESSEL INFO	
					Is there a pressure vessel – Yes/No	If yes – make model and size and whether fitted horizontally or vertically
WH 01	Gents	Triton instant	Mains	No	No	
WH 02	Kitchen	Zip 10ltr	Mains	No	No	
WH 03	1 st f Ladies	Triton instant	Mains	No	No

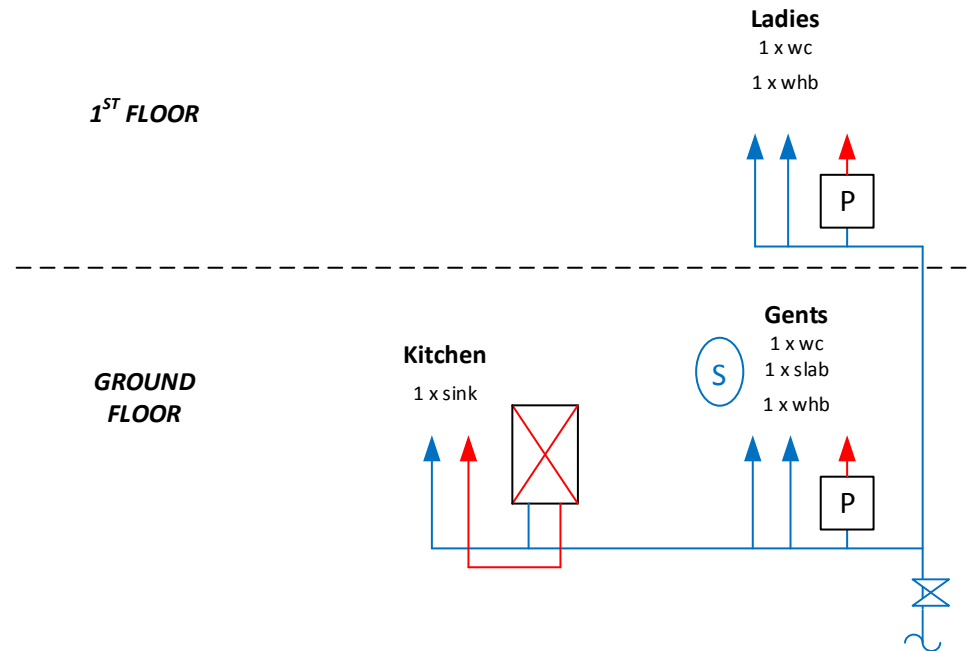
NB: Due to the complexity of the pipe work at this site it is not possible to ensure the total accuracy of these line drawings. They may require revision.
