## LEGIONELLA RISK ASSESSMENT

| <b>Site:</b> | Wellington ACF |
| <b>Report Ref:</b> | AQRA/AQST/LRA/078 |
| <b>Survey Date:</b> | 6 <sup>th</sup> July 2023 |

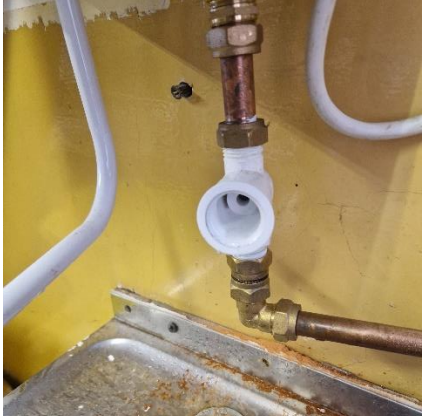
| <p><b>WH 04</b></p> | <p><b>WH 04 broken handle</b></p> |

| SYSTEM TYPES | | RISK RATING |
|---|---|---|
| 02 | Stores water heater handle is broke – requires repairing or replacing | High |

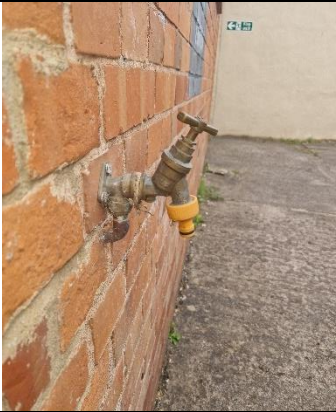
| <p>Sign</p> | <p>Outside bib</p> |

| SYSTEM TYPES | | RISK RATING |
|---|---|---|
| 04 | Recommend removing bib tap on CWM | Medium |
