# LEGIONELLA RISK ASSESSMENT

| <b>Site:</b> | Okehampton Platoon |
| <b>Address:</b> | Military Sidings, Tors Road, Okehampton EX20 1EF |
| <b>Report Ref:</b> | AQST/LRA/339 |

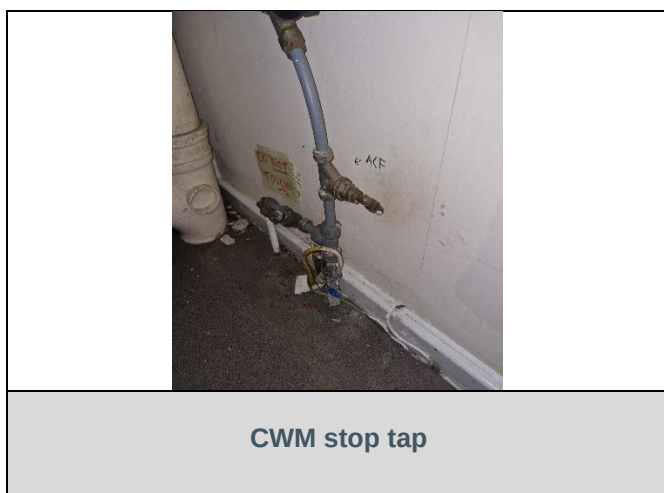
## Photos

| Source of supply | Towns mains |
| Number of mains cold water supply? | 1 |
| Location of main isolation valve? | Staff wc |
| Is the pipework labelled? | No |
| Materials of construction | 15mm Hep 20 |
| Mains water temperature °C (sentinel outlets) | Furthest Tap from Incoming Main<br>6.7°C |
| Is the pipework suitably insulated? | No |
| Mains Water Supply Risk Score | <b>Medium</b> |

| SYSTEM TYPES | | RISK RATING |
|---|---|---|
| 01 | CWM stop tap should be clearly labelled | |

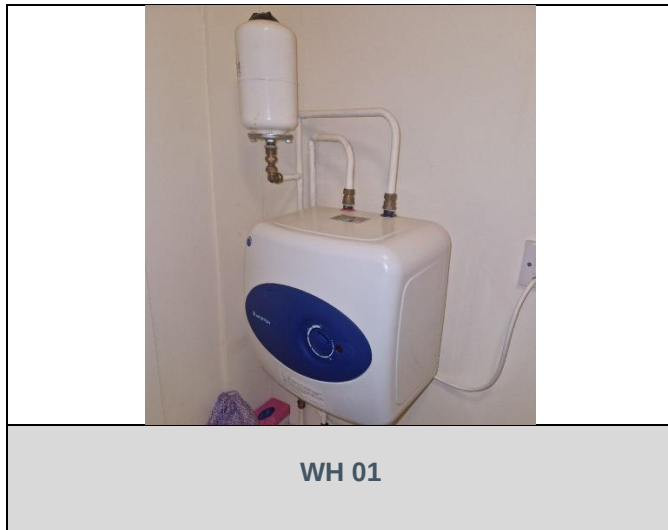
| Water Heater ID Number | Location | Make/model and capacity of each heater | Mains or tank fed | Full clean possible | EXPANSION VESSEL INFO | |
|---|---|---|---|---|---|---|
| WH 01 | Cadet wc | Ariston 15ltr | Mains | No | Yes | 2ltr vertical |
