# LEGIONELLA RISK ASSESSMENT

| <b>Site:</b> | Marlborough ATC |
| <b>Report Ref:</b> | AQST/LRA/412 |
| <b>Survey Date:</b> | 7 <sup>th</sup> March 2024 |

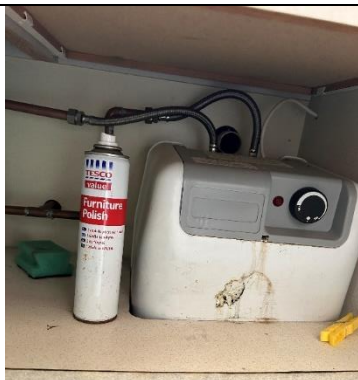
Flexi's on water heater

| SYSTEM TYPES | | RISK RATING |
|---|---|---|
| 01 | Flexi's should be WRAS approved or hard piped where possible | Medium |

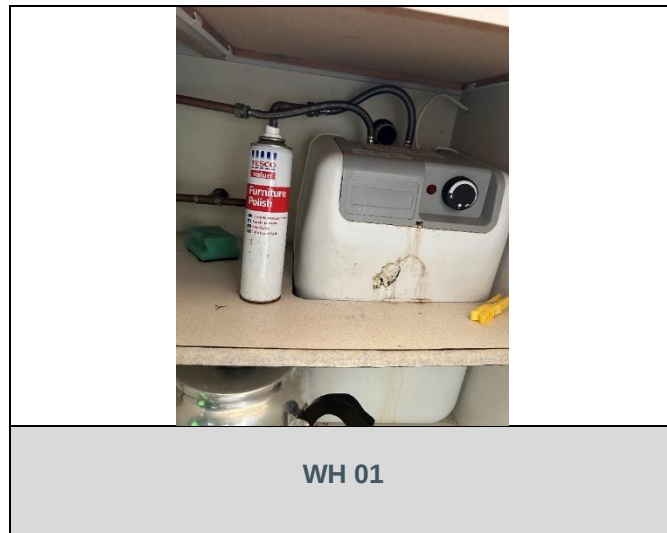
| Water Heater ID Number | Location | Make/model and capacity of each heater | Mains or tank fed | Full clean possible | EXPANSION VESSEL INFO | |
|---|---|---|---|---|---|---|
| WH 01 | Kitchen | Aquapoint 15ltr | Mains | No | No | |
