# LEGIONELLA RISK ASSESSMENT

## THE PREVENTION AND CONTROL OF LEGIONNAIRES' DISEASE

<b>Client:</b>	Wessex RF & CA
<b>Site:</b>	Bournemouth Platoon
<b>Address:</b>	Portman Road, Bournemouth BH7 6EU
<b>Risk Rating:</b>	Low
<b>Report Ref:</b>	AQST/LRA/
<b>Surveyed By:</b>	N. O'Leary
<b>Survey Date:</b>	5 <sup>th</sup> March 2024
<b>Report Date:</b>	3 <sup>rd</sup> April 2024
<b>Written By:</b>	L. Blakemore
<b>Checked By:</b>	J. Rooney
<b>Recommended Review Date:</b>	March 2026

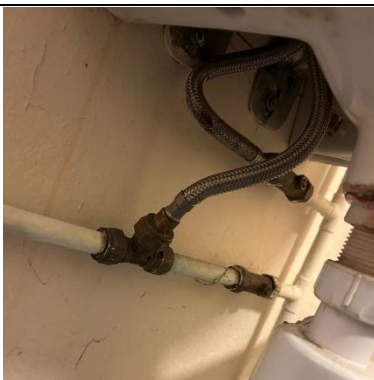
**Flexi's**

Are dead legs / infrequently used outlets present within system pipework?	No
Are thermostatic mixer valves present on individual outlets?	No
Are there single mixer valves serving a number of outlets?	No
Is the mixed temperature of the pipework >1m?	No
Are flexible hoses fitted to any services on the mains water system?	Yes
Is there any unused equipment connected?	No
Is any scale/debris present on any of the tap outlets?	No
Do any tap outlets have any spray or other inserts fitted?	No
Are strainers fitted?	No

SYSTEM TYPES		RISK RATING
	<b>HOT AND COLD WATER SYSTEMS:</b>	
01	Flexi's should be WRAS approved or hard piped where possible	Medium
	Actioned date:      Company/initials:	
	<b>POINT OF USE WATER HEATERS:</b>	
01	Disabled water heater is producing low temperatures. Water heater should be set to produce at least 50°C at outlets	High
	Actioned date:      Company/initials:

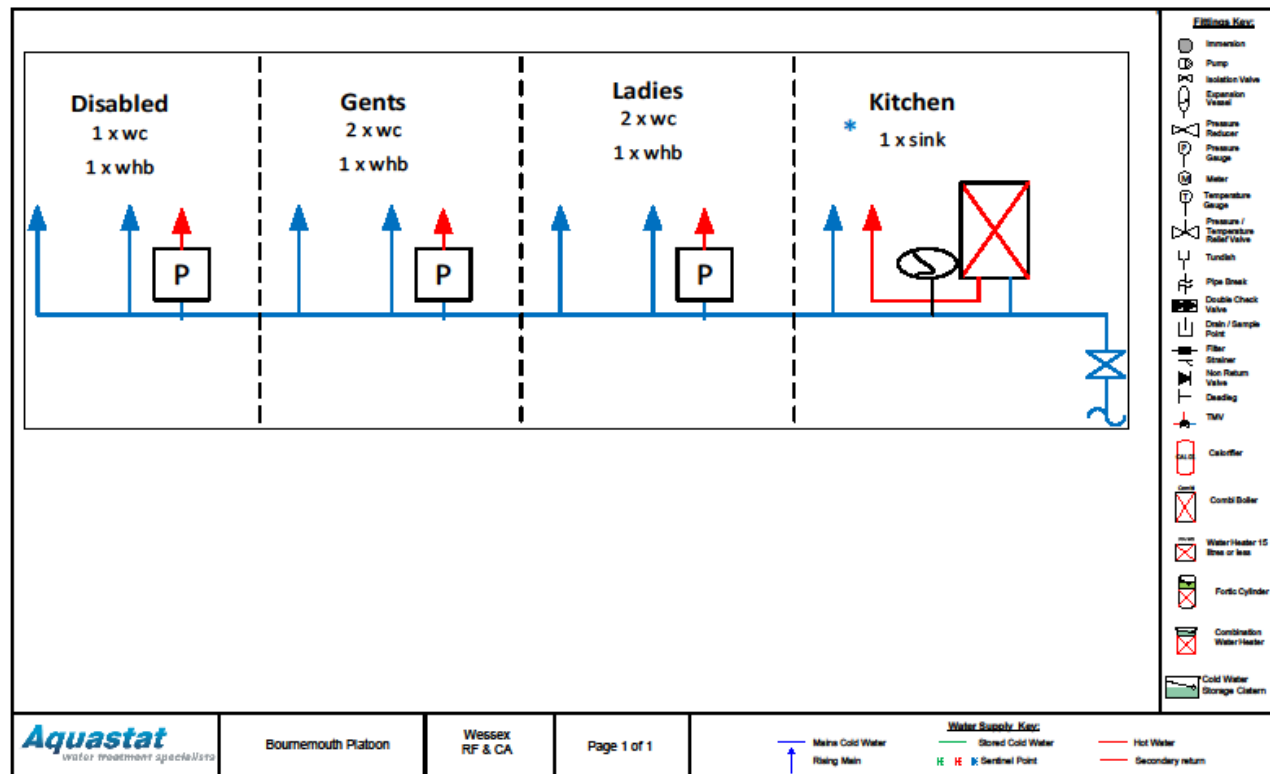
NB: Due to the complexity of the pipe work at this site it is not possible to ensure the total accuracy of these line drawings. They may require revision.
