LEGIONELLA RISK ASSESSMENT

THE PREVENTION AND CONTROL OF LEGIONNAIRES' DISEASE

Client:	Wessex RFCA
Site:	Wyvern Barracks Building 8
Address:	Wyvern Barracks, Barrack Road, Exeter, EX2 6AR
Risk Rating:	Medium
Report Ref:	AQST/LRA/331
Surveyed By:	Jon Barton
Survey Date:	11 th – 13 th March 2024
Report Date:	15 th March 2024
Recommended Review Date:	March 2026

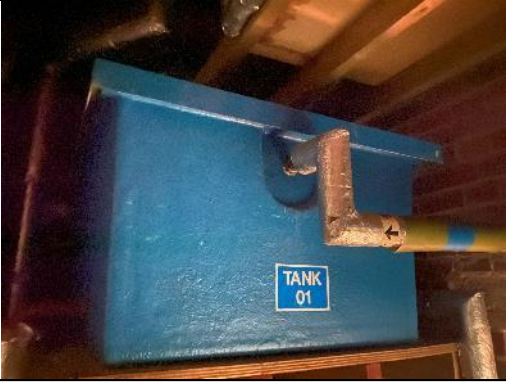
6.3 COLD WATER STORAGE TANK REPORT (continued)

Location	Exact location of tank	Roof space above male ablutions
Structure	Accurate dimensions l x w x h or dia	1500 x 900 x 600
	Materials of tank and any jointing's	GRP
	Insulation type and thickness	GRP
Lid Details	Is there a close-fitting lid	Yes
	Is it securely fixed in place	Yes
	Accurate dimensions for new lid	1550 x 950
	Separate ball valve hatch	No
	Vent size has it good rodent screen	Yes 1"
Overflow	Size and materials of main overflow	54mm copper
	Is there a rodent filter	Yes
	Size and materials of warning pipe	22mm plastic
	Is there a rodent filter	Yes
Supply	Size and materials of pipework	28mm copper
	Fed from mains, softener or tank	Mains
	Insulation type and thickness	Foil faced
	Any other return or vent pipes	No
Outlets	Size and Materials	Insulation type and thickness
Outlet 1	35mm copper	Foil faced
Outlet 2	42mm copper	Foil faced
Drain valve	Is there a drain valve – size if applicable	N/A
Water in Tank	Temperature C	12.C

Degree of sediment	Medium/heavy
	Biological slime severe/medium/light	Medium
	Extent of corrosion	Nil
	Is there adequate crossflow within the tank? i.e. inlet opposed from outlet?	Yes
	Is the stored water over capacity??	No
Labels	Is the tank labelled	Yes
	Supply pipe labelled or coded	Yes
	Outlets labelled or coded	Yes
Operation	How far to adequate drain	30m
	Power supply – volts/distance	10m
	Is lighting adequate	Yes
	Access limit ht x w	1310 x 630
CWST Risk Score		Medium

<p>External view</p>	<p>Internal view</p>

- Clean and disinfection required.

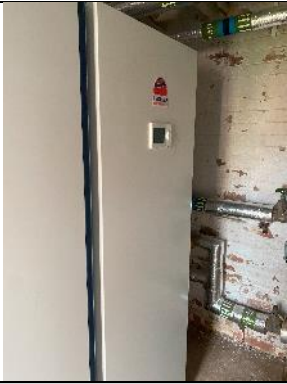
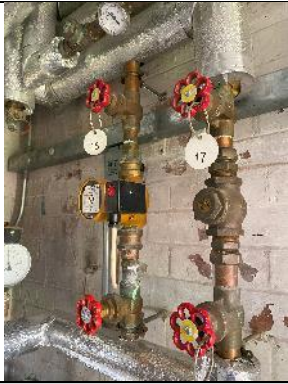
6. 4 HOT WATER STORAGE REPORT (continued)

Location of hot water storage vessel	Boiler room
Construction	Stainless steel
Size of hot water storage vessel	Approx. 300 litres
Horizontal/vertical	Vertical
Storage/non-storage	Storage
Main heat source	LPHW
Supplementary heating	No
Insulation type	Pre insulated
Is there an open vent	No
Is there an Expansion Vessel	No
Size of Expansion Vessel	-
IS there a flow through Valve fitted?	-
Is there a drain fitted & what size?	-
What size is access hatch	N/A
Is there a drain valve – if yes give size	½" on cold feed
Does drain valve work	Not attempted
Condition of water from drain valve	-
Size and materials cold feed pipe	35mm copper
Is cold feed valved	Yes
Fed from mains, tank or softened	Tank 1
Pressure gauge reading	-
Temp from main gauge on hot water flow	60.C
Temp from gauge on sec return flow	54.C
Safety valve size	N/A
Is system circulated by sec return (yes/no)	Yes – Single
Is calorifier circulated	By return only

Anti-stratification Pump (yes/no)	No
Has pump got a time clock	-
If yes – how many hours is it set in any 24	-
Isolating valves on flow/return	Yes
Is calorifier labelled	Yes
Is pipe work coded/labelled	Yes
Power supply voltage/distance	2m
How far to adequate drain	2m
Periods of availability for working	By prior appointment
Access limit Height x width	1800 x 1000
Temperature from nearest hot outlet	60.C
Hot Water Storage Vessel Risk Score	Low

- Satisfactory

<p style="text-align: center;">Cal 1</p>	<p style="text-align: center;">Hot water circulation pumps</p>

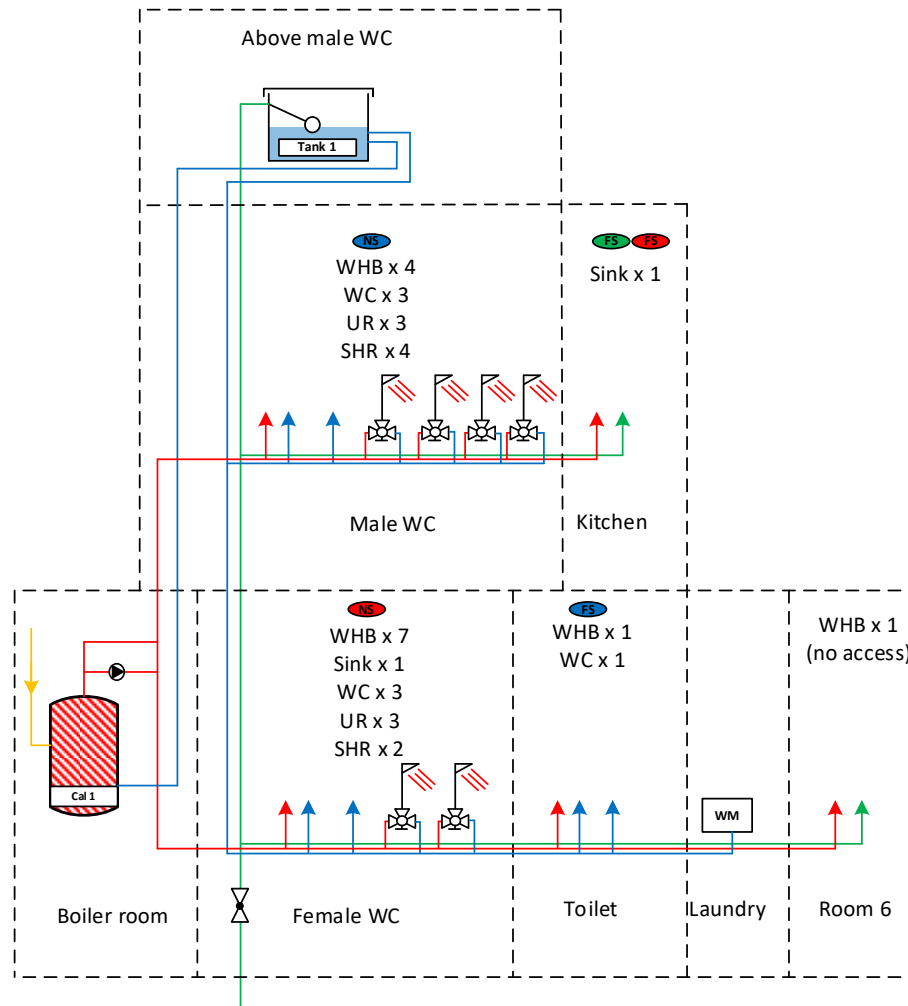
8. LINE DRAWINGS OF WATER SYSTEMS SITE: Wyvern Barracks - Building 8

NB: Due to the complexity of the pipe work at this site it is not possible to ensure the total accuracy of these line drawings. They may require revision.
