# LEGIONELLA RISK ASSESSMENT

| <b>Site:</b> | 2002 Kingswood ATC |
| <b>Report Ref:</b> | AQST/LRA/513 |

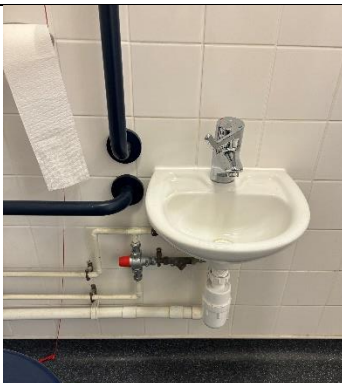
TMV feeding TMT

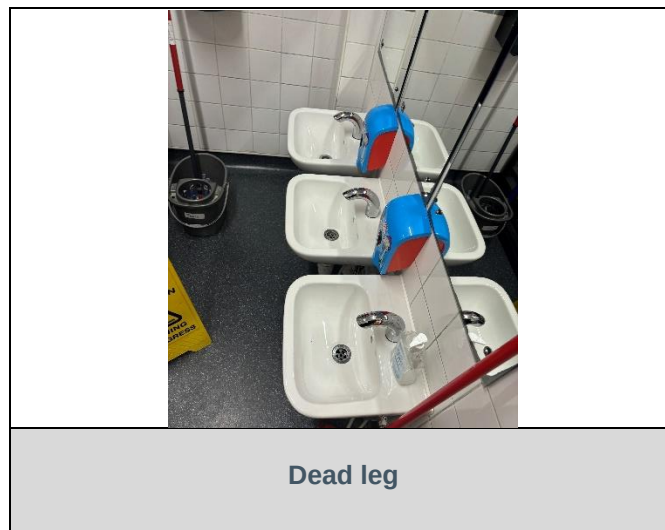
| LOCATIONS | SYSTEM | ACTION |
|---|---|---|
| Children's wc | HWS & CWM | No water to any whb's – requires further investigation |

| SYSTEM TYPES | | RISK RATING |
|---|---|---|
| 01 | There is no water in the children's wc – requires attention | High |
