## LEGIONELLA RISK ASSESSMENT

| <b>Site:</b> | Tetbury ACF |
| <b>Report Ref:</b> | AQRA/AQ1193 |
| <b>Survey Date:</b> | 28 <sup>th</sup> June 2023 |

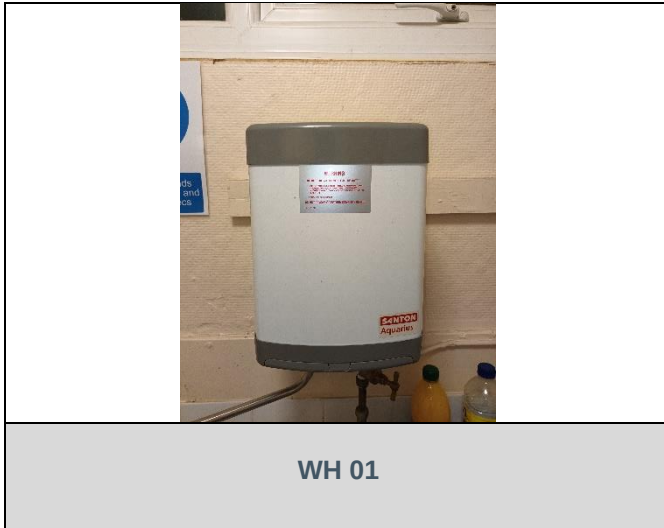
| Water Heater ID Number | Location | Make/model and capacity of each heater | Mains or tank fed | Full clean possible | Is there a pressure vessel – Yes/No | If yes – make model and size and whether fitted horizontally or vertically |
|---|---|---|---|---|---|---|
| WH 01 | Kitchen | Santon 7ltr | Mains | No | No | |
