LEGIONELLA RISK ASSESSMENT

THE PREVENTION AND CONTROL OF LEGIONNAIRES' DISEASE

Client:	Wessex RF & CA
Site:	1069 Wimborne JCC
Address:	156 Leigh Road, Wimborne BH21 2DB
Risk Rating:	Low
Report Ref:	AQST/LRA/520
Surveyed By:	D. Fletcher
Survey Date:	9 th May 2024
Report Date:	14 th May 2024
Written By:	L. Blakemore
Checked By:	J. Rooney
Recommended Review Date:	May 2026

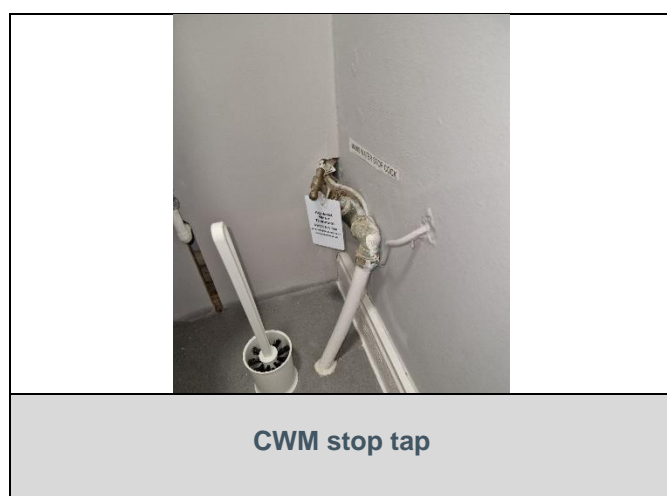
Photos

Source of supply	Towns mains
Number of mains cold water supply?	1
Location of main isolation valve?	Gents wc
Is there a water meter installed?	No
Is the pipework labelled?	Yes
Materials of construction	22mm copper
Are there any materials or fittings visibly present on the mains water system, that do not conform to the Water Regulations Advisory Scheme (WRAS) directory?	No
Mains water temperature °C (sentinel outlets)	Nearest Tap to Incoming Main 15.6 Furthest Tap from Incoming Main 15.3
Are all other distribution temperatures that were tested within the correct temperature range? i.e. Below 20 °C?	Yes
Are there any none flow through expansion vessels to any services on this system?	Yes
Is the pipework suitably insulated?	No
Does the cold-water supply have any inline filters including scale inhibitors/softeners?	Yes
COMMENTS	
Mains Water Supply Risk Score	Low
