LEGIONELLA RISK ASSESSMENT

Client:	Wessex RF & CA
Site:	Marine Academy Platoon
Address:	Marine Academy, Trevethick Road, Plymouth, Devon, PL5 2AF
Risk Rating:	MEDIUM
Report Ref:	AQST/LRA/342
Surveyed By:	D.Fletcher
Survey Date:	08/02/2024
Report Date:	23/02/2024
Written By:	E.Holt
Checked By:	J.Rooney
Recommended Review Date:	February 2026

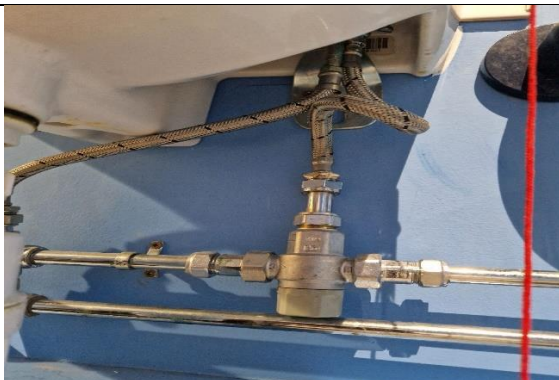
DISABLED TMV AND FLEXIBLE HOSE

SYSTEM TYPES		RISK RATING
	HOT AND COLD WATER SYSTEMS:	
1.	Ensure that Flexi Hoses are WRAS approved	HIGH
	Actioned date: Company/initials:	
	TMVs AND TMTs:

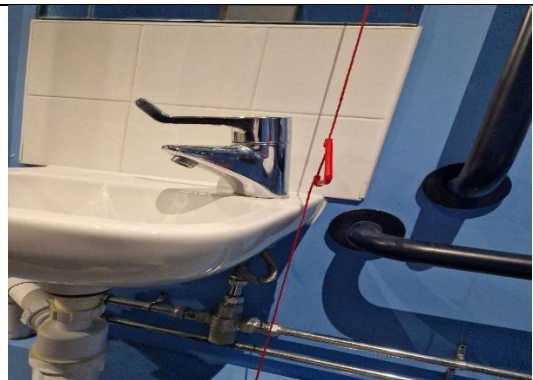
DISABLED TMV FEEDING TMV TAP

2.	Disabled WC has a TMV feeding a TMT – suggest removing TMV testing if TMT works as it should. If not , return TMV in situ and fit a standard pillar tap. Temp in to TMV 51.8. Out to TMV 41.5 and 37.8 at TMT	HIGH
	Actioned date: Company/initials:

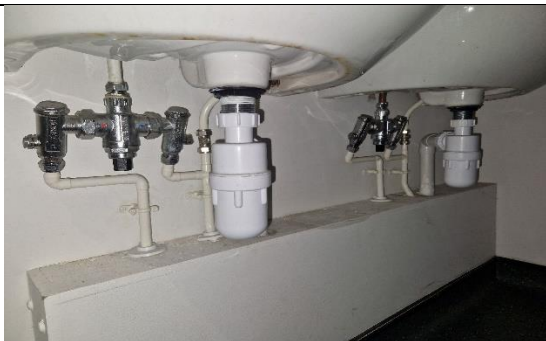
LADIES TMVS

4.	Ladies TMVs – recommendations as per Number 3 above.	HIGH
	Actioned date: Company/Initials:	
5.	An annual TMV Servicing to be completed which is properly logged	
	Actioned date: Company/Initials:	
	GENERAL: Control Schemes

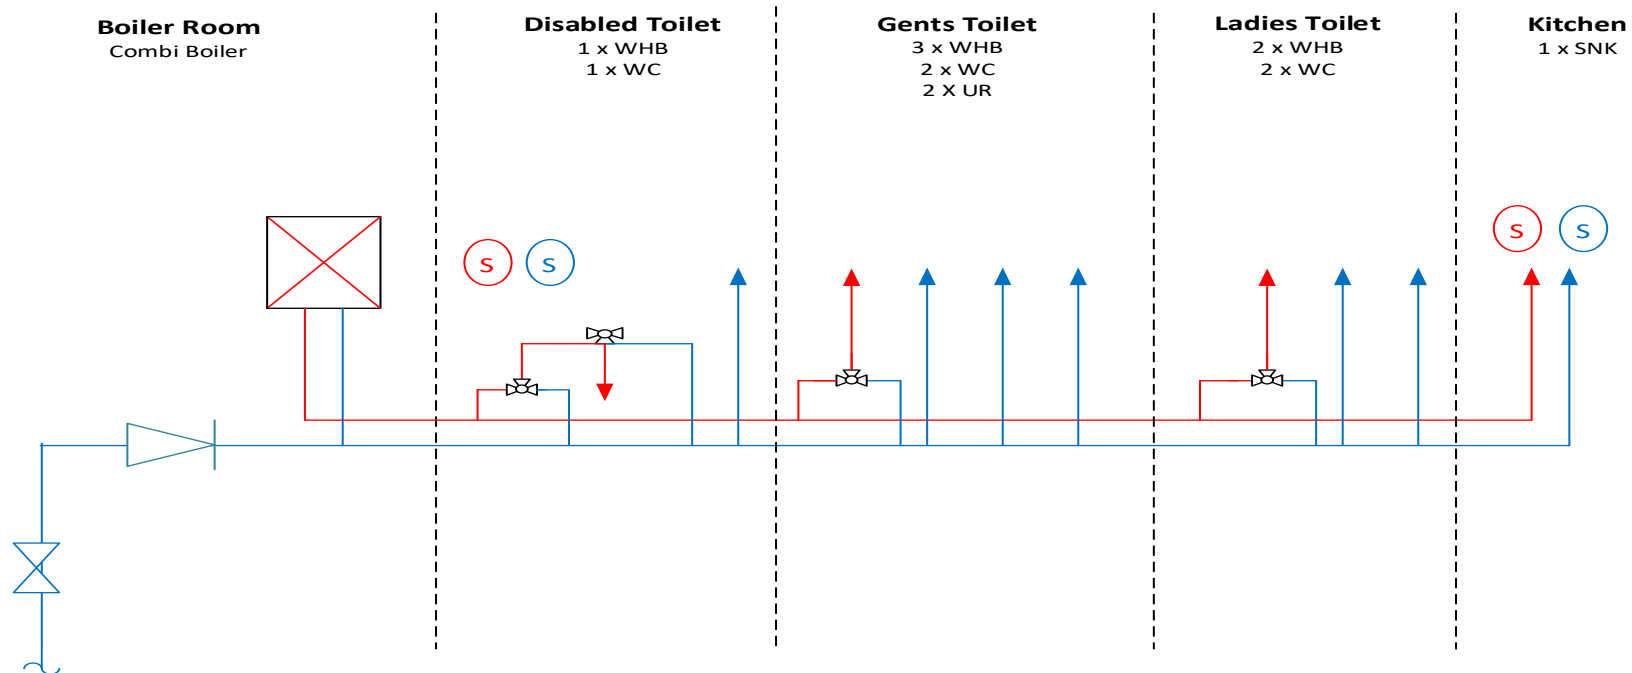
8. LINE DRAWINGS OF WATER SYSTEMS SITE: MARINE ACADEMY PLATOON
