LEGIONELLA RISK ASSESSMENT

Client:	Wessex RFCA
Site:	Wyvern Barracks Building 14
Address:	Wyvern Barracks, Barrack Road, Exeter, EX2 6AR
Risk Rating:	Low
Report Ref:	AQST/LRA/331
Surveyed By:	Jon Barton
Survey Date:	11 th -13 th March 2024
Report Date:	15 th March 2024
Recommended Review Date:	March 2026

PREMISES : Wyvern Barracks - Building 14

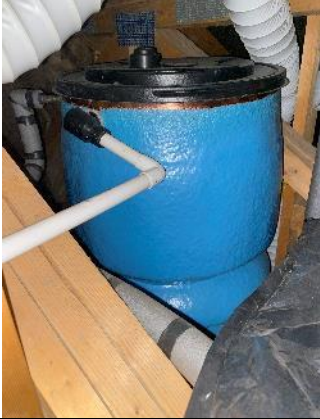
Water Heaters: There is a foritic water heater located in the roof space. This provides all hot water to the building.

Fortic water heater	Inside the header tank

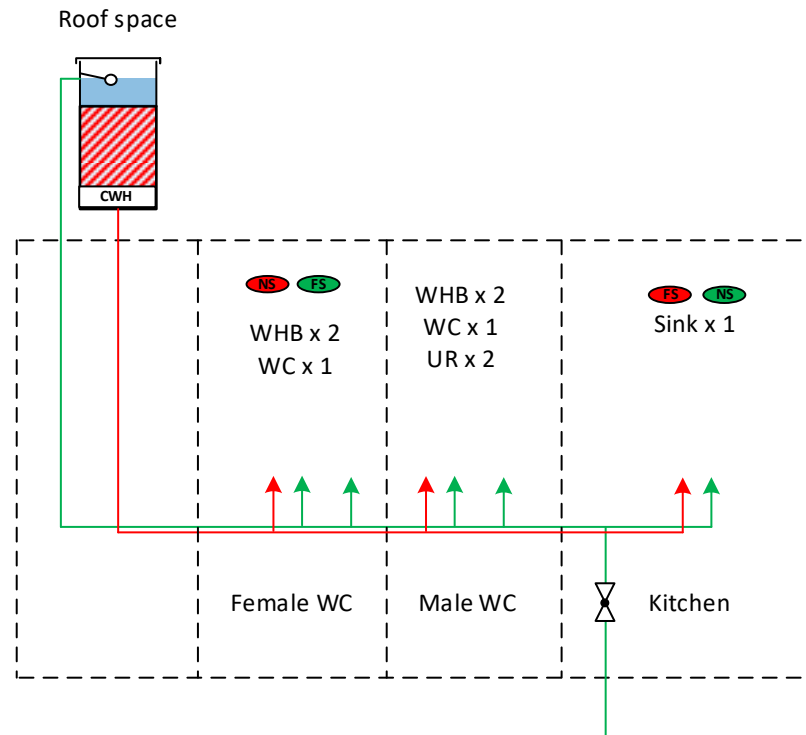
8. LINE DRAWINGS OF WATER SYSTEMS SITE: Wyvern Barracks - Building 14

NB: Due to the complexity of the pipe work at this site it is not possible to ensure the total accuracy of these line drawings. They may require revision.
