# LEGIONELLA RISK ASSESSMENT

## THE PREVENTION AND CONTROL OF LEGIONNAIRES' DISEASE

<b>Client:</b>	Wessex RF & CA
<b>Site:</b>	2401 Dawlish Squadron,
<b>Address:</b>	Dawlish ATC Centre, Dawlish School, Elm Grove Road, Dawlish, Devon, EX7 0BY
<b>Risk Rating:</b>	<b>LOW</b>
<b>Report Ref:</b>	AQST/LRA/366
<b>Surveyed By:</b>	N. O'Leary
<b>Survey Date:</b>	15 <sup>th</sup> February 2024
<b>Report Date:</b>	29 <sup>th</sup> February 2024
<b>Written By:</b>	E. Holt
<b>Checked By:</b>	J. Rooney
<b>Recommended Review Date:</b>	February 2026

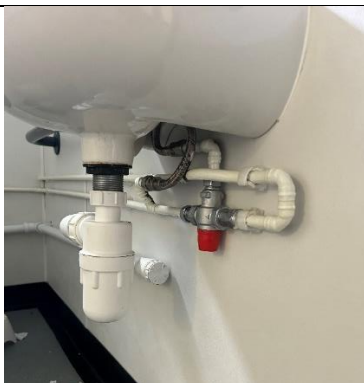
Disabled wc TMV and flexi's

SYSTEM TYPES		RISK RATING
	<b>TMVs AND TMTs:</b>	
1.	Disabled WC TMV located. Flexi hoses to be replaced with hard piping	MEDIUM
	Actioned date:                      Company/initials:	
	<b>POINT OF USE WATER HEATERS:</b>	
2.	Expansion vessels require a drain off at the base of the expansion vessel - lowest point	LOW
	Actioned date:                      Company/initials:
