# LEGIONELLA RISK ASSESSMENT

| <b>Site:</b> | 125 Charlton Kings ATC |
| <b>Report Ref:</b> | AQST/LRA/518 |
| <b>Survey Date:</b> | 4 <sup>th</sup> March 2024 |

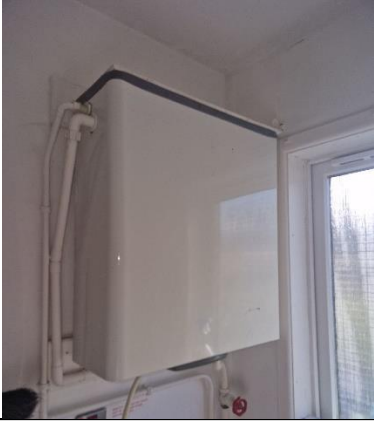
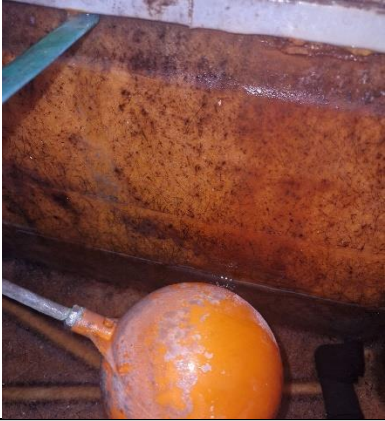
| Water Heater ID Number | Location | Make/model and capacity of each heater | Mains or tank fed | Full clean possible | EXPANSION VESSEL INFO | |
|---|---|---|---|---|---|---|
| WH 01 | Ladies | Sadia 25ltr | Mains | Yes | No | |

| WH 01 | Inside water heater |

| SYSTEM TYPES | | RISK RATING |
|---|---|---|
| 01 | Water heater should be set to produce at least 50°C at outlets | High |
| 02 | Water heater overflow requires a ¾" rodent screen (cup type) | High |
| 03 | We would recommend cleaning and disinfecting the water heater | High |
