LEGIONELLA RISK ASSESSMENT

Client:	Wessex RF & CA
Site:	Ivybridge Platoon
Address:	Filham Park, Ivybridge, Devon, PL21 0LE
Risk Rating:	MEDIUM
Report Ref:	AQST/LRA/343
Surveyed By:	D.Fletcher
Survey Date:	08/02/2024
Report Date:	21/02/2024
Written By:	E.Holt
Checked By:	J.Rooney
Recommended Review Date:	February 2026

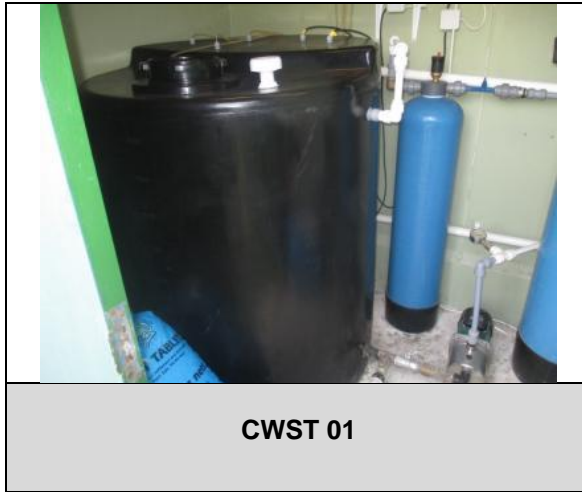
Tank Ref : 01

Location	Exact location of tank	Plant room
Structure	Accurate dimensions l x w x h or dia	1000 litres
	Materials of tank and any jointing's	Plastic
	Insulation type and thickness	None
Lid Details	Is there a close-fitting lid	Yes
	Is it securely fixed in place	Yes
	Accurate dimensions for new lid	N/A
	Separate ball valve hatch	Yes
	Vent size has it good rodent screen	1 ¼" + screen
Overflow	Size and materials of main overflow	1 ½" plastic
	Is there a rodent filter	Yes
	Size and materials of warning pipe	N/A
	Is there a rodent filter	N/A
Supply	Size and materials of pipework	¾" Hep 20
	Fed from mains, softener or tank	Bore hole
	Insulation type and thickness	None
	Any other return or vent pipes	No
Outlets	Size and Materials	Insulation type and thickness
Outlet 1	1" plastic & iron	None
Outlet 2		Are they valved
Drain valve	Is there a drain valve – size if applicable	1" Yes
Water in Tank	Temperature C	15°C
	Degree of sediment	Unknown – cloudy

Biological slime severe/medium/light	Nil
	Extent of corrosion	N/A
	Is there adequate crossflow within the tank? i.e. inlet opposed from outlet?	No
	Is the stored water over capacity??	Unknown
Labels	Is the tank labelled	No
	Supply pipe labelled or coded	No
	Outlets labelled or coded	No
Operation	How far to adequate drain	2m
	Power supply – volts/distance	240v 1m
	Is lighting adequate	Yes
	Access limit ht x w	Double doors
CWST Risk Score		Medium

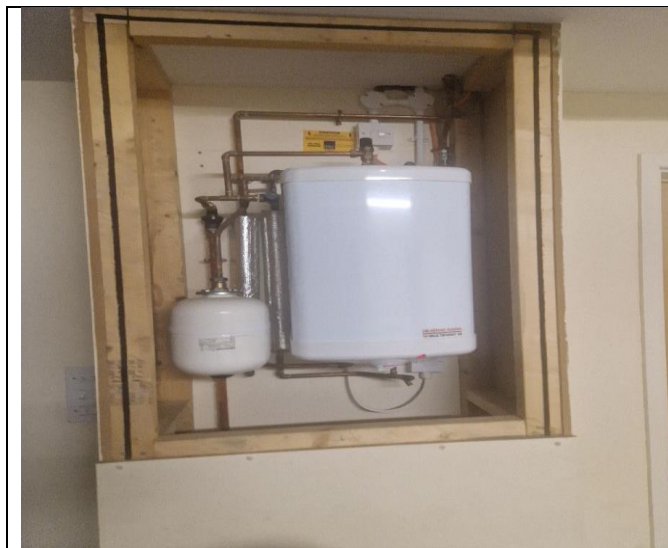
Water Heater ID Number	Location	Make/model and capacity of each heater	Mains or tank fed	Full clean possible	EXPANSION VESSEL INFO	
					Is there a pressure vessel – Yes/No	If yes – make model and size and whether fitted horizontally or vertically
POU WH1	Boxwork in Range	30ltr Sadia	Mains	No	Yes	2ltr upside down
POU WH2	Kitchen	10ltr Redring	Mains	No	Yes	2ltr

3.	POU WH1 – Expansion Vessel is upside down and requires a drain to allow flushing	HIGH
	Actioned date: Company/Initials:	
4.	Kitchen Hydro Boiler is faulty and needs replacing and creating a dead leg on the cold water system	HIGH
	Actioned date: Company/Initials:

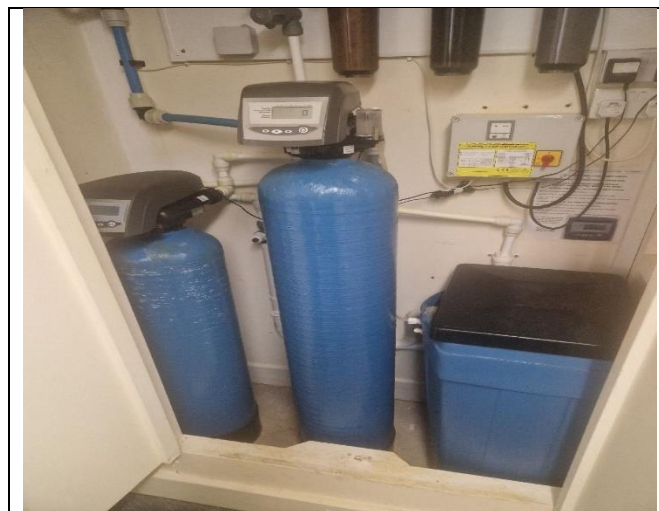
WATER SOFTENER

Water Softener was located at site.

LOCATION	MAKE/MODEL	SERVICE RECORDS AVAILABLE	SALT SUPPLY AT TIME OF VISIT
Cupboard by the range	Unknown	None	Yes

13.	Water softener should be serviced as per manufacturers recommendations and recorded in the log book	HIGH
	Actioned date: Company/Initials:

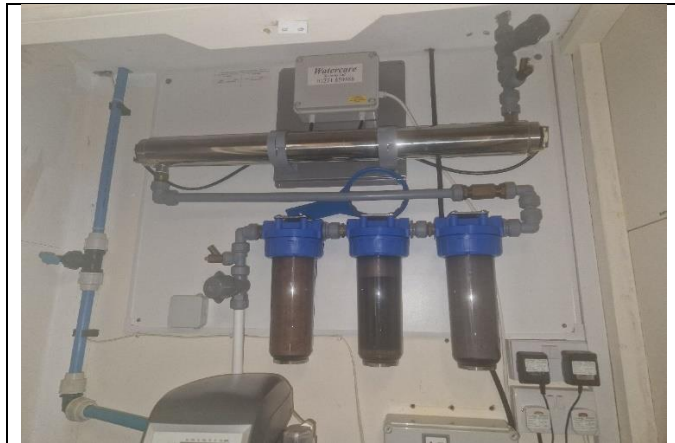
UV PLANT WITH 2 X MICRON FILTERS

7.	UV Plant/Micron filters changed by Water Care. No records seen.	HIGH
	Actioned date: Company/Initials:	
8.	Suggest sampling CWM for Bacteriological Sample	HIGH
	Actioned date: Company/Initials:
