LEGIONELLA RISK ASSESSMENT

Client:	Wessex RF & CA
Site:	HQ NORMANDY COY Cornwall ACF
Address:	Bar Road, Falmouth, Cornwall TR11 4NN
Risk Rating:	Low
Report Ref:	AQST/LRA/136
Surveyed By:	Stephen Cross MWMSoc
Survey Date:	9 th August 2023
Report Date:	8 th September 2023
Recommended Review Date:	August 2025

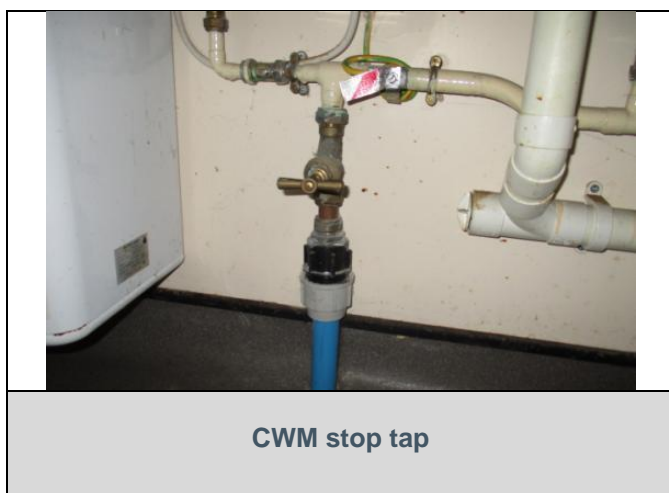
Photos

Source of supply	Mains water
Number of mains cold water supply?	1
Location of main isolation valve?	Kitchen
Is there a water meter installed?	Unknown
Is the pipework labelled?	No
Materials of construction	Copper
Are there any materials or fittings visibly present on the mains water system, that do not conform to the Water Regulations Advisory Scheme (WRAS) directory?	No
Mains water temperature °C (sentinel outlets)	Nearest Tap to Incoming Main 19°C Furthest Tap from Incoming Main 19°C
Are all other distribution temperatures that were tested within the correct temperature range? i.e. Below 20 °C?	Yes
Are there any none flow through expansion vessels to any services on this system?	Yes
Is the pipework suitably insulated?	Partially
Does the cold-water supply have any inline filters including scale inhibitors/softeners?	No
Comments	
Mains Water Supply Risk Score	High

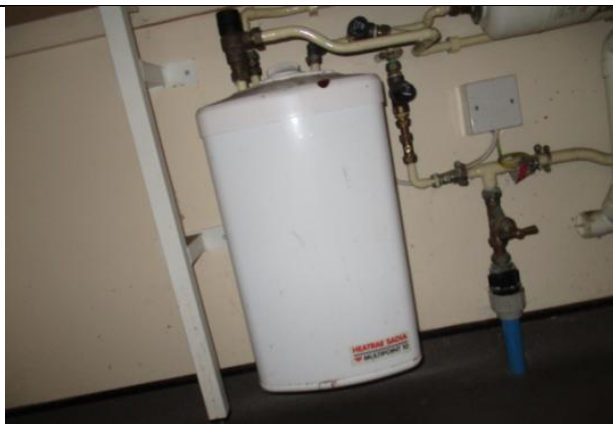
Water Heater ID Number	Location	Make/model and capacity of each heater	Mains or tank fed	Full clean possible	EXPANSION VESSEL INFO	
					Is there a pressure vessel – Yes/No	If yes – make model and size and whether fitted horizontally or vertically
WH 01	Kitchen	Sadia 10ltr	Mains	No	Yes	2ltr horizontal
WH 02	Accessible wc	Instant	Mains	No	No	
WH 03	Accessible wc	Instant	Mains	No	No	
WH 04	Male wc	Instant	Mains	No	No	
WH 05	Male wc	Instant	Mains	No	No	
WH 06	Female wc	Instant	Mains	No	No	
WH 07	Female	Instant	Mains	No	No

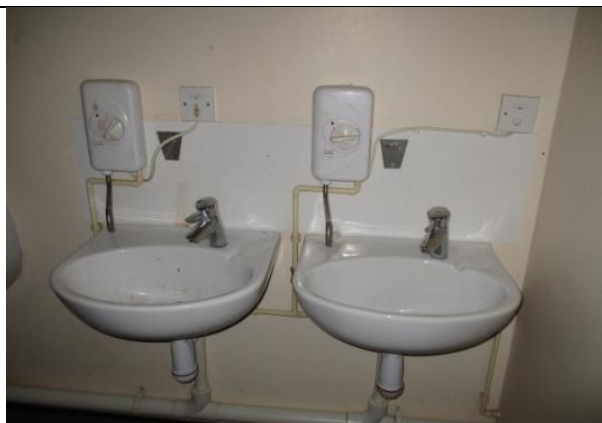
Example of water heaters 02-07
