## LEGIONELLA RISK ASSESSMENT

<b>Client:</b>	Wessex RFCA
<b>Site:</b>	Wyvern Barracks Building 5
<b>Address:</b>	Wyvern Barracks, Barrack Road, Exeter, EX2 6AR
<b>Risk Rating:</b>	Medium
<b>Report Ref:</b>	AQST/LRA/331
<b>Surveyed By:</b>	Jon Barton
<b>Survey Date:</b>	11 <sup>th</sup> -13 <sup>th</sup> March 2024
<b>Report Date:</b>	15 <sup>th</sup> March 2024
<b>Recommended Review Date:</b>	March 2026

PREMISES : Wyvern Barracks – Building 5

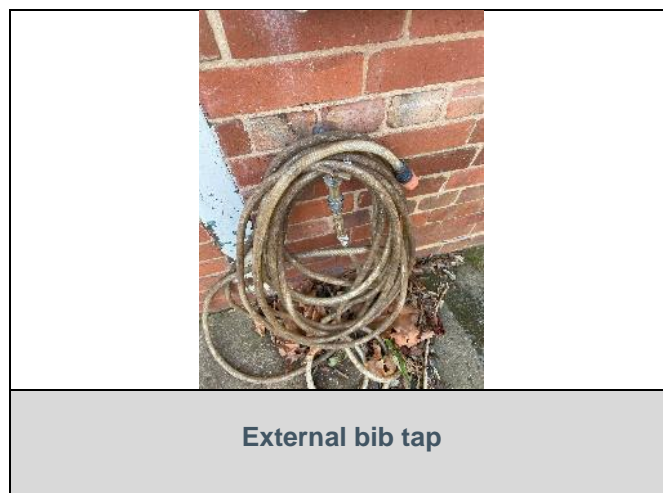
Are dead legs / infrequently used outlets present within system pipework?	Possible infrequently used outlet (outside tap)
Are thermostatic mixer valves present on individual outlets?	No
Are there single mixer valves serving a number of outlets?	No
Is the mixed temperature of the pipework >1m?	-
Are flexible hoses fitted to any services on the mains water system?	No
Is there any unused equipment connected?	No
Is any scale/debris present on any of the tap outlets?	No
Do any tap outlets have any spray or other inserts fitted?	No
Are strainers fitted?	No
