LEGIONELLA RISK ASSESSMENT

THE PREVENTION AND CONTROL OF LEGIONNAIRES' DISEASE

Client:	Wessex RF & CA
Site:	1032 Yeovil ATC
Address:	Milford Road, Yeovil BA21 4QF
Risk Rating:	Medium
Report Ref:	AQST/LRA/379
Surveyed By:	D. Fletcher
Survey Date:	22 nd April 2024
Report Date:	3 rd May 2024
Written By:	L. Blakemore
Checked By:	J. Rooney
Recommended Review Date:	April 2026

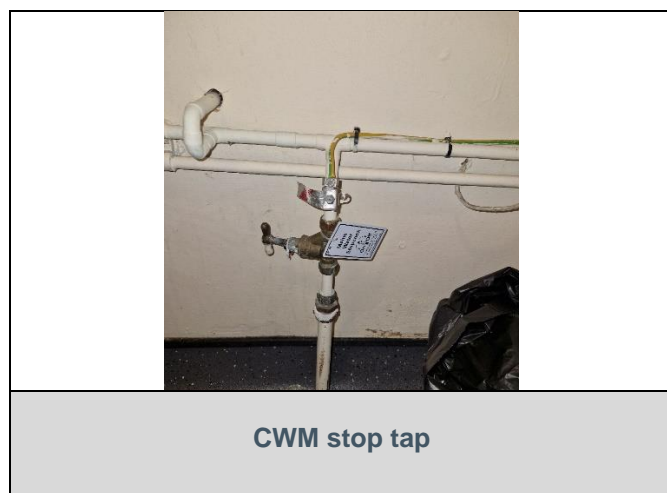
Photos

Source of supply	Towns mains
Number of mains cold water supply?	1
Location of main isolation valve?	Adult wc
Is there a water meter installed?	No
Is the pipework labelled?	Yes
Materials of construction	22mm – 15mm Copper
Are there any materials or fittings visibly present on the mains water system, that do not conform to the Water Regulations Advisory Scheme (WRAS) directory?	No
Mains water temperature °C (sentinel outlets)	Nearest Tap to Incoming Main Furthest Tap from Incoming Main 11.4
Are all other distribution temperatures that were tested within the correct temperature range? i.e. Below 20 °C?	Yes
Are there any none flow through expansion vessels to any services on this system?	Yes
Is the pipework suitably insulated?	No
Does the cold-water supply have any inline filters including scale inhibitors/softeners?	No
COMMENTS	
Mains Water Supply Risk Score	Low

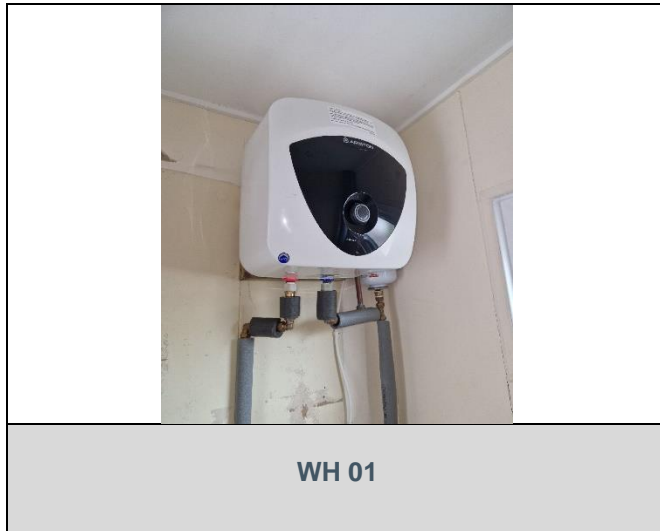
Water Heater ID Number	Location	Make/model and capacity of each heater	Mains or tank fed	Full clean possible	EXPANSION VESSEL INFO	
					Is there a pressure vessel – Yes/No	If yes – make model and size and whether fitted horizontally or vertically
WH 01	Female wc	Ariston 15ltr	Mains	No	Yes	2ltr vertical
