## LEGIONELLA RISK ASSESSMENT

| <b>Site:</b> | Stonehouse ACF |
| <b>Report Ref:</b> | AQRA/AQ1190 |
| <b>Survey Date:</b> | 28 <sup>th</sup> June 2023 |

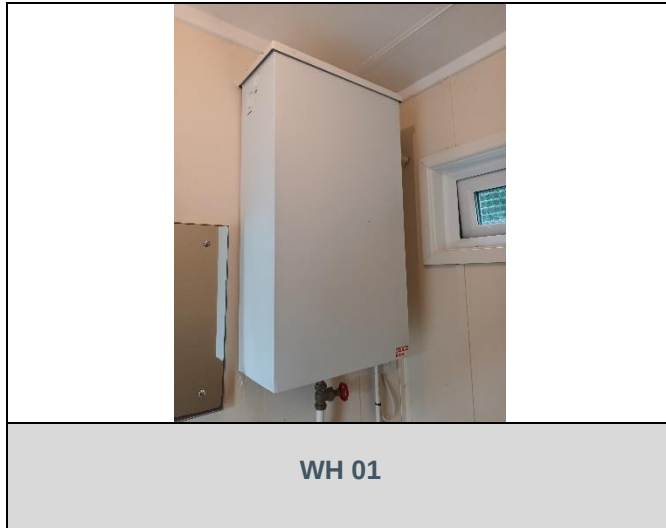
| Water Heater ID Number | Location | Make/model and capacity of each heater | Mains or tank fed | Full clean possible | EXPANSION VESSEL INFO | |
|---|---|---|---|---|---|---|
| WH 01 | Gents | Santon 25ltr | Mains | No | No | |
