## LEGIONELLA RISK ASSESSMENT

| <b>Client:</b> | Wessex RF & CA |
| <b>Site:</b> | Totnes Platoon |
| <b>Report Ref:</b> | AQST/LRA/193 |

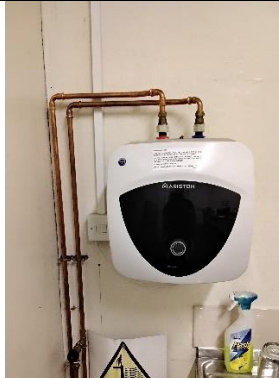
| <b>WH 01</b> | <b>WH 02</b> |

| Water Heater ID Number | Location | Make/model and capacity of each heater | Mains or tank fed | Full clean possible | EXPANSION VESSEL INFO | |
|---|---|---|---|---|---|---|
| WH 03 | 1 <sup>st</sup> f wc | Heatrae Sadia | Mains | No | No | |

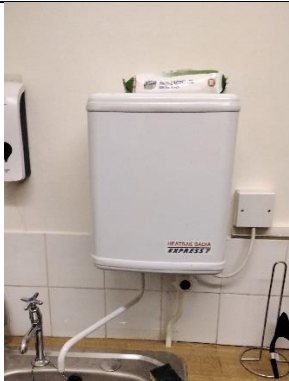
| <b>WH 03</b> | <b>WH 04</b> |

| Water Heater ID Number | Location | Make/model and capacity of each heater | Mains or tank fed | Full clean possible | EXPANSION VESSEL INFO | |
|---|---|---|---|---|---|---|
| WH 04 | 1 <sup>st</sup> f Kitchenette | Heatrae Sadia 7ltr | Mains | No | No | |

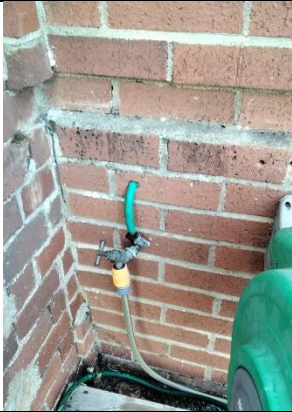
| <p>Sign</p> | <p>Example of bib</p> |
