# LEGIONELLA RISK ASSESSMENT

| <b>Client:</b> | Wessex RF & CA |
| <b>Site:</b> | 2391 Parkstone ATC |
| <b>Report Ref:</b> | AQST/LRA/404 |

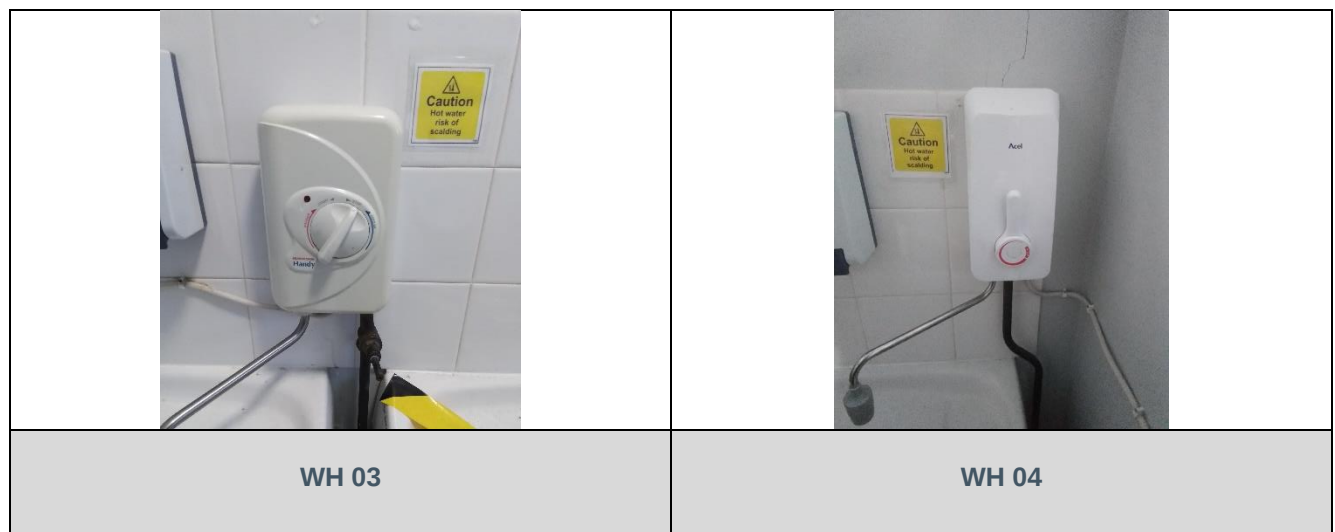
| Water Heater ID Number | Location | Make/model and capacity of each heater | Mains or tank fed | Full clean possible | EXPANSION VESSEL INFO | |
|---|---|---|---|---|---|---|
| WH 03 | Gents | Heatrae instant | Mains | No | No | |
| WH 04 | Ladies | Acel instant | Mains | No | No | |
