LEGIONELLA RISK ASSESSMENT

Client:	Wessex RFCA
Site:	TA Centre, Allenby Barracks
Address:	Allenby Barracks, Bovington, Dorset, BH20 6JA
Risk Rating:	Medium
Report Ref:	AQRA/AQST/LRA/090
Surveyed By:	Jon Barton
Survey Date:	8 th August 2023
Report Date:	10 th August 2023
Recommended Review Date:	August 2025

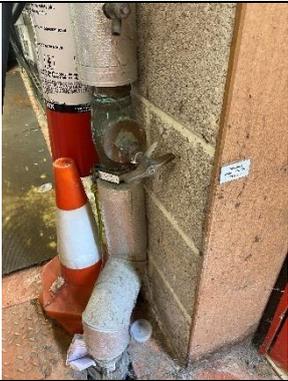
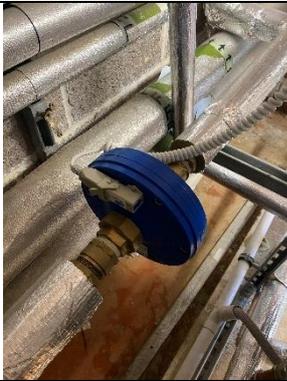
<p style="text-align: center;">Main stop tap</p>	<p style="text-align: center;">Electronic scale inhibitor</p>

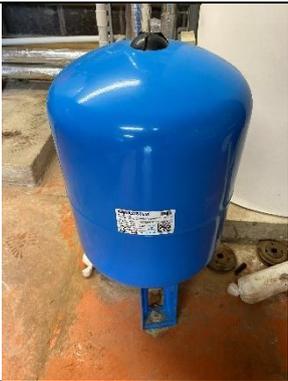
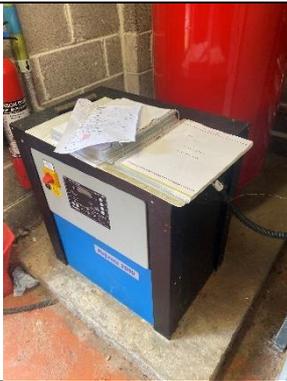
<p style="text-align: center;">Expansion vessel within the plant room</p>	<p style="text-align: center;">Pressurisation unit within the boiler room</p>

- All satisfactory during the survey.
- Recommend flushing the expansion vessel quarterly.

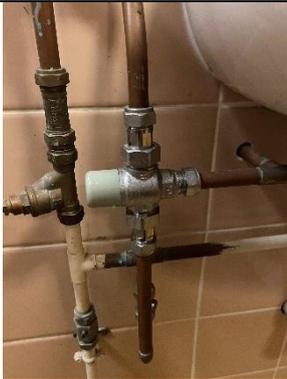
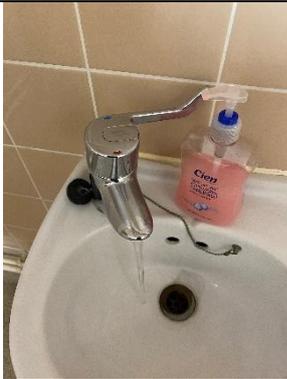
<p>TMV located with the fitter's bay</p>	<p>Thermostatic mixer tap with strainers located in the RHQ female WC area</p>

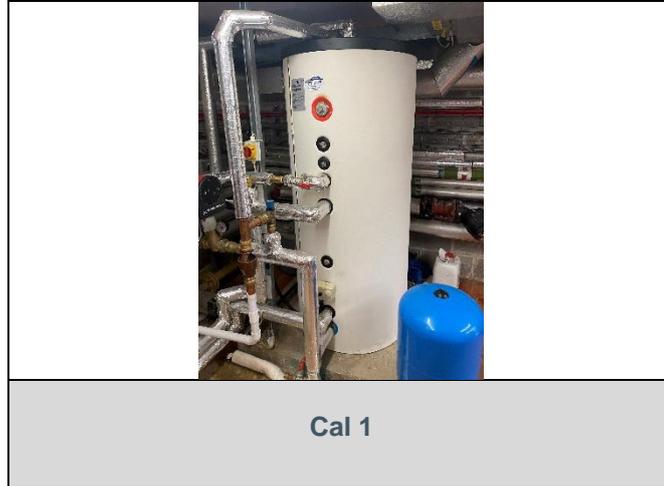
HWSV Ref : Cal 1

Location of hot water storage vessel	Boiler room
Construction	Stainless steel
Size of hot water storage vessel	475 litres
Horizontal/vertical	Vertical
Storage/non-storage	Storage
Main heat source	Primary coil
Supplementary heating	None
Insulation type	Pre-insulated
Is there an open vent	No
Is there an Expansion Vessel	Yes
Size of Expansion Vessel	50 litres
IS there a flow through Valve fitted?	No
Is there a drain fitted & what size?	Yes ½ inch
What size is access hatch	200mm
Is there a drain valve – if yes give size	Yes, 22mm
Does drain valve work	Not attempted
Condition of water from drain valve	-
Size and materials cold feed pipe	42mm copper
Is cold feed valved	Yes
Fed from mains, tank or softened	Mains
Pressure gauge reading	PRV
Temp from main gauge on hot water flow	60.C
Temp from gauge on sec return flow	54.C
Safety valve size	35mm
Is system circulated by sec return (yes/no)	Yes, single
Is calorifier circulated	No

Anti-stratification Pump (yes/no)	No
Has pump got a time clock	N/A
If yes – how many hours is it set in any 24	-
Isolating valves on flow/return	Yes
Is calorifier labelled	Yes
Is pipe work coded/labelled	Yes
Power supply voltage/distance	2 m
How far to adequate drain	5 m
Periods of availability for working	By prior appointment
Access limit Height x width	Double doors
Temperature from nearest hot outlet	59.C
Hot Water Storage Vessel Risk Score	Low

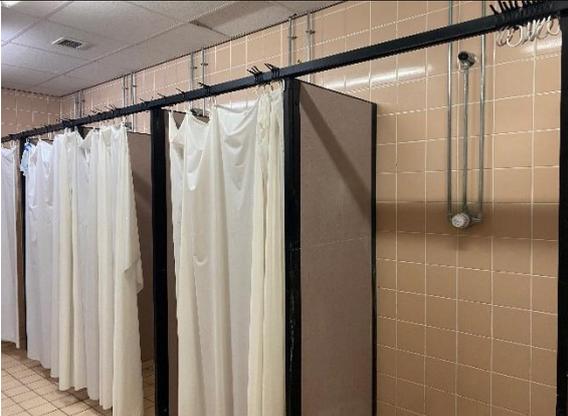
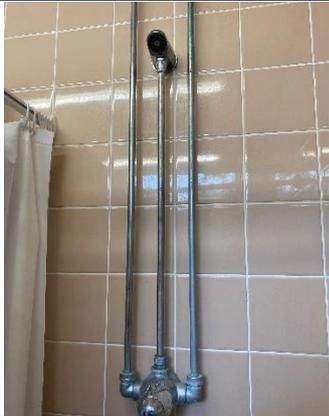
Location	Nos of showers	Dismantled/ cleaned and disinfected YES/NO	Overall condition	Any repairs replacements	Regularity of Use
Male showers	6	No	Good	No	Flushed weekly
Female showers	2	No	Good	No	Flushed weekly
COMMENTS:					
All showers are in good working order and flushed weekly by site.

Male shower area	Showing single shower with clean shower head

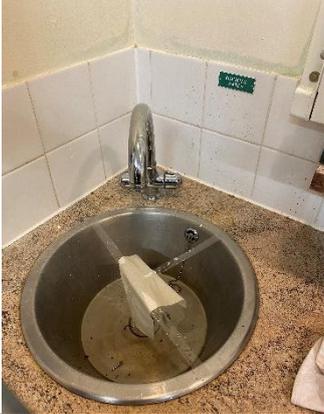
<p>Taped up basin in the bar</p>	<p>Outside tap with no flow of water</p>

LOCATIONS	SYSTEM	ACTION
Bar area	Hot and cold	The basin has been taped off resulting in lack of use. Repair whatever the issue is and reinstate flow to the basin.
Outside the kitchen WC	Mains	There is no flow to the outside tap, all isolations are open indicating there is a fault with the tap. Replace the tap.

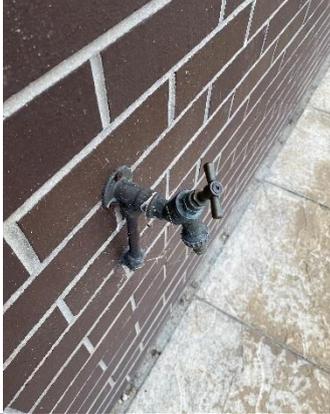
SYSTEM TYPES		RISK RATING
COLD WATER MAINS:		
The outside tap (kitchen WC area) was not operational and is creating a dead leg on the water system. See section 6.6		Medium
Actioned date:	Company/initials:	
The bar hand wash station has been taped off creating a dead leg. See section 6.6		Medium
Actioned date:	Company/initials:	
Fit a double check valve at the point where the mains water T's off to supply the pressurisation unit and quick fill (main boiler room). This will protect the mains water from possible back contamination from stagnant water supplying the pressurisation unit/quick fill.		Medium
Actioned date:	Company/initials:	
COLD WATER STORAGE TANKS:		
None on site.		
HOT WATER CALORIFIERS:		
Satisfactory at the time of the survey.		
POINT OF USE WATER HEATERS:		
Satisfactory at the time of the survey.		
SHOWERS AND SPRAY OUTLETS:		
Satisfactory at the time of the survey.		
GENERAL: Control Schemes

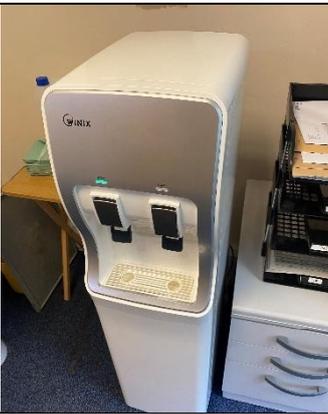
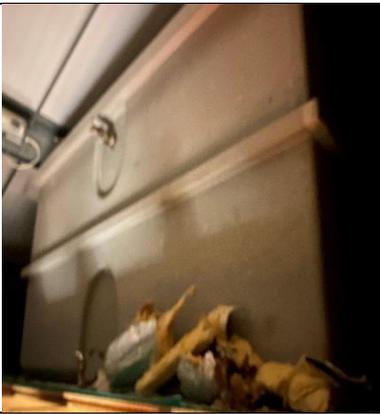
<p>Water cooler in room 2</p>	<p>Old CWST, now removed from the water system</p>
