LEGIONELLA RISK ASSESSMENT

Client:	Wessex RF & CA
Site:	Glastonbury Platoon
Address:	Street Road, Glastonbury, Somerset BA6 9EF
Risk Rating:	Low
Report Ref:	AQST/LRA/486
Surveyed By:	N. O'Leary
Survey Date:	15 th March 2024
Report Date:	11 th April 2024
Written By:	L. Blakemore
Checked By:	J. Rooney
Recommended Review Date:	March 2026

PREMISES : Glastonbury Platoon

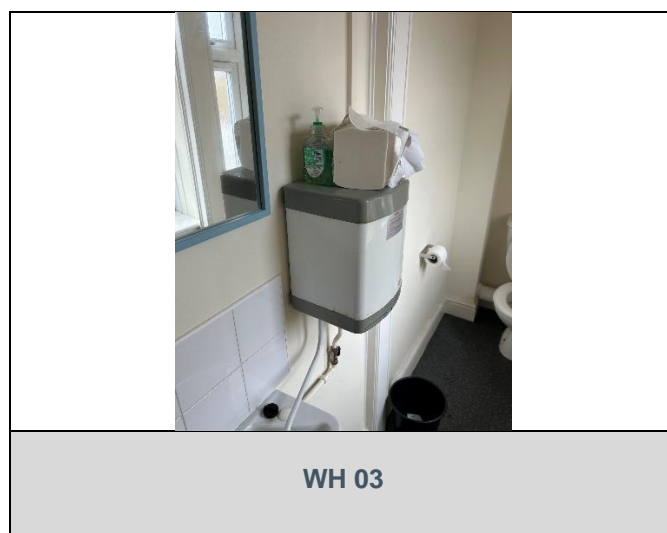
6.7 POINT OF USE WATER HEATERS

Water Heater ID Number	Location	Make/model and capacity of each heater	Mains or tank fed	Full clean possible	EXPANSION VESSEL INFO	
					Is there a pressure vessel – Yes/No	If yes – make model and size and whether fitted horizontally or vertically
WH 01	G/F Disabled	Hyco SF15K	Mains	No	Yes	2ltr vertical
WH 02	1 st f Kitchen	Hyco 15ltr	Mains	No	No	
WH 03	2 nd f wc	Santon 7ltr	Mains	No	No

SYSTEM TYPES		RISK RATING
	POINT OF USE WATER HEATERS:	
01	Kitchen POU water heater is isolated as it has faulty wiring and trips the entire building – requires attention	High
	Actioned date: Company/initials:	
	HOT AND COLD WATER SYSTEMS:	
01	Flexi's should be WRAS approved or hard piped where possible	Medium
	Actioned date: Company/initials:	
	GENERAL: Control Schemes	
01	All little used outlets should be flushed on a weekly basis and recorded in the log book	High
	Actioned date: Company/initials:
