LEGIONELLA RISK ASSESSMENT

THE PREVENTION AND CONTROL OF LEGIONNAIRES' DISEASE

Client:	Wessex RF & CA
Site:	675 (Rifles) Sqn Army Air Corps ACF Centre (Yeovil)
Address:	Southville Road, Yeovil, Somerset, BA21 4JA
Risk Rating:	LOW
Report Ref:	AQST/LRA/363
Surveyed By:	Alan Rodgerson
Survey Date:	7 th February 2024
Report Date:	29 th February 2024
Written By:	E. Holt
Checked By:	J. Rooney
Recommended Review Date:	February 2024

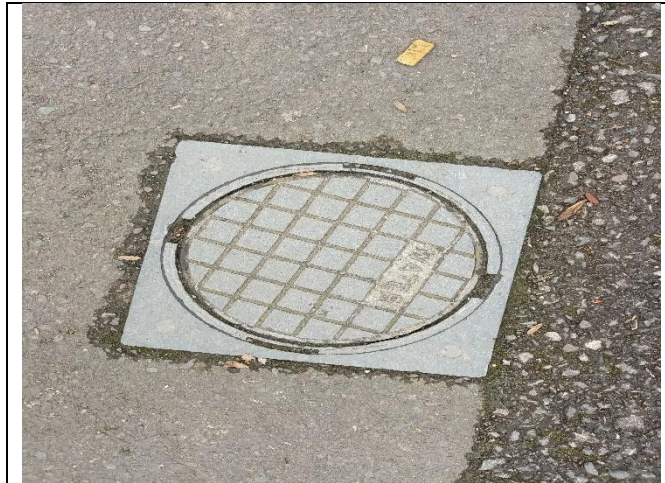
MAINS

Source of supply	Wessex Water
Number of mains cold water supply?	1
Location of main isolation valve?	Boundary Box
Is there a water meter installed?	No
Is the pipework labelled?	No
Materials of construction	Unknown
Are there any materials or fittings visibly present on the mains water system, that do not conform to the Water Regulations Advisory Scheme (WRAS) directory?	None
Mains water temperature °C (sentinel outlets)	Nearest Tap to Incoming Main 10.0 Furthest Tap from Incoming Main 19.2
Are all other distribution temperatures that were tested within the correct temperature range? i.e. Below 20 °C?	Yes
Are there any non flow through expansion vessels to any services on this system?	No
Is the pipework suitably insulated?	No
Does the cold-water supply have any inline filters including scale inhibitors/softeners?	No
COMMENTS	
Mains Water Supply Risk Score	Low

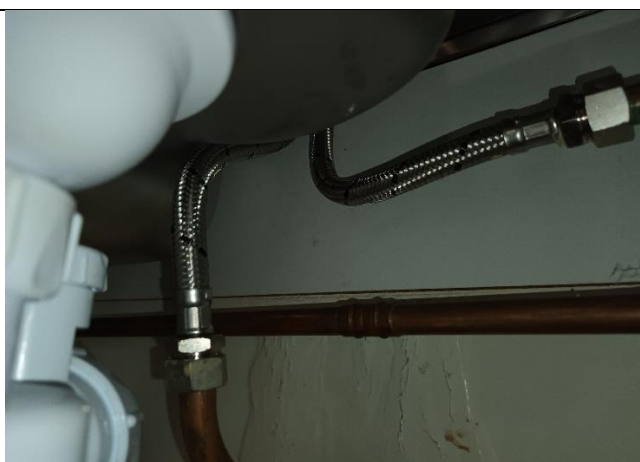
FLEXIBLE HOSES

Are dead legs / infrequently used outlets present within system pipework?	None observed
Are thermostatic mixer valves present on individual outlets?	Yes
Are there single mixer valves serving a number of outlets?	Yes
Is the mixed temperature of the pipework >1m?	No
Are flexible hoses fitted to any services on the mains water system?	Yes
Is there any unused equipment connected?	No
Is any scale/debris present on any of the tap outlets?	No
Do any tap outlets have any spray or other inserts fitted?	No
Are strainers fitted?	No

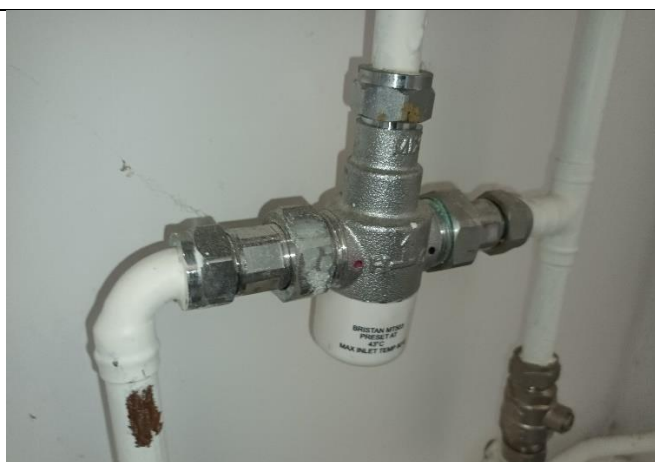
TMV

There are TMVs fitted to all wash hand basins.

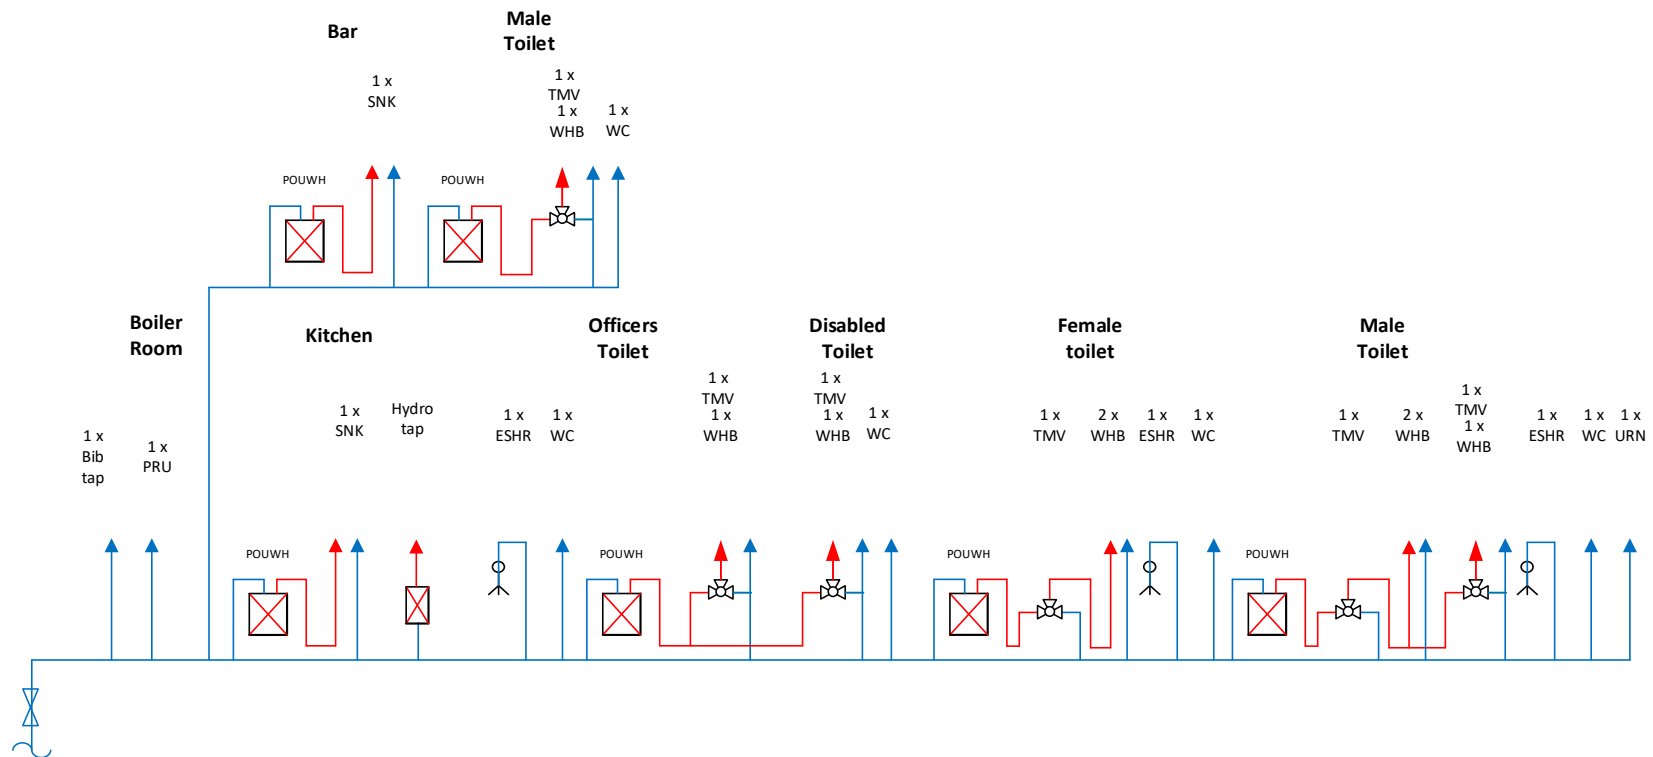
675b SQN AAC Yeovil

NB: Due to the complexity of the pipe work at this site it is not possible to ensure the total accuracy of these line drawings. They may require revision.
