# LEGIONELLA RISK ASSESSMENT

## THE PREVENTION AND CONTROL OF LEGIONNAIRES' DISEASE

<b>Client:</b>	Wessex RF & CA
<b>Site:</b>	Marlborough Platoon
<b>Address:</b>	London Road, Marlborough, Wiltshire SN8 2AJ
<b>Risk Rating:</b>	Low
<b>Report Ref:</b>	AQST/LRA/411
<b>Surveyed By:</b>	N. O'Leary
<b>Survey Date:</b>	7 <sup>th</sup> March 2024
<b>Report Date:</b>	4 <sup>th</sup> April 2024
<b>Written By:</b>	L. Blakemore
<b>Checked By:</b>	J. Rooney
<b>Recommended Review Date:</b>	March 2026

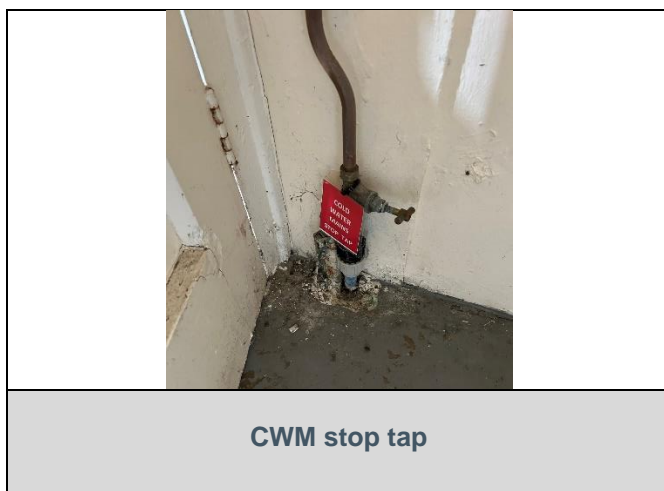
## Photos

Source of supply	Mains water supply
Number of mains cold water supply?	1
Location of main isolation valve?	Gents
Is there a water meter installed?	No
Is the pipework labelled?	Yes
Materials of construction	Copper
Are there any materials or fittings visibly present on the mains water system, that do not conform to the Water Regulations Advisory Scheme (WRAS) directory?	No
Mains water temperature °C (sentinel outlets)	Nearest Tap to Incoming Main 10.0 Furthest Tap from Incoming Main 9.0
Are all other distribution temperatures that were tested within the correct temperature range? i.e. Below 20 °C?	Yes
Are there any none flow through expansion vessels to any services on this system?	Yes
Is the pipework suitably insulated?	Yes
Does the cold-water supply have any inline filters including scale inhibitors/softeners?	No
<b>COMMENTS</b>	
Mains Water Supply Risk Score	Low

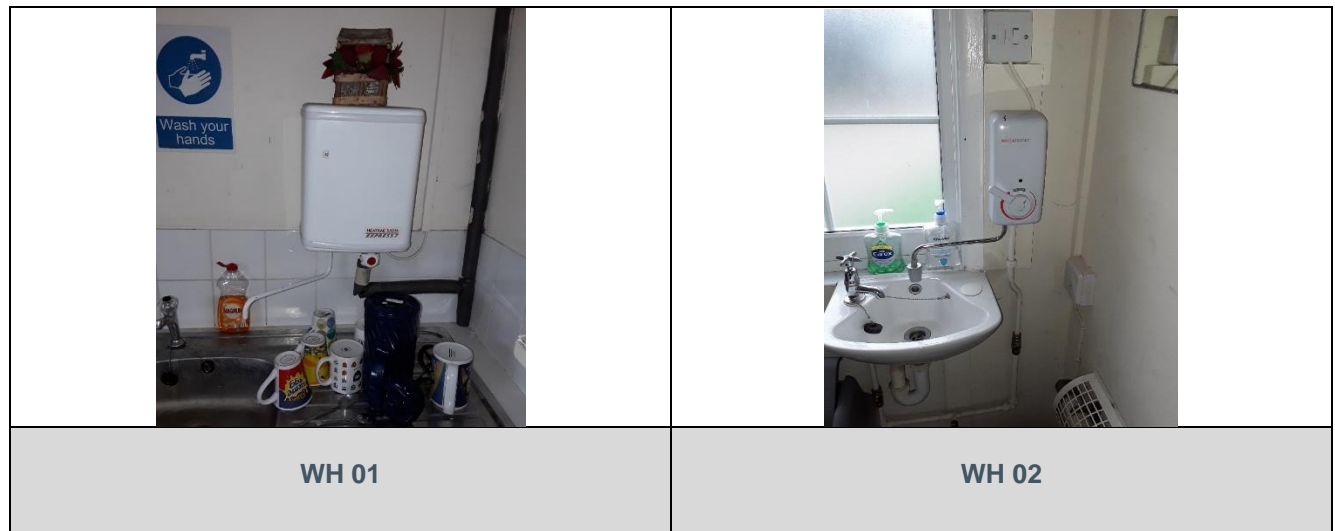
Water Heater ID Number	Location	Make/model and capacity of each heater	Mains or tank fed	Full clean possible	EXPANSION VESSEL INFO	
					Is there a pressure vessel – Yes/No	If yes – make model and size and whether fitted horizontally or vertically
WH 01	Kitchen	Heatrae Sadia	Mains	No	No	
WH 02	Ladies	Heatstore instant	Mains	No	No	
WH 03	Gents	Redring vortex	Mains	No	No

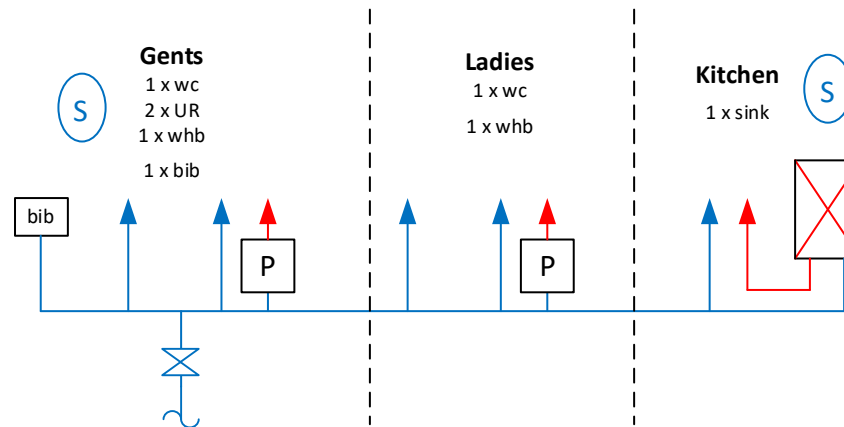
## 8. LINE DRAWINGS OF WATER SYSTEMS

**NB: Due to the complexity of the pipe work at this site it is not possible to ensure the total accuracy of these line drawings. They may require revision.**
