LEGIONELLA RISK ASSESSMENT

Client:	Wessex RF & CA
Site:	Mutley Platoon
Address:	Ford Park Lane, Mutley Plain, Plymouth PL4 6YY
Risk Rating:	Low
Report Ref:	AQST/LRA/219
Surveyed By:	David Fletcher
Survey Date:	31 st October 2023
Report Date:	3 rd November 2023
Recommended Review Date:	October 2025

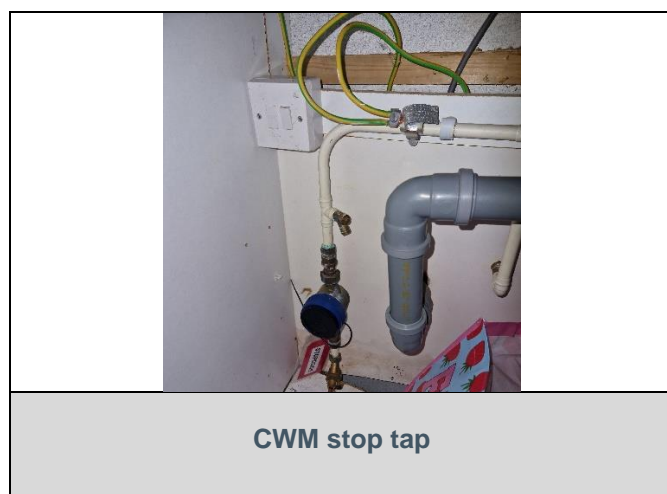
Photos

Source of supply	Towns mains
Number of mains cold water supply?	1
Location of main isolation valve?	Under kitchen sink
Is there a water meter installed?	Yes
Is the pipework labelled?	Yes
Materials of construction	15mm copper
Are there any materials or fittings visibly present on the mains water system, that do not conform to the Water Regulations Advisory Scheme (WRAS) directory?	No
Mains water temperature °C (sentinel outlets)	Nearest Tap to Incoming Main 14.6 Furthest Tap from Incoming Main 14.6
Are all other distribution temperatures that were tested within the correct temperature range? i.e. Below 20 °C?	Yes
Are there any none flow through expansion vessels to any services on this system?	No
Is the pipework suitably insulated?	No
Does the cold-water supply have any inline filters including scale inhibitors/softeners?	No
COMMENTS	
Mains Water Supply Risk Score	Low

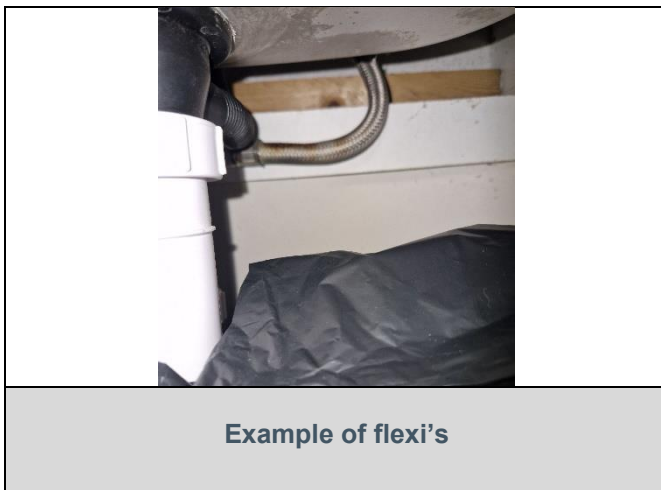
Are dead legs / infrequently used outlets present within system pipework?	No
Are thermostatic mixer valves present on individual outlets?	No
Are there single mixer valves serving a number of outlets?	No
Is the mixed temperature of the pipework >1m?	No
Are flexible hoses fitted to any services on the mains water system?	Yes
Is there any unused equipment connected?	No
Is any scale/debris present on any of the tap outlets?	No
Do any tap outlets have any spray or other inserts fitted?	No
Are strainers fitted?	No

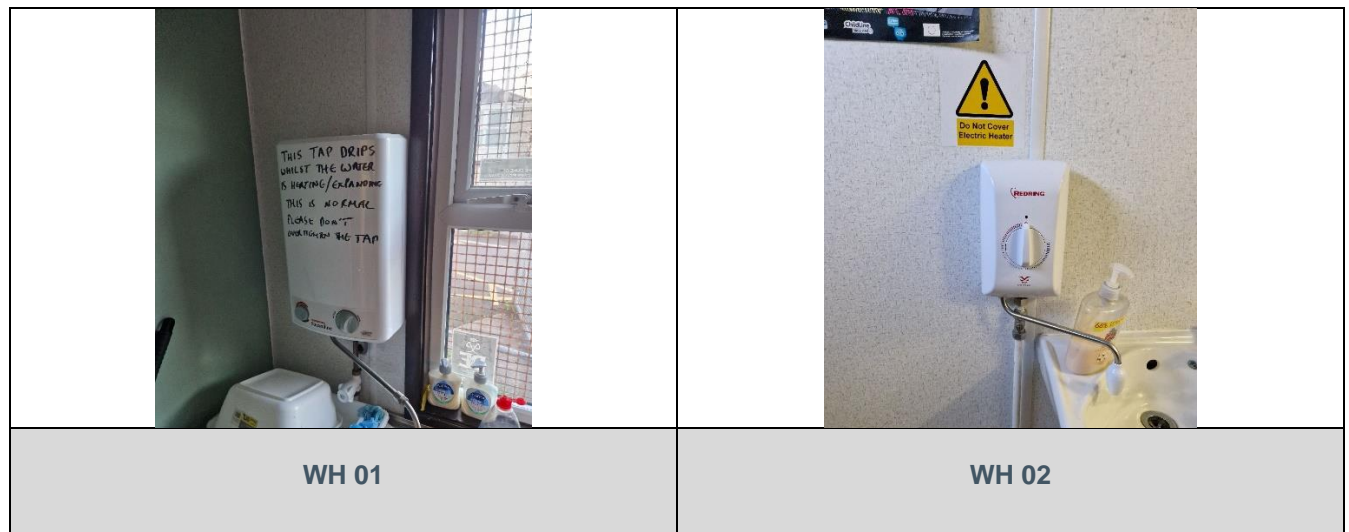
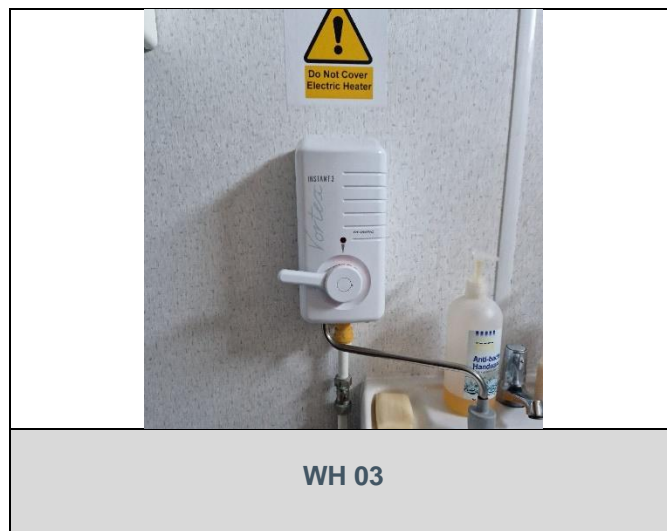
Water Heater ID Number	Location	Make/model and capacity of each heater	Mains or tank fed	Full clean possible	EXPANSION VESSEL INFO	
					Is there a pressure vessel – Yes/No	If yes – make model and size and whether fitted horizontally or vertically
WH 01	Servery	Streamline Sadia	Mains	No	No	
WH 02	Gents	Instant redring	Mains	No	No	
WH 03	Disabled	Instant vortex	Mains	No	No	
WH 04	Ladies	Instant vortex	Mains	No	No
