# LEGIONELLA RISK ASSESSMENT

## THE PREVENTION AND CONTROL OF LEGIONNAIRES' DISEASE

| <b>Site:</b> | Wells Platoon |
| <b>Report Ref:</b> | AQST/LRA/487 |

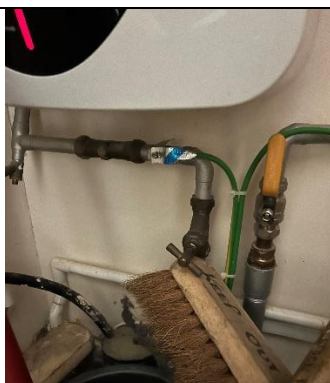
| Mains Water Supply Risk Score | Low |

CWM stop tap

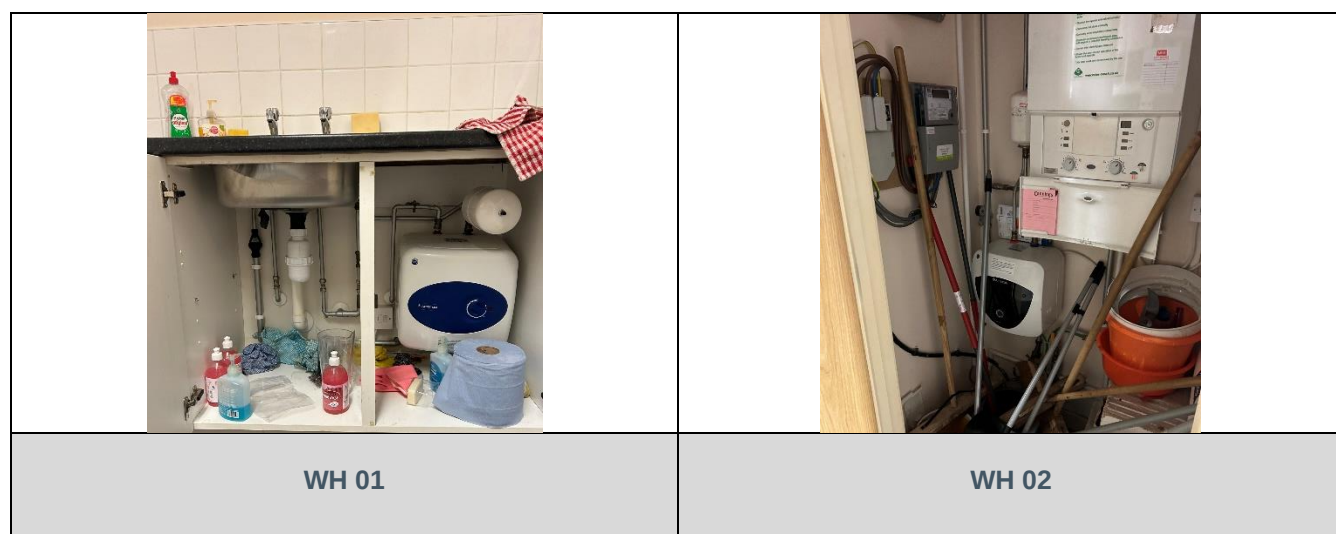
| Water Heater ID Number | Location | Make/model and capacity of each heater | Mains or tank fed | Full clean possible | EXPANSION VESSEL INFO | |
|---|---|---|---|---|---|---|
| WH 01 | Kitchen | Ariston 10ltr | Mains | No | Yes | 2ltr Varem horizontal |
| WH 02 | Cupboard next to Gents | Ariston 10ltr | Mains | No | Yes | 2ltr Varem vertical |

| SYSTEM TYPES | | RISK RATING |
|---|---|---|
| 01 | Wc POU water heater expansion vessel requires a drain off fitting.<br>Kitchen POU water heater expansion vessel should be fitted with a drain valve and installed vertically | Medium |
