LEGIONELLA RISK ASSESSMENT

Client:	Wessex RF & CA
Site:	Clevedon Platoon & ATC
Address:	Albert Road, Clevedon BS21 7SE
Risk Rating:	Low
Report Ref:	AQST/LRA/209
Surveyed By:	Ryan Hill
Survey Date:	21 st September 2023
Report Date:	1 st November 2023
Recommended Review Date:	Sept 2025

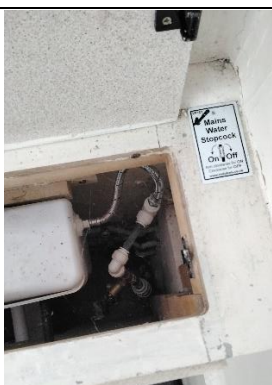
CWM stop tap

Source of supply	Towns mains
Number of mains cold water supply?	1
Location of main isolation valve?	Gents wc behind cistern
Is there a water meter installed?	No
Is the pipework labelled?	Yes
Materials of construction	15mm copper
Are there any materials or fittings visibly present on the mains water system, that do not conform to the Water Regulations Advisory Scheme (WRAS) directory?	No
Mains water temperature °C (sentinel outlets)	Nearest Tap to Incoming Main 17.6 Furthest Tap from Incoming Main 17.6
Are all other distribution temperatures that were tested within the correct temperature range? i.e. Below 20 °C?	Yes
Are there any none flow through expansion vessels to any services on this system?	No
Is the pipework suitably insulated?	Yes
Does the cold-water supply have any inline filters including scale inhibitors/softeners?	No
COMMENTS	
Mains Water Supply Risk Score	Low
