## LEGIONELLA RISK ASSESSMENT

| <b>Site:</b> | Sidmouth Platoon |
| <b>Report Ref:</b> | AQST/LRA/218 |
| <b>Survey Date:</b> | 30 <sup>th</sup> October 2023 |

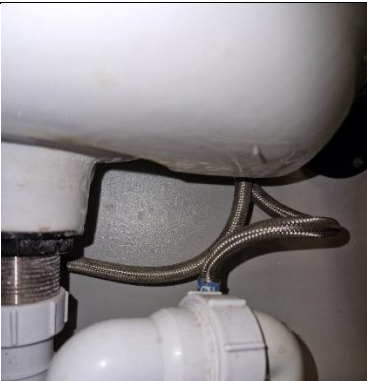
| Example of flexi's | Example of TMV |

| SYSTEM TYPES | | | RISK<br>RATING |
|---|---|---|---|
| 02 | Flexi hoses should be WRAS approved and not coiled/twisted | | High |

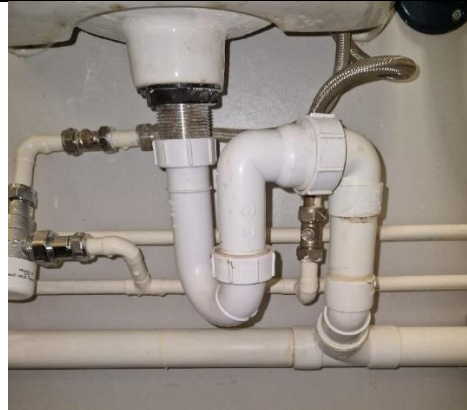
Disabled cold isolated to tap

| SYSTEM TYPES | | | RISK<br>RATING |
|---|---|---|---|
| 03 | Cold feed to disabled tap is isolated – suggest changing tap to push button type (tap currently sprays over the floor) | | High |

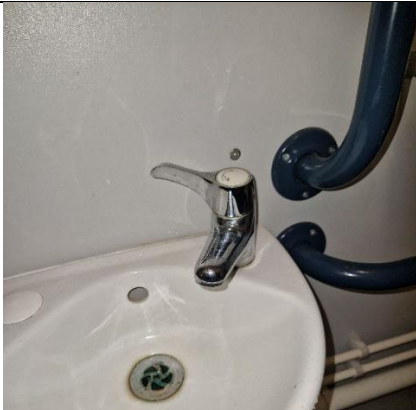
Disabled wc tap
