LEGIONELLA RISK ASSESSMENT

Client:	Wessex RF & CA
Site:	1995 Bradford-on-Avon ATC
Address:	Kennet Gardens, Bradford-on-Avon, Wiltshire BA15 1LT
Risk Rating:	Low
Report Ref:	AQST/LRA/418
Surveyed By:	N. O'Leary
Survey Date:	8 th March 2024
Report Date:	9 th April 2024
Written By:	L. Blakemore
Checked By:	J. Rooney
Recommended Review Date:	March 2026

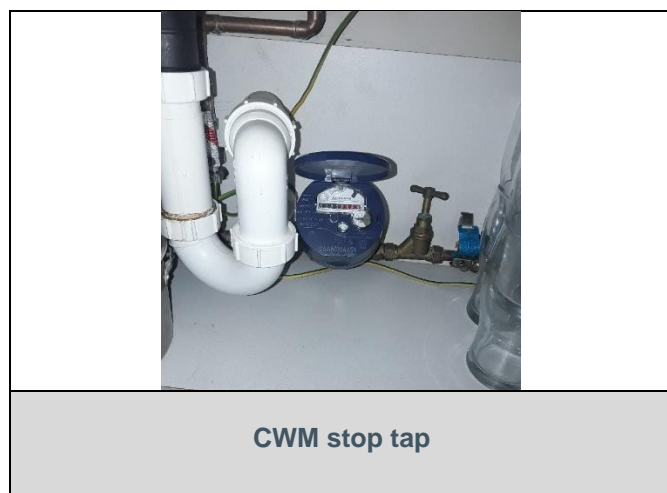
Photos

Source of supply	Mains water supply
Number of mains cold water supply?	1
Location of main isolation valve?	Kitchen
Is there a water meter installed?	No
Is the pipework labelled?	No
Materials of construction	Copper
Are there any materials or fittings visibly present on the mains water system, that do not conform to the Water Regulations Advisory Scheme (WRAS) directory?	No
Mains water temperature °C (sentinel outlets)	Nearest Tap to Incoming Main 9.0 Furthest Tap from Incoming Main 8.0
Are all other distribution temperatures that were tested within the correct temperature range? i.e. Below 20 °C?	Yes
Are there any none flow through expansion vessels to any services on this system?	Yes
Is the pipework suitably insulated?	Yes
Does the cold-water supply have any inline filters including scale inhibitors/softeners?	No
COMMENTS	
Mains Water Supply Risk Score	Low
