LEGIONELLA RISK ASSESSMENT

Client:	Wessex RFCA
Site:	Wyvern Barracks Building 1
Address:	Wyvern Barracks, Barrack Road, Exeter, EX2 6AR
Risk Rating:	Medium
Report Ref:	AQST/LRA/331
Surveyed By:	Jon Barton
Survey Date:	11 th -13 th March 2024
Report Date:	15 th March 2024
Recommended Review Date:	March 2026

PREMISES : Wyvern Barracks – Building 1

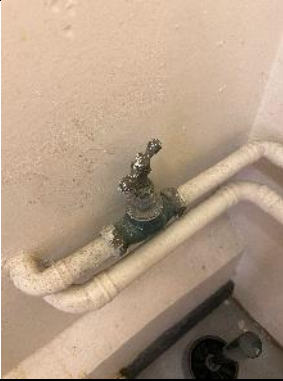
<p>Stop tap within the shower room</p>	<p>Upside down expansion vessel associated with a water heater</p>

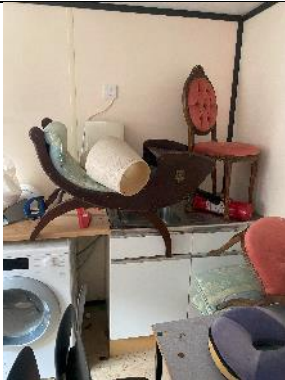
Are dead legs / infrequently used outlets present within system pipework?	Small dead leg and infrequently used outlets located.
Are thermostatic mixer valves present on individual outlets?	No
Are there single mixer valves serving a number of outlets?	No
Is the mixed temperature of the pipework >1m?	-
Are flexible hoses fitted to any services on the mains water system?	No
Is there any unused equipment connected?	Possibly the washing machine in the portacabin
Is any scale/debris present on any of the tap outlets?	No
Do any tap outlets have any spray or other inserts fitted?	Yes
Are strainers fitted?	No

Infrequently used sink in the portacabin.	Locked off external toilets

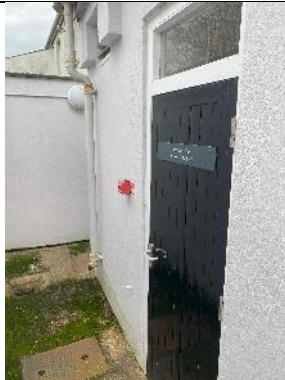
Location:	Assets:	Reason:
Various locked doors	Unknown	This is a military site. It is not reasonably practical to gain access to all locked doors.
Rear external toilets	Hot and cold water	No key available.
