LEGIONELLA RISK ASSESSMENT

Client:	Wessex RF & CA
Site:	Bovey Tracey Platoon
Address:	St Johns Lane, Station Road, Bovey Tracey TQ13 9AL
Risk Rating:	Low
Report Ref:	AQST/LRA/191
Surveyed By:	Ryan Hill
Survey Date:	14 th September 2023
Report Date:	20 th October 2023
Recommended Review Date:	September 2025

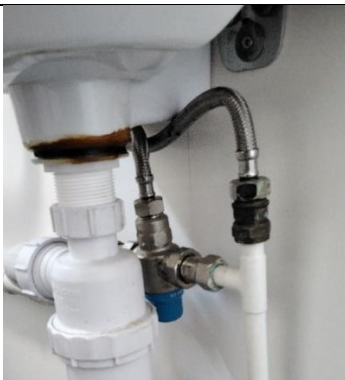
Example of TMV and flexi's

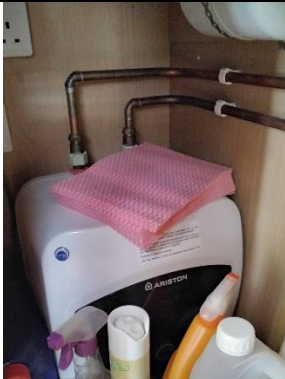
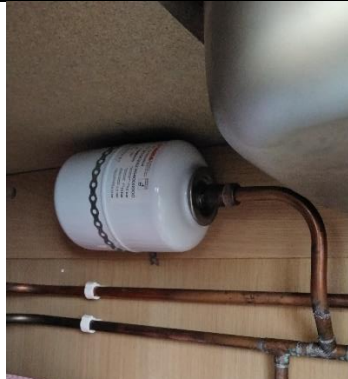
WH 01	WH 01 expansion vessel

Water Heater ID Number	Location	Make/model and capacity of each heater	Mains or tank fed	Full clean possible	EXPANSION VESSEL INFO	
					Is there a pressure vessel – Yes/No	If yes – make model and size and whether fitted horizontally or vertically
WH 01	Kitchen	Ariston 15ltr	Mains	No	Yes	Varem 2ltr horizontal
WH 02	Gents wc	Ariston 15ltr	Mains	No	Yes	Varem 2ltr upside down

SYSTEM TYPES			RISK RATING
	POINT OF USE WATER HEATERS:		
01	Both expansion vessels should be refitted		High
	Actioned date:	Company/initials:
