## LEGIONELLA RISK ASSESSMENT

| <b>Site:</b> | Weston-super-Mare ACF |
| <b>Report Ref:</b> | AQST/LRA/211 |

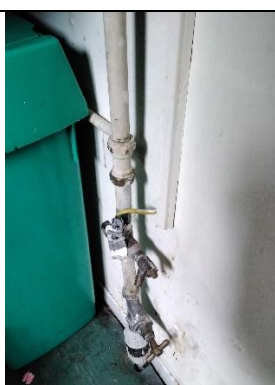
CWM stop tap

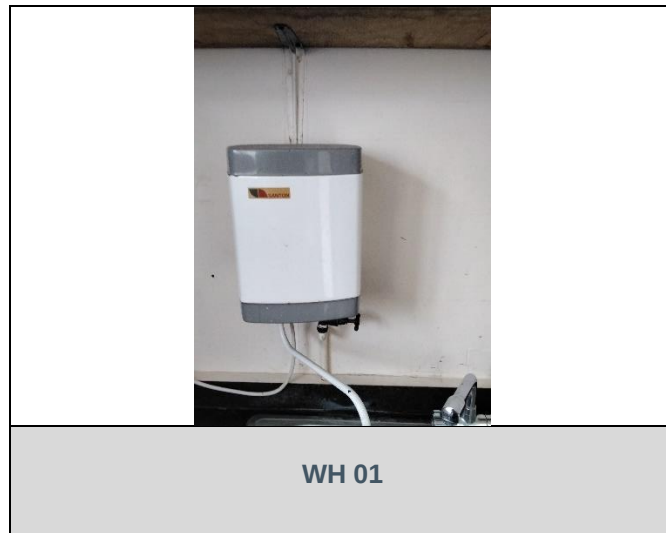
| Water Heater ID Number | Location | Make/model and capacity of each heater | Mains or tank fed | Full clean possible | EXPANSION VESSEL INFO | |
|---|---|---|---|---|---|---|
| WH 01 | Kitchen | Santon 7ltr | Mains | No | No | |
