## LEGIONELLA RISK ASSESSMENT

<b>Client:</b>	Wessex RFCA
<b>Site:</b>	Wyvern Barracks Building 10
<b>Address:</b>	Wyvern Barracks, Barrack Road, Exeter, EX2 6AR
<b>Risk Rating:</b>	High
<b>Report Ref:</b>	AQST/LRA/331
<b>Surveyed By:</b>	Jon Barton
<b>Survey Date:</b>	11 <sup>th</sup> -13 <sup>th</sup> March 2024
<b>Report Date:</b>	15 <sup>th</sup> March 2024
<b>Recommended Review Date:</b>	March 2026

PREMISES : Wyvern Barracks – Building 10

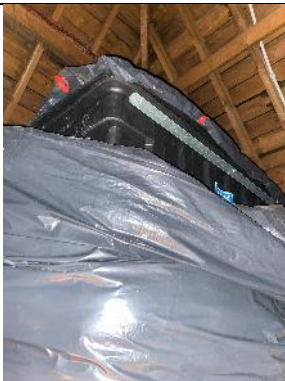
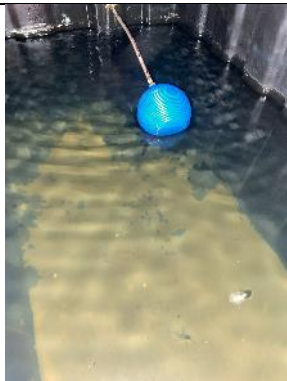
External view	Internal view

Degree of sediment	Heavy
	Biological slime severe/medium/light	Light
	Extent of corrosion	Nil
	Is there adequate crossflow within the tank? i.e. inlet opposed from outlet?	Yes
	Is the stored water over capacity??	No
<b>Labels</b>	Is the tank labelled	Yes
	Supply pipe labelled or coded	Yes
	Outlets labelled or coded	Yes
<b>Operation</b>	How far to adequate drain	20m
	Power supply – volts/distance	5m
	Is lighting adequate	Yes
	Access limit ht x w	800 x 800
<b>CWST Risk Score</b>		<b>High</b>

- Clean and disinfection required
