LEGIONELLA RISK ASSESSMENT

Client:	Wessex RFCA
Site:	Wyvern Barracks Building 9
Address:	Wyvern Barracks, Barrack Road, Exeter, EX2 6AR
Risk Rating:	Medium
Report Ref:	AQST/LRA/331
Surveyed By:	Jon Barton
Survey Date:	11 th – 13 th March 2024
Report Date:	15 th March 2024
Recommended Review Date:	March 2026

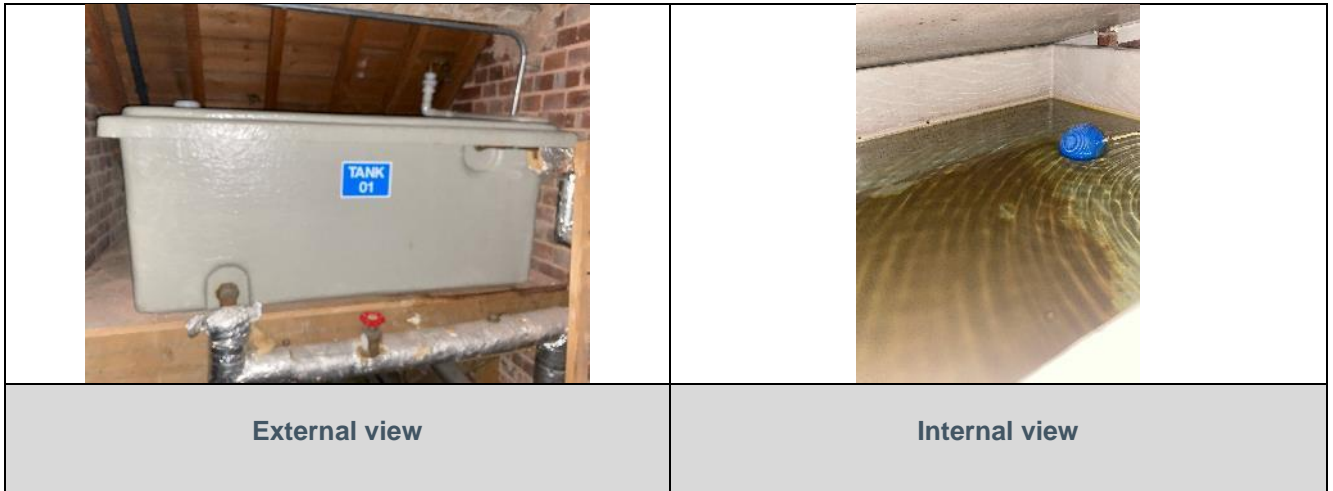
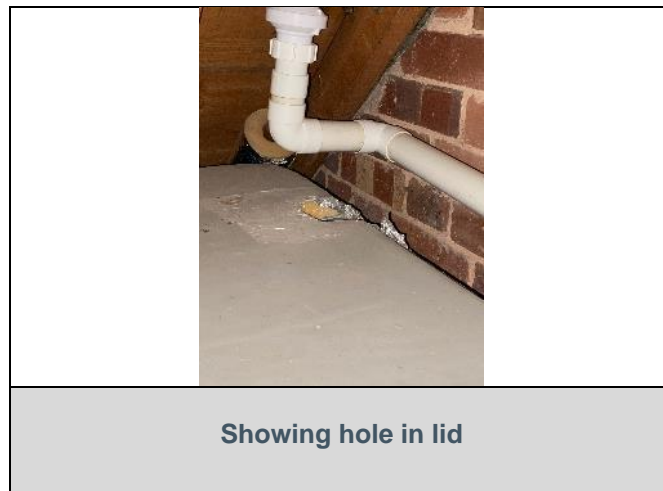
Tank Ref : Tank 1

Location	Exact location of tank	Above male ablutions
Structure	Accurate dimensions lxxh or dia	1300 x 1100 x 550
	Materials of tank and any jointing's	GRP
	Insulation type and thickness	GRP
Lid Details	Is there a close-fitting lid	Yes
	Is it securely fixed in place	Yes
	Accurate dimensions for new lid	1350 x 1150
	Separate ball valve hatch	No
	Vent size has it good rodent screen	Yes 1"
Overflow	Size and materials of main overflow	1 ½ plastic
	Is there a rodent filter	Yes
	Size and materials of warning pipe	N/A
	Is there a rodent filter	N/A
Supply	Size and materials of pipework	22mm copper
	Fed from mains, softener or tank	Mains
	Insulation type and thickness	Foil faced
	Any other return or vent pipes	No
Outlets	Size and Materials	Insulation type and thickness
Outlet 1	42mm copper	Foil faced
Drain valve	Is there a drain valve – size if applicable	N/A
Water in Tank	Temperature C	13.C
	Degree of sediment	Heavy
	Biological slime severe/medium/light	Medium

Extent of corrosion	Nil
	Is there adequate crossflow within the tank? i.e. inlet opposed from outlet?	No – no stagnation issues observed
	Is the stored water over capacity??	No
Labels	Is the tank labelled	Yes
	Supply pipe labelled or coded	Yes
	Outlets labelled or coded	Yes
Operation	How far to adequate drain	20m
	Power supply – volts/distance	10m
	Is lighting adequate	Yes
	Access limit ht x w	1130 x 640
CWST Risk Score		High

- Clean and disinfection required.
- Hole in lid requires covering.

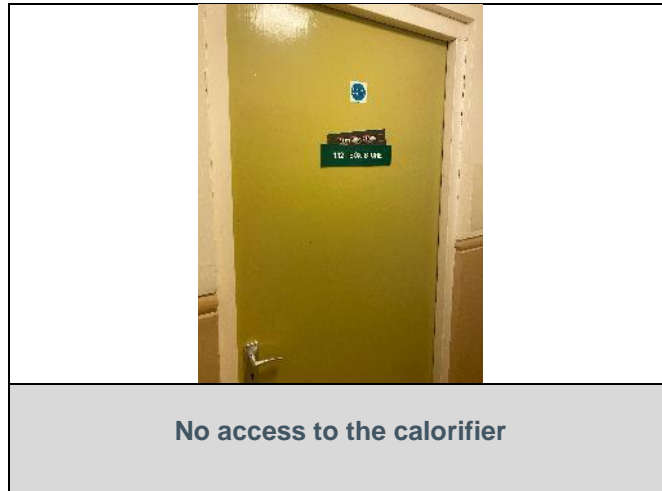
HWSV Ref : Cal 1

Is pipe work coded/labelled	
Power supply voltage/distance	
How far to adequate drain	
Periods of availability for working	
Access limit Height x width	
Temperature from nearest hot outlet	76.C
Hot Water Storage Vessel Risk Score

-No access to the time of the survey. Ensure keys are available upon request.

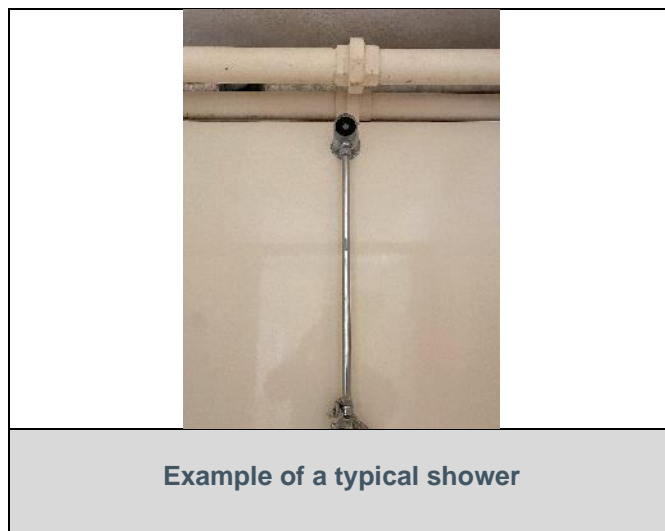
6.5 SHOWERS & SPRAY OUTLETS

Location	Nos of showers	Dismantled/ cleaned and disinfected YES/NO	Overall condition	Any repairs replacements	Regularity of Use
Male ablutions	4	No	Good	No	Unknown
Female ablutions	1	No	Good	No	Unknown
COMMENTS:					
<ul style="list-style-type: none"> The showers are in a satisfactory condition. Weekly flushing required if not used weekly.

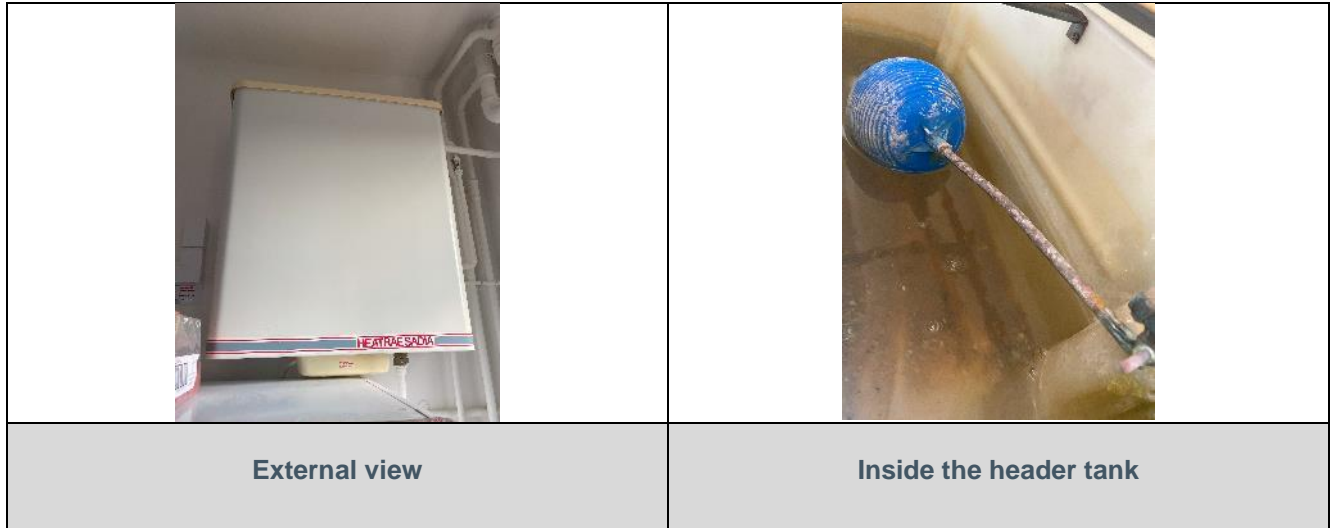
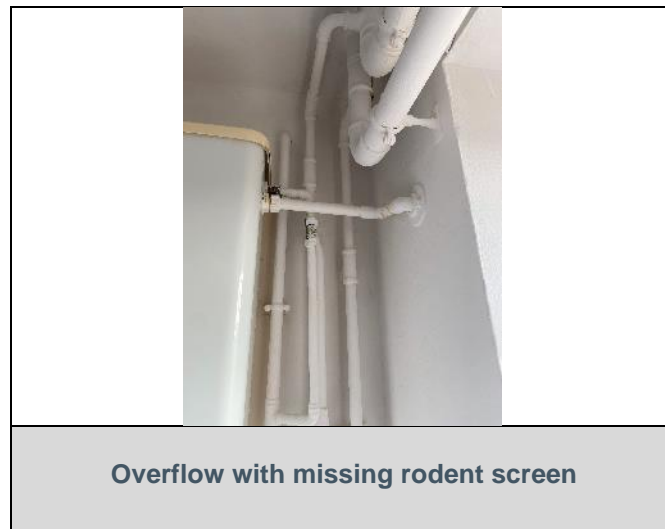
6.7 POINT OF USE WATER HEATERS

Water Heater ID Number	Location	Make/model and capacity of each heater	Mains or tank fed	Full clean possible	Is there a pressure vessel – Yes/No	If yes – make model and size and whether fitted horizontally or vertically
1	Room 8 kitchen	Sadia 25	Mains	Yes	No	-

Actioned date:	Company/initials:	
The outlet temperature represents a scald risk (76.C). Reduce the hot water temperature to a more suitable range.		H & S
Actioned date:	Company/initials:	
POINT OF USE WATER HEATERS:		
The combination water heater should be set to 60.C		High
Actioned date:	Company/initials:	
The water heater header tank requires cleaning and disinfecting		Medium
Actioned date:	Company/initials:	
The overflow pipe is missing a 22mm rodent screen on the overflow		Low
Actioned date:	Company/initials:	
SHOWERS AND SPRAY OUTLETS:		
Satisfactory		
GENERAL: Control Schemes		
There is a new logbook on site. This logbook new logbook should contain the following information: -A copy of this risk assessment -An up to date management structure listing the on-site responsible people -The RFCA legionella policy -Aquastat's reports (or add a statement showing where these records are kept) -Evidence of any servicing/maintenance -Results from any legionella or TVC samples		High

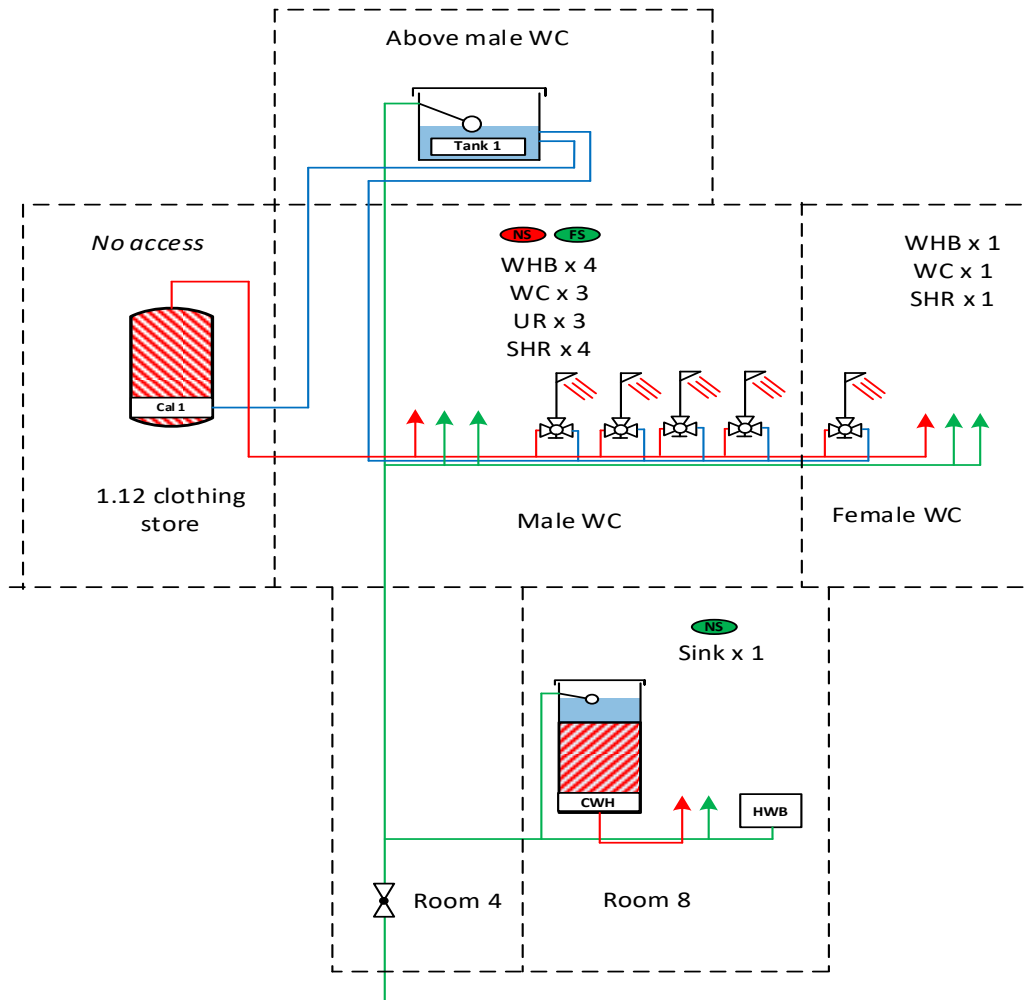
8. LINE DRAWINGS OF WATER SYSTEMS SITE: Wyvern Barracks - Building 9

NB: Due to the complexity of the pipe work at this site it is not possible to ensure the total accuracy of these line drawings. They may require revision.
